TECHNICAL SERVICE BULLETIN

Bulletin Number: T-16-02

VERSION: R03 (February 23, 2017)

2016-2017 SLINGSHOT – Stat-O-Seal Replacement

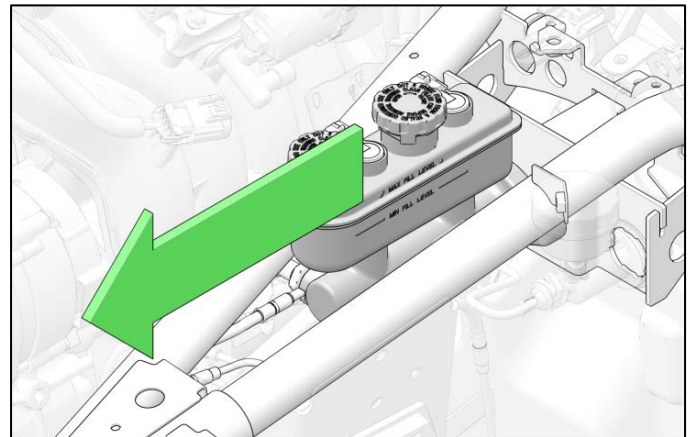
Certain Slingshot vehicles may have been manufactured where the brake pressure switch was over torqued. This may result in a yielded brake seal posing a leak in the brake system. A leak in the brake system, after a period of non-use, may result in decreased brake performance increasing the risk of a crash.

9. Gently slide the Master Cylinder forward to allow access to the Brake Pressure Switches.

Be careful when moving the Master Cylinder not to damage any brake lines, wiring, or the master cylinder boot.
