GROUP  
Safety Recall Campaign

MODEL  
2008-2009MY  
Sportage (KM)

NUMBER  
SC138 (Rev 1, 4/19/2017)

SUBJECT: HECU ASSEMBLY AND CONNECTOR COVER  
INSPECTION AND REPLACEMENT (SC138)

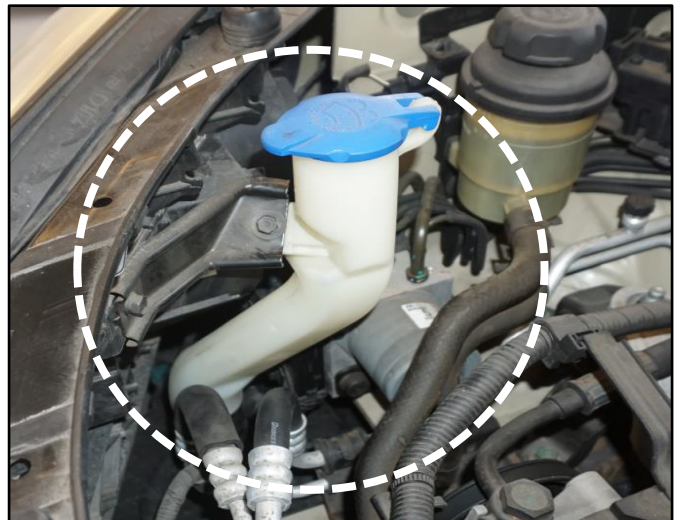
2. Loosen bolt and remove washer fluid filler neck to provide access to the HECU.

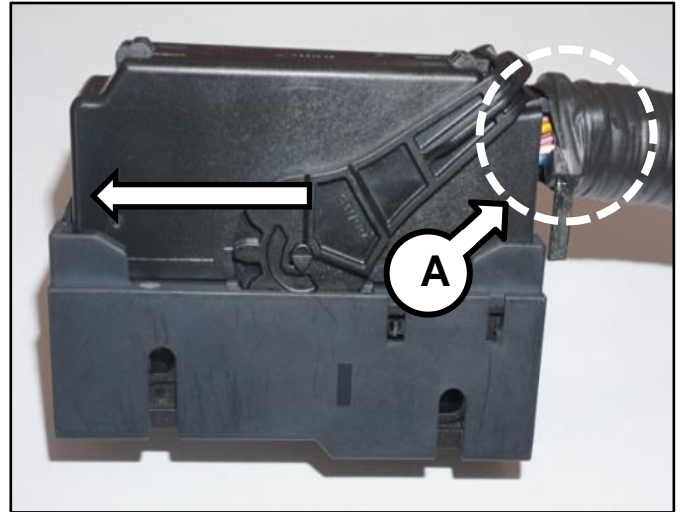
3. Move locking lever to release the connector and remove it from the HECU.  
Carefully cut the zip tie and tape (A).

Connector shown removed from the HECU for illustration purposes only.

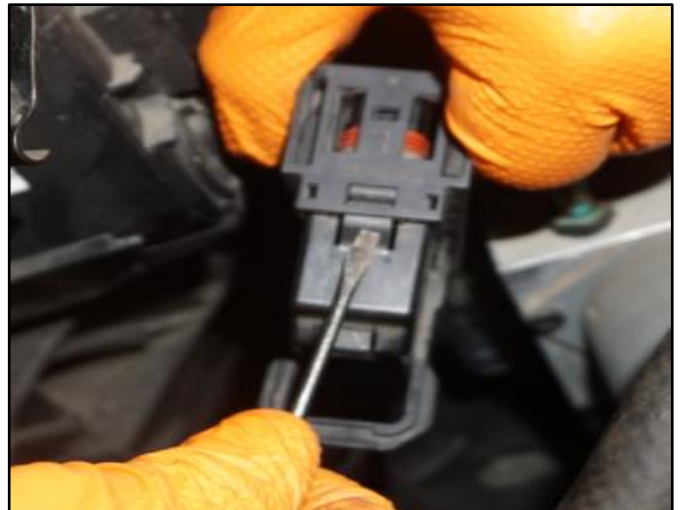
4. Press tab to release, remove, and discard the old connector cover.

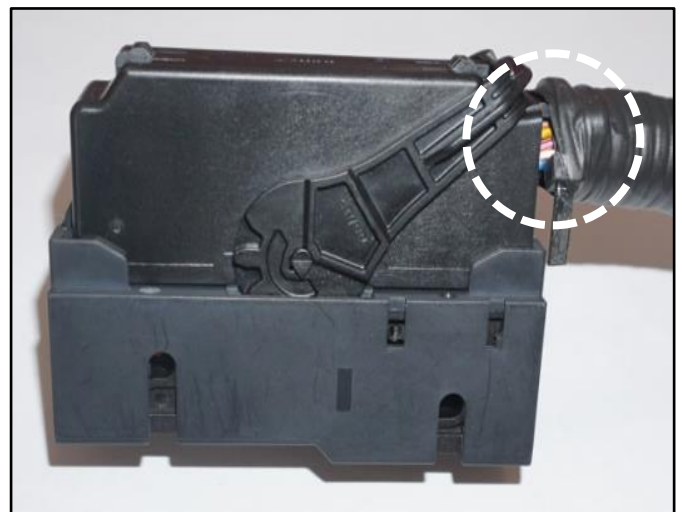
5. Use the correct new cover. (Refer to the parts information on page 9.) The three (3) different production ranges overlap; always select the new cover so that it matches the original.

Check for “clicking” sound to make sure the cover is locked onto the connector.

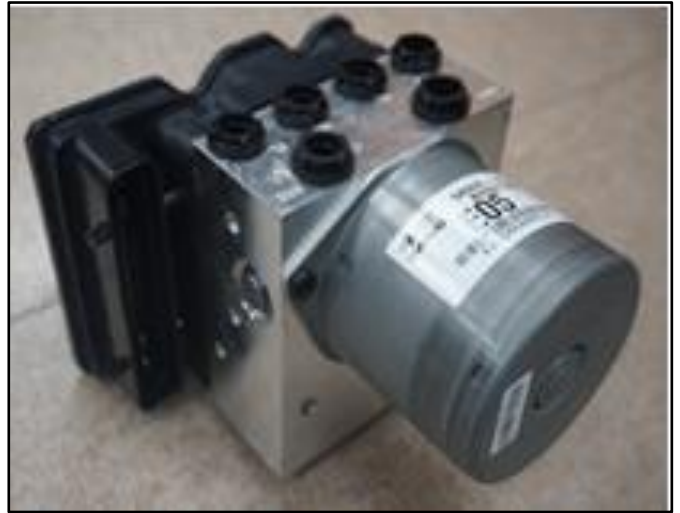
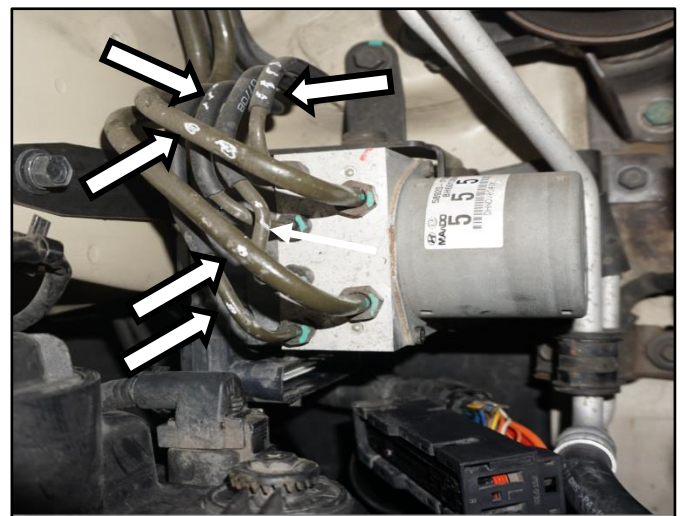
2. Mark HECU lines prior to removing the HECU and document for future reference to avoid incorrect re-assembly.

Remove the lines and remove the HECU.

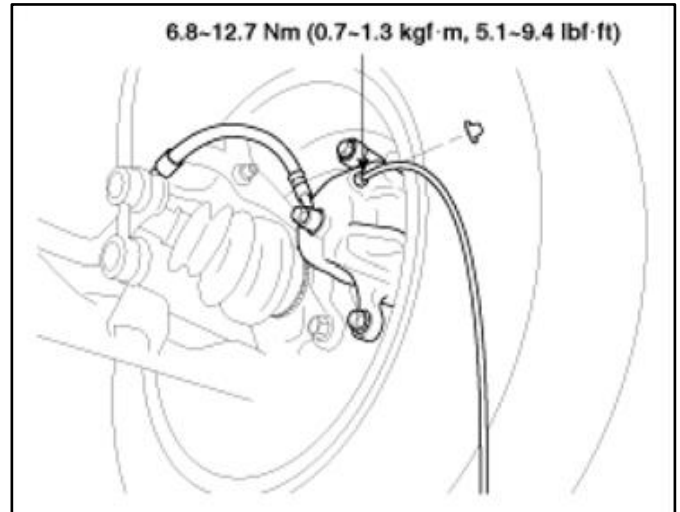
12. Pump the brake pedal several times, and then loosen the bleeder screw on the right rear wheel until fluid starts to run out without bubbles.

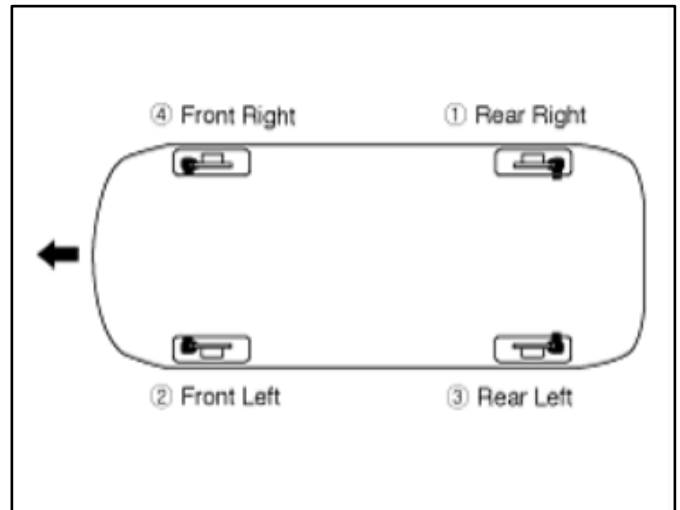
13. Follow sequence shown in the illustration.

Repeat step 12 for each wheel until there are no more bubbles in the fluid.
