Thor Motor Coach Recall Repair Instructions

Recall # **16V-893**

Description/Title: **Mor-Ryde Ramp Door Hinge Assembly Weld Failure**

Affected Product Line(s): **Certain 2016 and 2017 Outlaw Motor Homes**

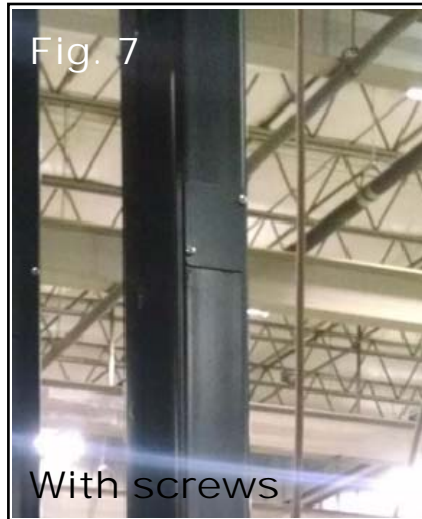
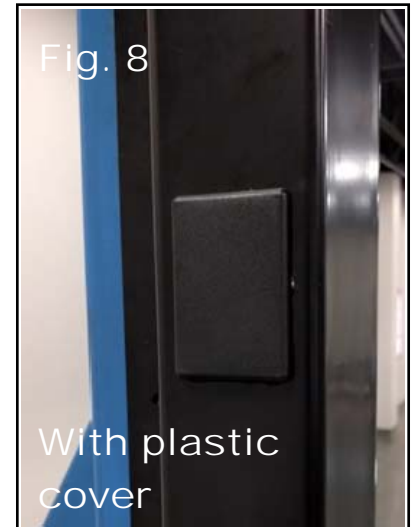
Mor-ryde Hinge Replacements - Open rear ramp door and remove covers over the spring adjusting bolts on both sides of frame. There are two different versions of these covers as shown in Figures 7 and 8.

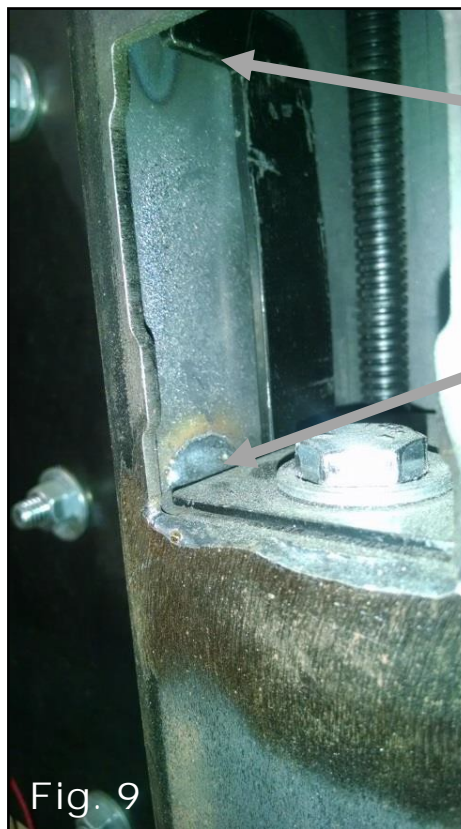
After the cover is removed, mark the position of the hook and loosen the 3/4" bolt until the hooks touch the plate that the bolt head is sitting on, Figure 9. Do this on both sides of the frame. It is easiest to use an air ratchet for this.

Loosen bolt using a 3/4" socket until this hook touches the plate that the bolt head is sitting on.

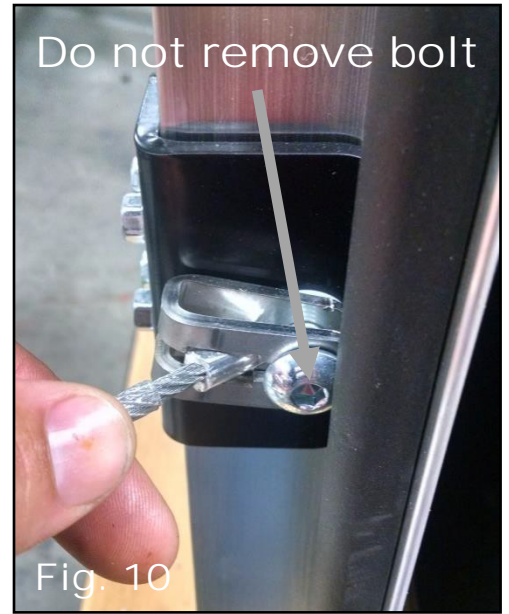
To unhook the cable from the door, close the door until the cable no longer has tension on it. With a pair of needle nose pliers, push the end of the cable into the clip and pull the cable end out first, Figure 10. **Do not remove the cable bracket.** Repeat on opposite side. **Warning!** At this point, you have all the weight of the door to control.

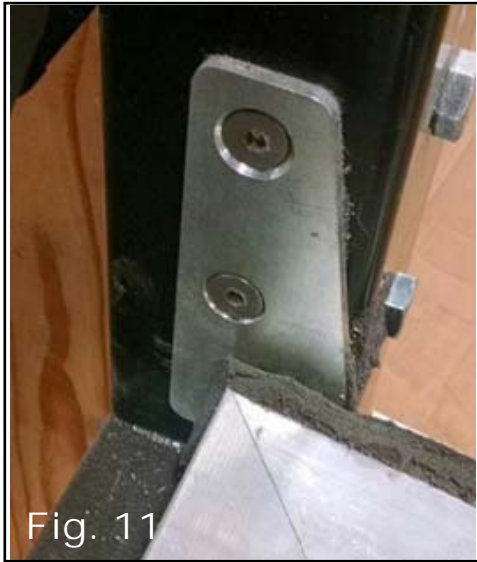
Carefully lower the door down to the ground supporting the door and being careful not to damage the door or the frame. Starting with the bottom bolt, remove the hinges and replace with new, Figure 11. Replace both hinges.

Using the Mor-ryde Hinge Replacement steps above in reverse, reinstall the door and adjust tension to original marked position of the hook. Reseal the hinge using black silicone.
