RECALL CAMPAIGN BULLETIN

NTB17-005

VOLUNTARY RECALL CAMPAIGN 2015-2016 ROGUE OCCUPANT CLASSIFICATION SYSTEM CONTROL UNIT REPLACEMENT

APPLIED VEHICLE: 2015-2016 Rogue (T32)

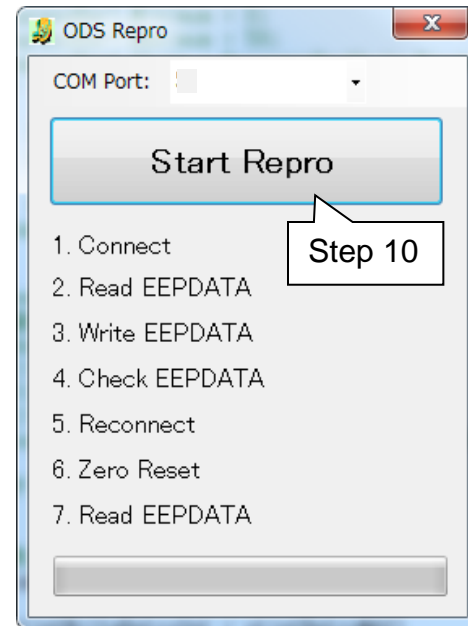
Figure 5

NOTE: If the error message “an error occurred on connection” displays:

- a. Disconnect the J-51594 OCS reprogramming cable, both ends.
- b. Reconnect the cable; make sure it is securely connected at both ends.

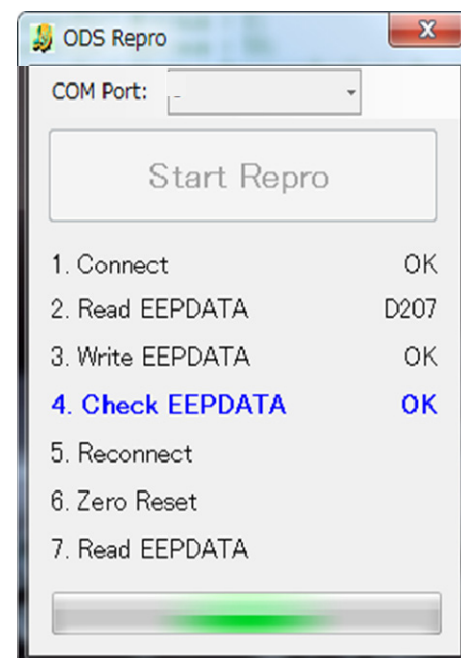
Figure 7

- Items 1 through 4 (Figure 7) will likely complete quickly.
- If the OCS reprogramming stops (displays NG) at item 1, 2, 3 or 4, refer to Figures 12 through 15 on pages 12 and 13.

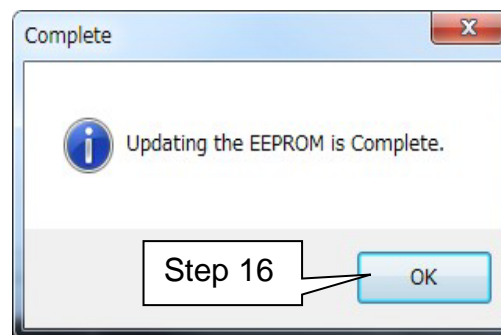
Figure 10

15. When this screen displays (Figure 10), OCS reprogramming is complete.
