IMPORTANT SAFETY RECALL
NHTSA Recall# 16V-659

Wabash National Corporation (WNC) has decided that a defect which relates to motor vehicle safety, exists in certain converter dollies manufactured by WNC.

Subject: Converter Dollies

Re.: Version 2A: Welded Repair

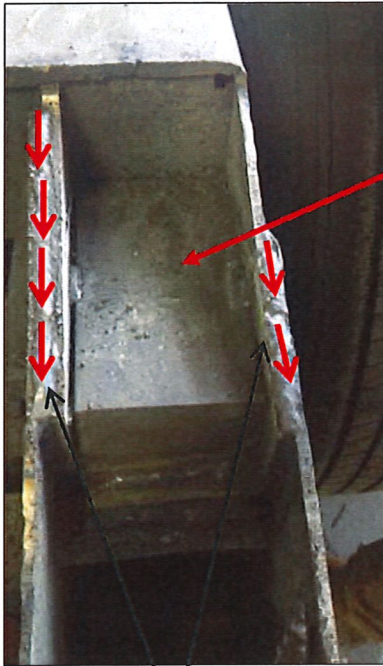
Figure 6

Please note that this block will not be present on all models, and is of no structural concern.

Step 5: Apply Interior Welds (Fig 6)

- Apply the 7" & 4" lap joint welds that were just previously tacked into position.
