Bulletin No.: 20760B
Date: March 2016

PRODUCT SAFETY RECALL

SUBJECT: Brake Pedal Pivot Nut/Bolt Loose

MODELS: 2015 - 2016 Chevrolet Silverado Crew Cab LD with Special Services (RPO 5W4)
2015 - 2016 Chevrolet Silverado HD
2015 - 2016 Chevrolet Tahoe PPV (RPO 9C1)
2015 - 2016 Chevrolet Tahoe with Special Services (RPO 5W4)
2015 - 2016 GMC Sierra HD

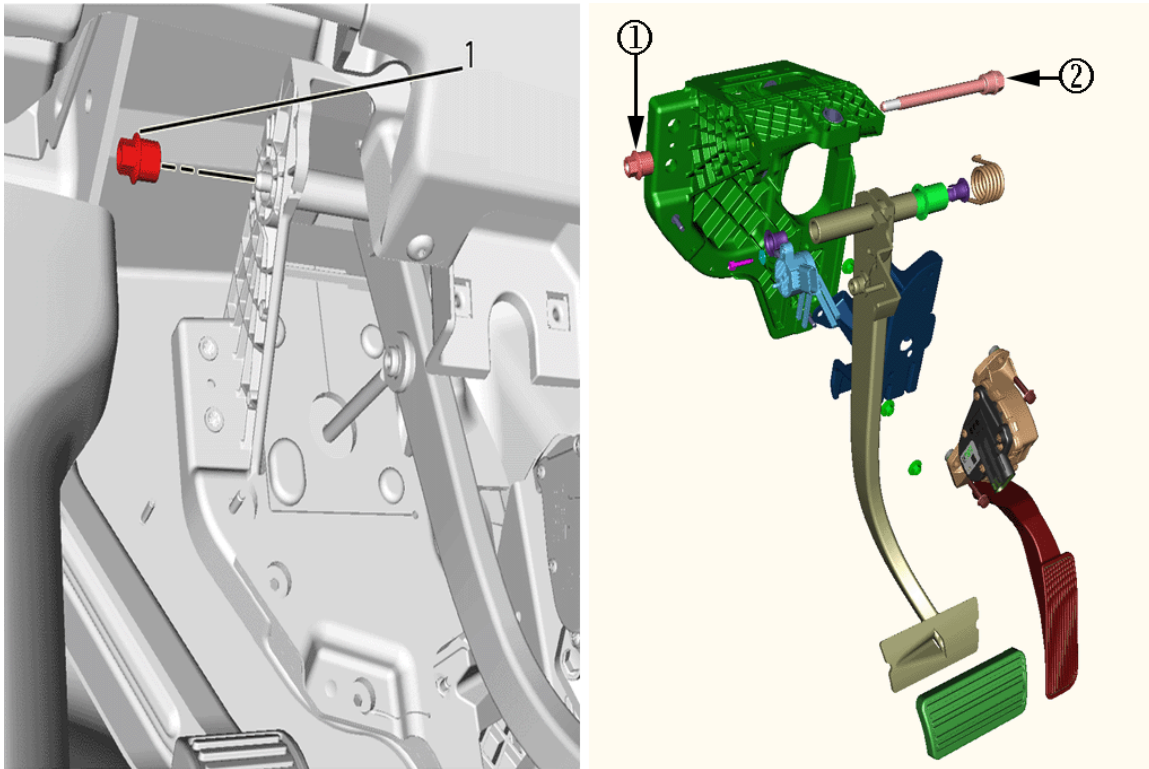
Caution: Apply pressure to the brake pedal pivot bolt while removing the nut to ensure the bolt does not back out of the housing. Part damage could occur if the bolt backs out of the housing.

5. Holding the brake pedal pivot bolt (2) with a box end wrench, remove the brake pedal pivot nut (1).

7. Holding the brake pedal pivot bolt (2) with a box end wrench, install the brake pedal pivot nut (1).
8. Holding the brake pedal pivot bolt with a box end wrench, torque the brake pedal pivot nut to 26 Nm (19 lb ft).
9. On vehicles equipped with a manual transmission, install the clutch pedal. Refer to *Clutch Pedal Replacement* in SI.
10. Install the Floor Front Air Outlet Duct - Left Side. Refer to *Floor Front Air Outlet Duct Replacement - Left Side* in SI.
11. Install the Instrument Panel Knee Bolster. Refer to *Instrument Panel Knee Bolster Replacement* in SI.
