Recall Bulletin

PRODUCT SAFETY RECALL

SUBJECT: Brake Pedal Pivot Nut/Bolt Loose

MODELS: 2015 – 2016 Chevrolet Silverado HD
2015 – 2016 Chevrolet Tahoe PPV (RPO 9C1)
2015 – 2016 GMC Sierra HD

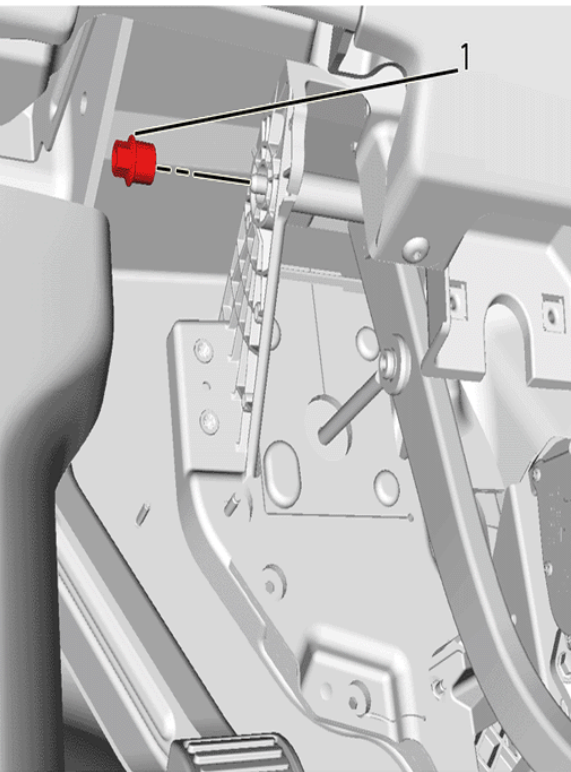
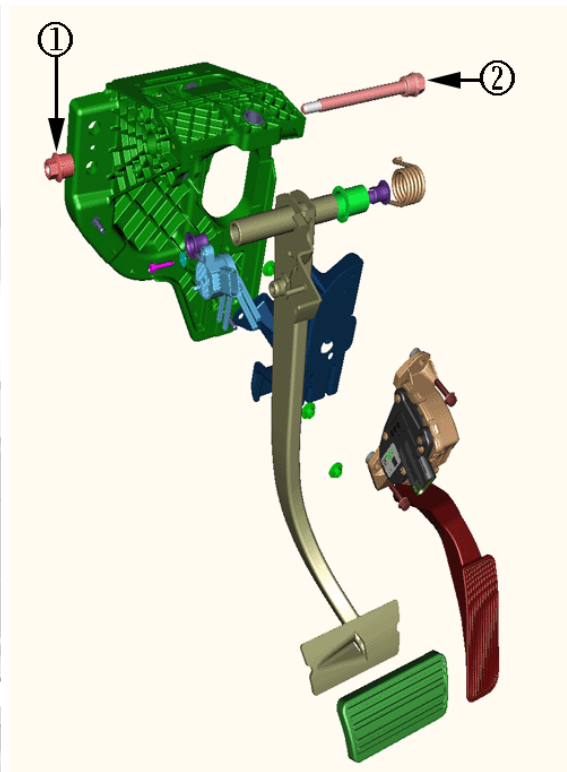
Caution: Apply pressure to the brake pedal pivot bolt while removing the nut to ensure the bolt does not back out of the housing. Part damage could occur if the bolt backs out of the housing.

4. Holding the brake pedal pivot bolt (2) with a box end wrench, remove the brake pedal pivot nut (1).
