Product Safety Recall

15826 Front Passenger Air Bag Inflator

Reference Number: N150826000

Release Date: March 2017
Revision: 00

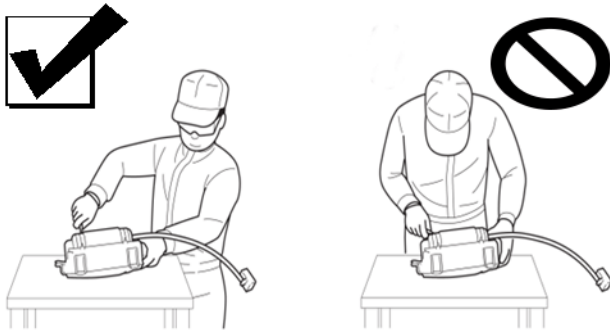
4751076

Warning: Confirm the stopper plate to inflator fitment is correct. **DO NOT** pinch the harness between the inflator and the stopper plate.

Warning: When working with the airbag module, avoid standing directly in front of the parts
