Product Safety Recall

15826-01 Front Passenger Air Bag Inflator

Reference Number: N150826000

Release Date: May 2017
Revision: 01

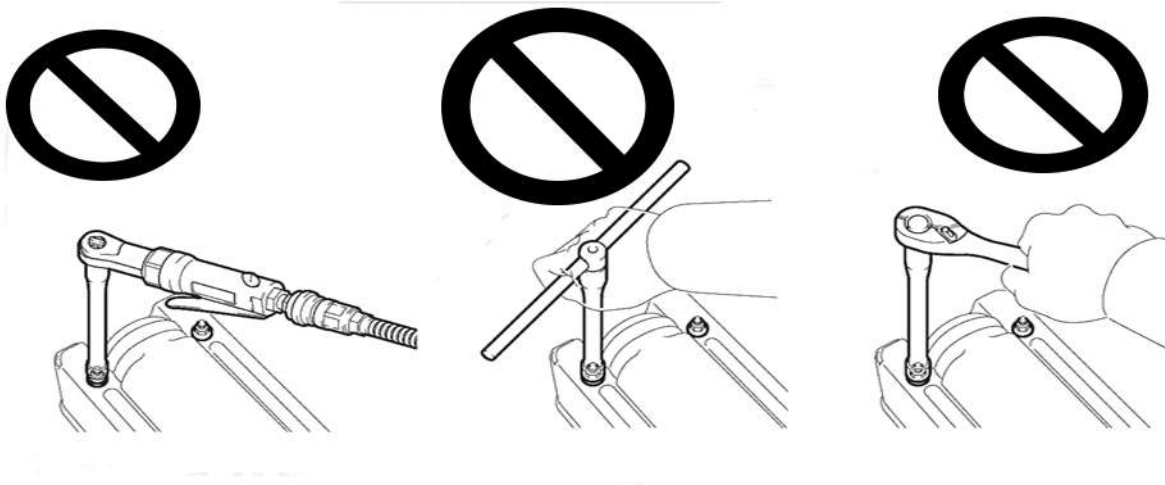
4751084

Important: If any gap exists, the aligned flats may move apart, resulting in failure in normal deployment of the airbag.

8. Remove the 3 remaining old self-locking nuts and install temporarily 3 **NEW** self-locking nuts by hand. Store the removed self-locking nuts in a replacement part box or the like.
9. Push the inflator and plate to towards the position determining plate to eliminate any gap.

Important: The tightening torque is low (3.9 N·m). Use of an air ratchet wrench or tightening strongly with a T-handle wrench or a ratchet handle may cause deformation of the stud bolt.
