Product Safety Recall

16146 Right Rear Side Air Bag

Reference Number: N162076520

Release Date: January 2017

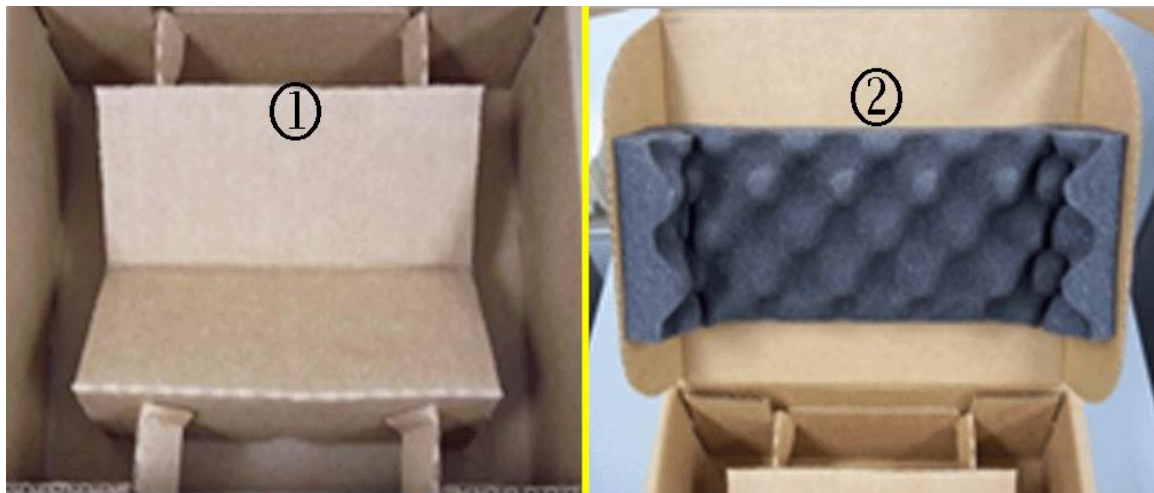
3961570

Important: The components required for the completed return package are dunnage (1) and foam (2), as shown in the graphic above.

1. **DO NOT DEPLOY THE AIRBAG.** Ensure that the box the replacement airbag arrived in is not damaged and place the side impact airbag in the box. Also, make sure to include a copy of the repair order in the box.

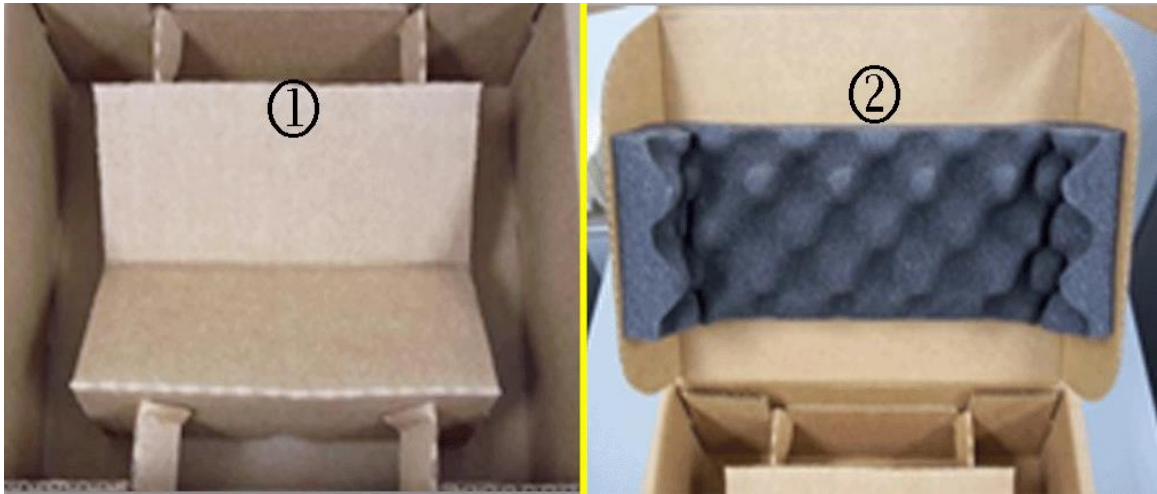
3961570

Important: The components required for the completed return package are dunnage (1) and foam (2), as shown in the graphic above.

1. **DO NOT DEPLOY the AIRBAG.** Ensure that the box the replacement airbag arrived in is not damaged and place the side impact airbag in the box. Also, make sure to include a copy of the repair order in the box.
