SERVICE BULLETIN

UTILITY TRAILER MANUFACTURING CO.

SB-08-200

Subject: BENDIX SR-5 VALVE Recall – INTERIM NOTIFICATION

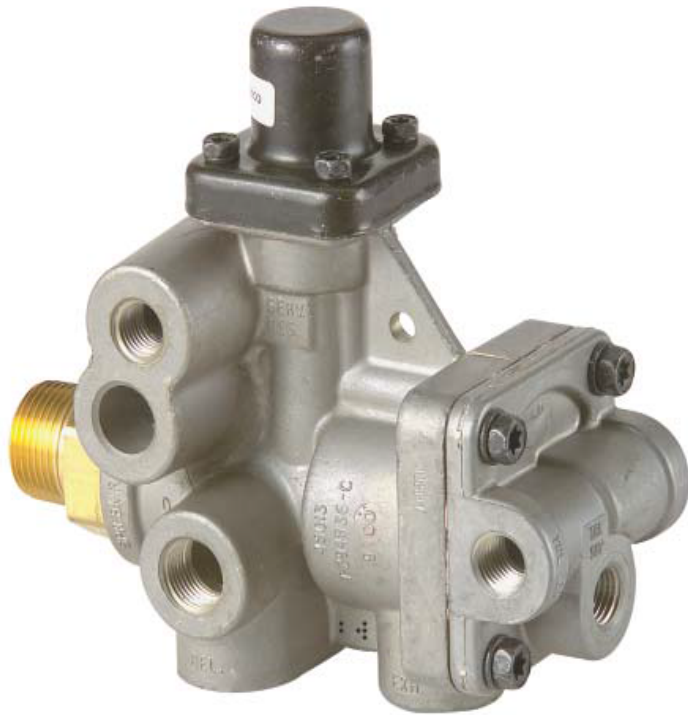
Under certain conditions (primarily off-highway or in trailer yards) there can be a delay in the application of the spring brakes to park the trailer after the operator pulls the dash valve button. This slow to park condition could lead to trailer roll away after decoupling from the tractor.

If the internal leakage develops in the SR-5, a leak can be heard or observed. This leakage will continue until the trailer reservoirs & spring brake chambers are depleted of air pressure.

Additionally, if uncoupled & the internal leakage is present, there will be a loss of air pressure in the trailer reservoir, resulting in the eventual parking of the brakes. ‘Slow to apply’ condition can range from 30 seconds to several minutes depending on the severity of the leak (compared to <3 second compliance requirement)

Missing Radius on Aluminum valve Body

When combined with certain field conditions – causes misalignment of internal Check Valve

To verify that the Bendix® SR-5™ valve has been repaired per the recall campaign, look for the presence of a black or green tie wrap secured to the valve body. **No further action is required.**
