# SERVICE CAMPAIGN BULLETIN

SUBJECT:			No: <b>SC-15-004REV</b>
<b>POTENTIAL TRANSMISSION SHUDDER/SURGE – SERVICE CAMPAIGN – REVISED</b>			DATE: <b>October, 2016</b>
			MODEL: <b>2016 Outlander</b>
CIRCULATE TO:	<input checked="" type="checkbox"/> GENERAL MANAGER	<input checked="" type="checkbox"/> PARTS MANAGER	<input checked="" type="checkbox"/> TECHNICIAN
<input checked="" type="checkbox"/> SERVICE ADVISOR	<input checked="" type="checkbox"/> SERVICE MANAGER	<input checked="" type="checkbox"/> WARRANTY PROCESSOR	<input checked="" type="checkbox"/> SALES MANAGER

***This bulletin supercedes SC-15-004, issued December 2015, to provide clarification regarding vehicles covered by both SC-15-004 and SR-16-006 “CVT Hesitation – Safety Recall Campaign.” Revisions are italicized and indicated by ◀.***

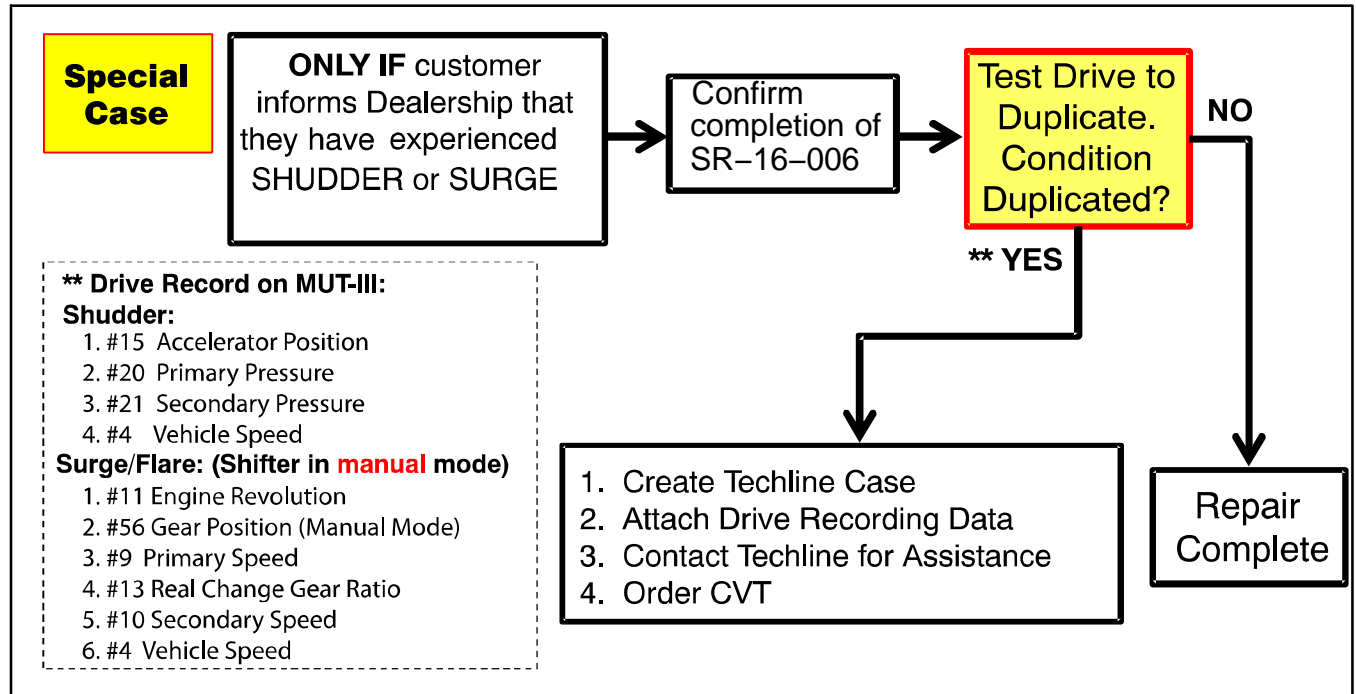
## PROCEDURE FOR SHUDDER/SURGE CONDITION (Only if Reported by Customer)

Certain vehicles with CVT-8 transmissions may exhibit a shudder condition at low speeds (10 – 40 mph), or a surge/flare of engine rpm at higher speeds. This may be caused by a malfunctioning of the CVT's hydraulic pressure control software. In the worst case scenario, with continued driving under these conditions, the CVT belt may become damaged, causing a warning light to turn on.

Condition	Driving Criteria	Judgment Criteria
<b>Pattern A</b> (Slow acceleration)	Shudder	<ul style="list-style-type: none"> <li>Slow &amp; gentle acceleration</li> <li>10 to 40 MPH</li> <li>Constant acceleration</li> <li>Approximately 10% throttle angle</li> <li>Slight uphill grade or flat road</li> </ul>	<ul style="list-style-type: none"> <li>Vehicle shuddering is felt</li> <li>Can be described also as a "bucking"</li> <li>Can also be described as a "judder" or repeated "jerking"</li> </ul>

Condition	Driving Criteria	Judgment Criteria
<b>Pattern B</b> (Constant Vehicle Speed)	Surge/Flare	<ul style="list-style-type: none"> <li>Steady speed highway driving (follow all applicable laws) <ul style="list-style-type: none"> <li>~ 40 MPH</li> <li>~ 50 MPH</li> <li>~ 65 MPH</li> </ul> </li> <li>ATF Temp &gt; 158 F (warmed up)</li> <li>Shifter in <b>Manual</b> Mode</li> </ul>	<ul style="list-style-type: none"> <li>Engine RPM surging or flaring (more than 200 RPM from base) at steady state vehicle condition</li> </ul>

Follow this procedure ONLY if customer has reported experiencing a shudder or surge condition.

1. Verify that the vehicle has been reprogrammed according to SR-16-006.
2. Test drive the vehicle to see if the shudder/surge condition can be duplicated.

Refer to **FIGURE 1** and **FIGURE 2**: Setup MUT-III with the applicable Drive Record parameters, then follow the Test Drive procedures to duplicate these conditions.

3. Was the shudder/surge condition duplicated?
  - **YES** – Go to step 4.
  - **NO** – Repair is complete. Return vehicle to customer.
4. Create a Techline case.
5. Attach the following Drive Recording Data from MUT-III to the Techline case.

6. Contact Techline for assistance.
7. Order the applicable new CVT-8 transmission assembly.
8. Replace the CVT-8 transaxle, flush the external cooler, and perform the CVT ECU coding procedures found in TSB-15-23-001.
