David J. Johnson  
Director  
Service Engineering Operations  
Ford Customer Service Division

**SUBJECT:** **Safety Recall 17S01 – Supplement #10**

Certain 2005-2006 Ford GT, 2005-2009 and 2012 Mustang, 2006-2009 Milan, 2006-2009 and 2012 Fusion and MKZ/Zephyr, 2007-2009 Edge and MKX, and 2007-2009 Ranger Vehicles  
Passenger Airbag Inflator Replacement

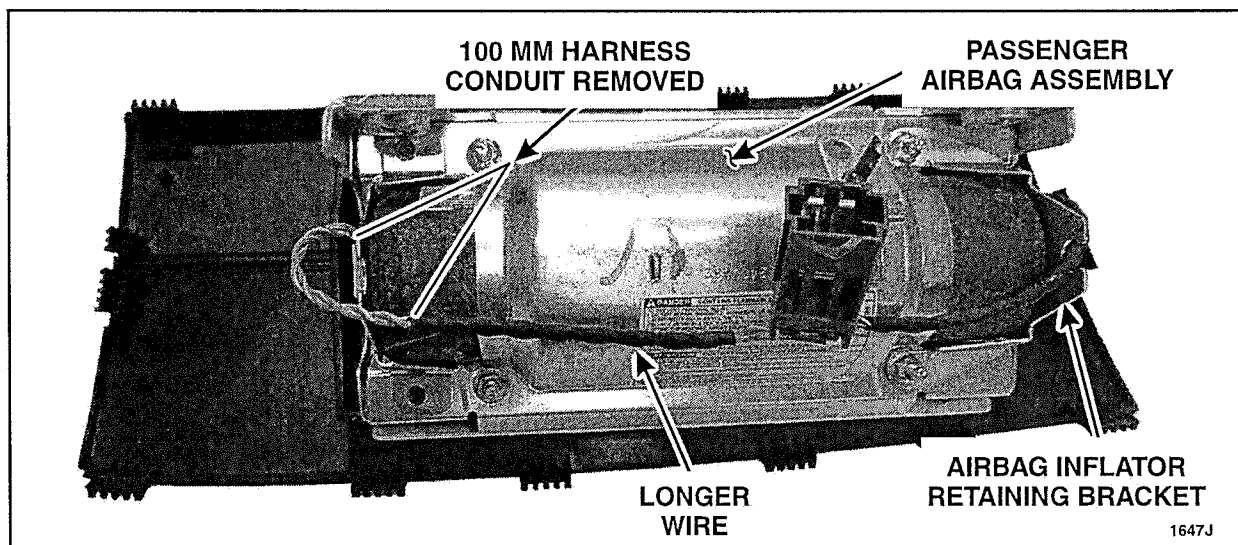
**FIGURE 2**

**NOTE:** Carry out this step on the longer wire on the end opposite of the airbag inflator retaining bracket. See Figure 2.

4. Remove approximately 100 mm (3.93 in) of the conduit from the passenger airbag assembly wire harness. See Figure 2.

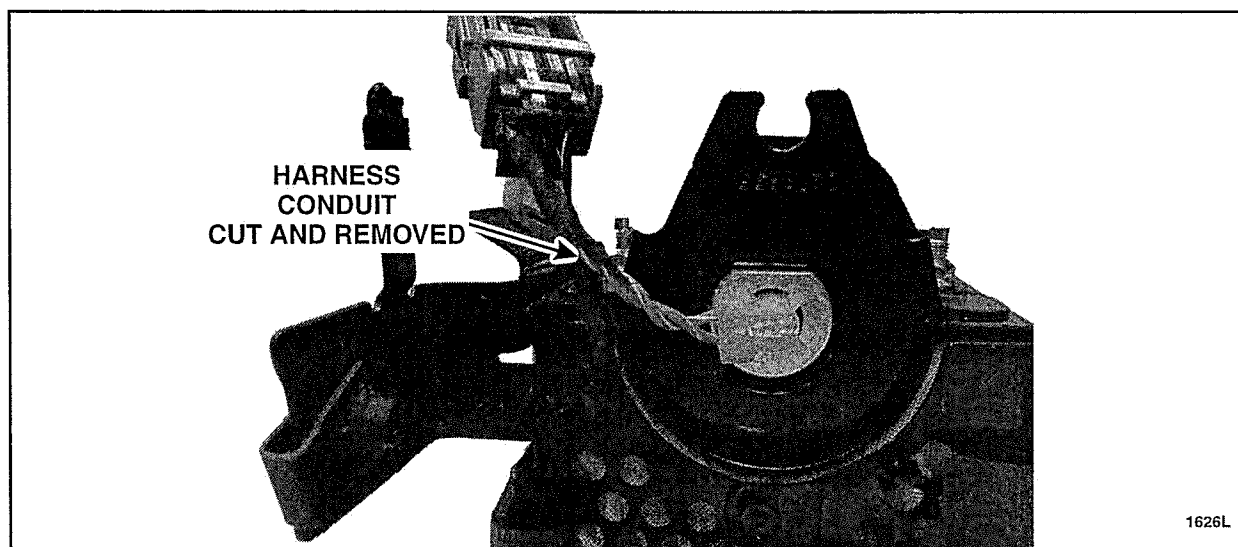
**FIGURE 2**

**NOTE:** Carry out this step on the shorter wire on the end opposite of the airbag inflator retaining bracket. See Figure 2.

4. Remove the conduit from the passenger airbag assembly wire harness in the area shown. See Figure 2.

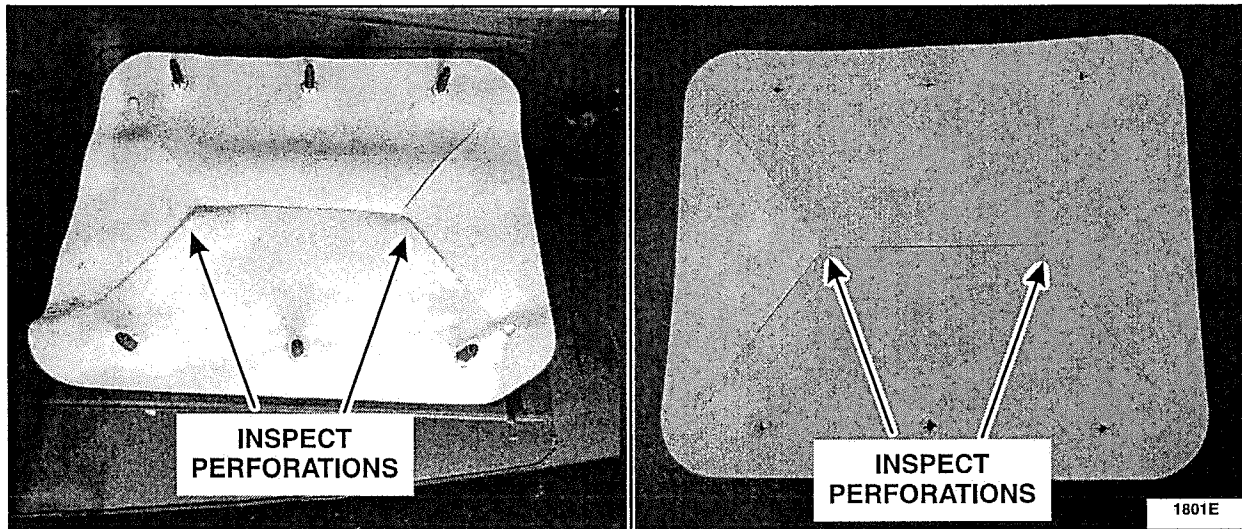
FIGURE 6

**NOTE:** If any damage is present on the existing or new airbag cushion sheet it must be replaced. Type of damage includes, but is not limited to, cuts, creases, folds, or the perforations being broken.

6. Inspect the white airbag cushion sheet installed on the instrument panel and the new airbag cushion sheet included with the new airbag module. See Figure 6.
