RECALL 17V-047: DRIVER'S FRONT AIR BAG MODULE – PRIOR PARTS REPLACEMENT

This Service Information bulletin replaces SI B65 02 17 **dated April 2017**

**Model Year 2000-2003 BMW X5, 3 and 5 Series
Driver's Front Air Bag Module
Safety Recall 17V-047
Last updated: 1/26/2017**

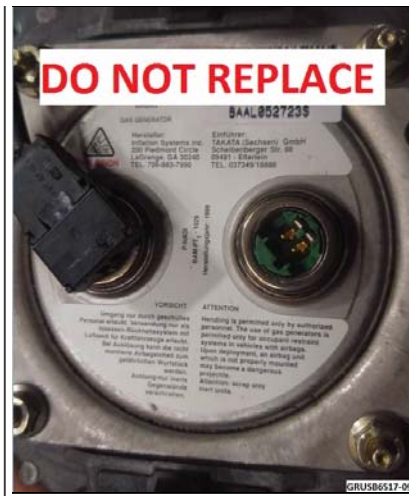
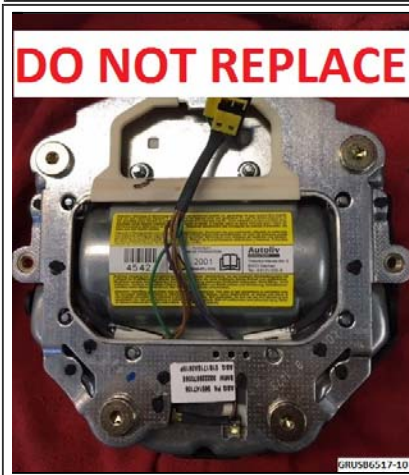
Air bags from other manufacturers (non-Takata), or Takata air bags with different chemical compositions (white label) are not affected by this recall and DO NOT need to be replaced.

Reinstall the driver's air bag.

Note: Before installing the replacement part, the new air bag module's serial number must be documented by the technician on the repair order so it can also be entered into the warranty claim's comment section.
