January 25, 2017

SUBJECT: NEW VEHICLE DEMONSTRATION / DELIVERY HOLD - Safety Recall 17S03
Certain 2016 Model Year Focus and C-Max Vehicles
Left-Hand Underbody Apron Weld Inspection and Repair

CERTAIN 2016 MODEL YEAR FOCUS AND C-MAX VEHICLES — LEFT-HAND UNDERBODY APRON WELD INSPECTION AND REPAIR

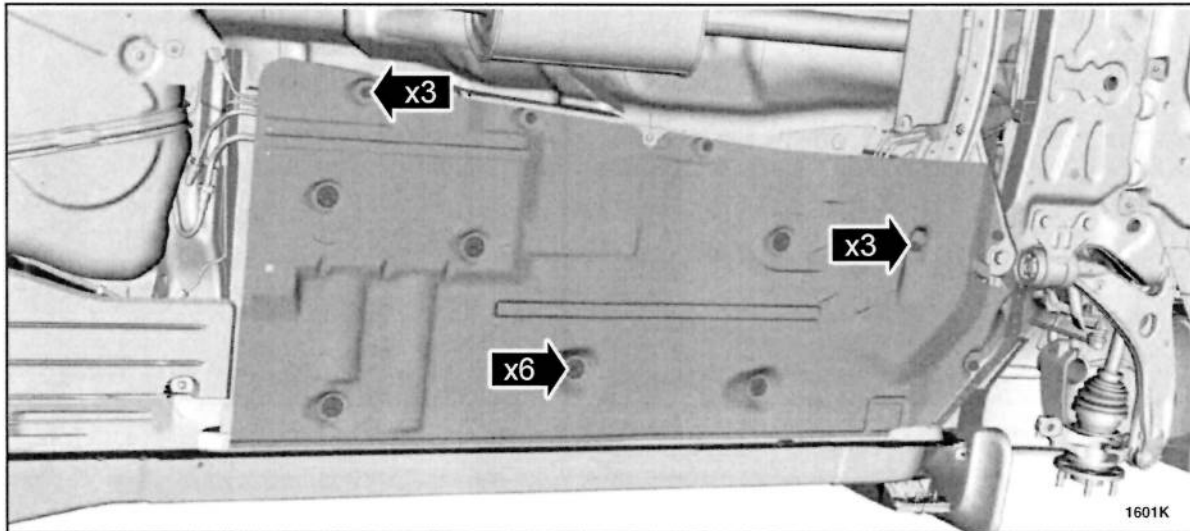
FIGURE 1

1. Remove the retainers and the LH splash shield. See Figure 1.

3. Remove the retainers and the RH splash shield. See Figure 1.

9. If removed, install the crossbrace, four bolts, and two nuts. See Figure 6.
- Torque: 35 lb.ft (47 Nm).
10. Install both RH and LH splash shields and the retainers. See Figure 1.
11. Install the hood latch release. See Figure 5.
- a. Attach the routing cable clips, retainers, and the hood latch release.
 - b. Reposition back the LH carpet and foam.
12. Install the hood latch release handle and the LH cowl trim panel. See Figure 4.
- a. Attach the clips to attach the hood latch release handle and install the hood latch release handle.
 - b. Install the hood latch release handle access cover.
 - c. Reposition the front door weatherstrip and the driver door scuff plate.
