Campaign code.
L73X-R.01.17

Campaign description.
Evap system upgrade

Model.
Aventador Coupe and Roadster.

L73X-R.01.17	To: Official Lamborghini Service Network Subject: Update of fuel vapor circuit Date: February 24, 2017 Pages: 59	 
--------------	---	---

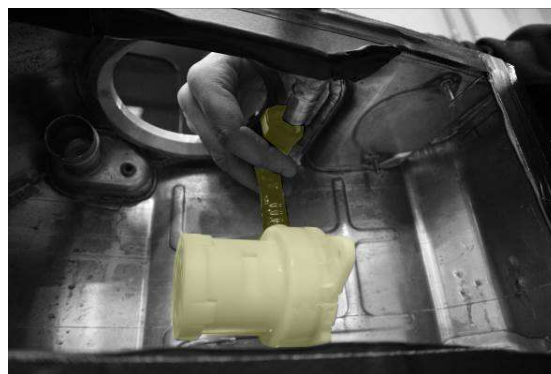
The picture below shows how to extract the old FLVV valve to be replaced.

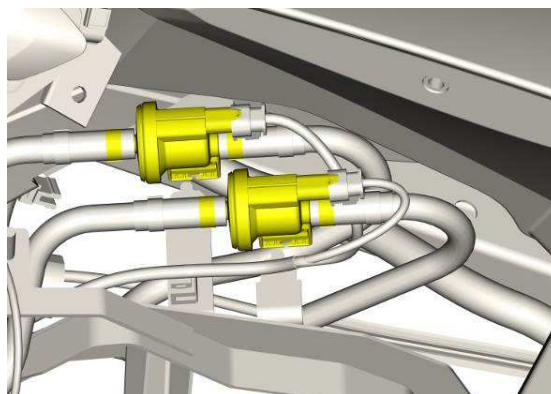
After removal these components must not be reinstalled on the vehicle.

Remove the purge electro-valve metal hose clamps, disconnect the electrical connectors then remove the 2 purge electro-valves from the fuel vapor hoses.

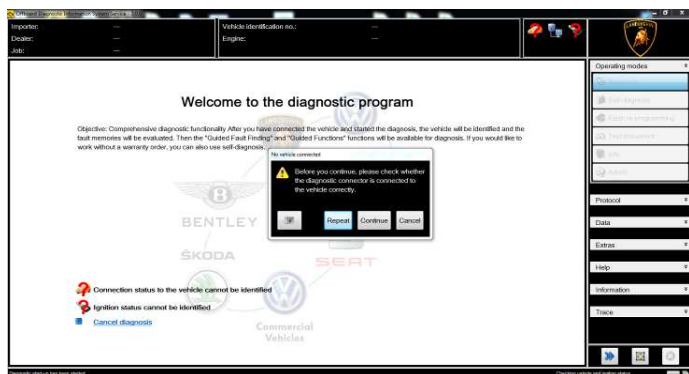
A. If the error message regarding the VAS5054 interface and the two icons for status of on board connection and key ON are shown as in the picture below:

- Click “Cancel”;
- Repeat the VAS5054 HW interface installation following the procedure (*) “VCI Manager v2.0”, by entering in the menu “Extras” on the right side and clicking on “Diagnostic interface”.

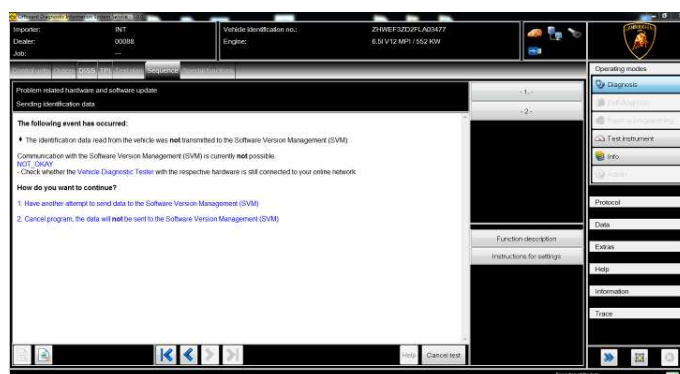
C. If the loss of connection happens during the target/actual comparison during SVM procedure:

- It is not possible to connect to central server, check the working connection of internet and retry by clicking “1”.

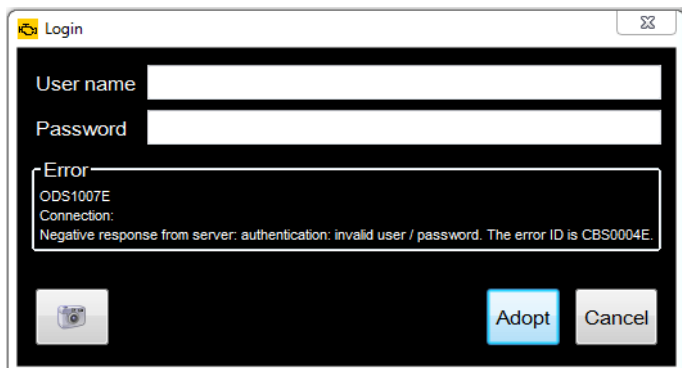
D. If the incorrect identification message is shown as in the picture below (error code: ODS1007E):

- be sure that your Geko account is valid;

E. be sure that the label “Geko” is written on the token that you are using for the authentication;

- be sure the Password inserted is correct;
- click on Cancel and perform the application test (see document “ODIS_Checking_ConnectionServer_SVM_2.0” (*)).
