December 1, 2017

**SUBJECT: NEW VEHICLE DEMONSTRATION / DELIVERY HOLD –
Compliance Recall 17C20**
Certain 2018 Model Year Expedition Vehicles
Comfort Lock Inspection and Marriage Bolt Torque

CERTAIN 2018 MODEL YEAR EXPEDITION VEHICLES — COMFORT LOCK INSPECTION AND MARRIAGE BOLT TORQUE

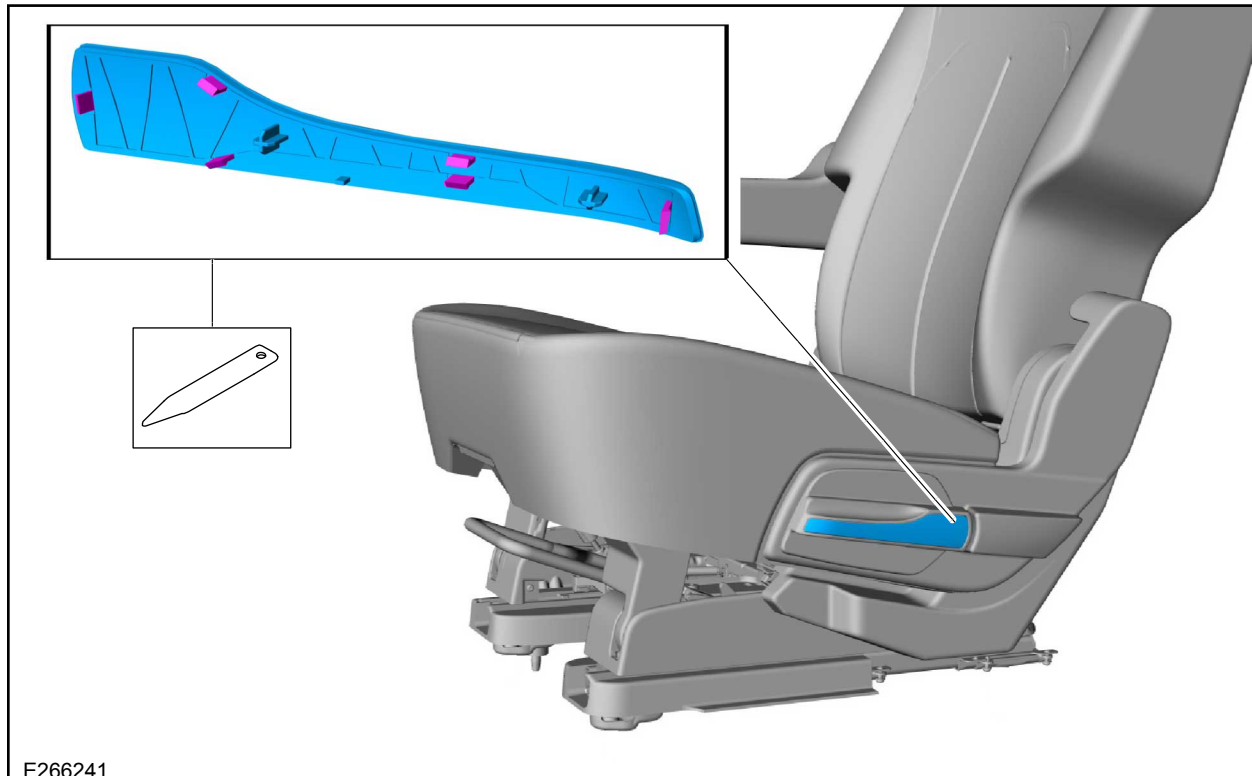
FIGURE 3

2. Release the retainers and remove the recline handle cover. See Figure 3.

7. Install the second row seat cushion pivot arm cover and screws. See Figure 6.
8. Install the second row seat side shield and screws. See Figure 5.
9. Install the recline handle and screw. See Figure 4.
10. Install the recline handle cover. See Figure 3.
11. If removed, install the RH and LH 40% 2nd row seats. Please follow the WSM procedures in Section 501-10B.

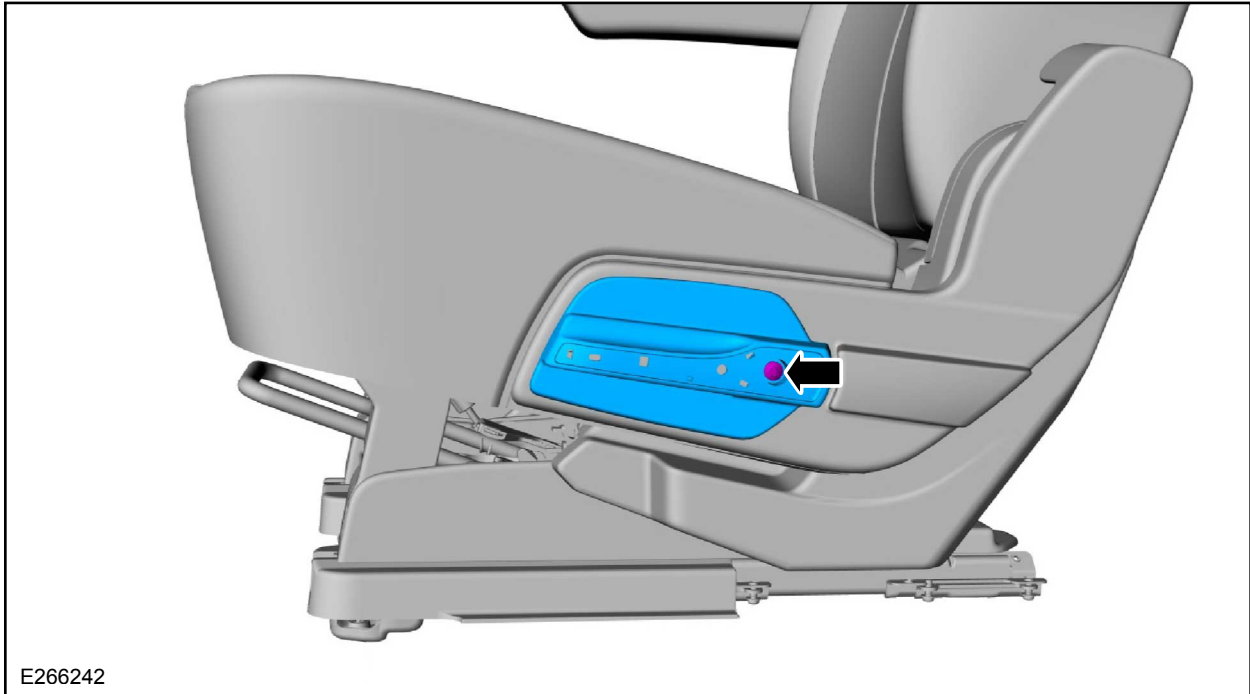
FIGURE 4

3. Remove screw and the recline handle. See Figure 4.

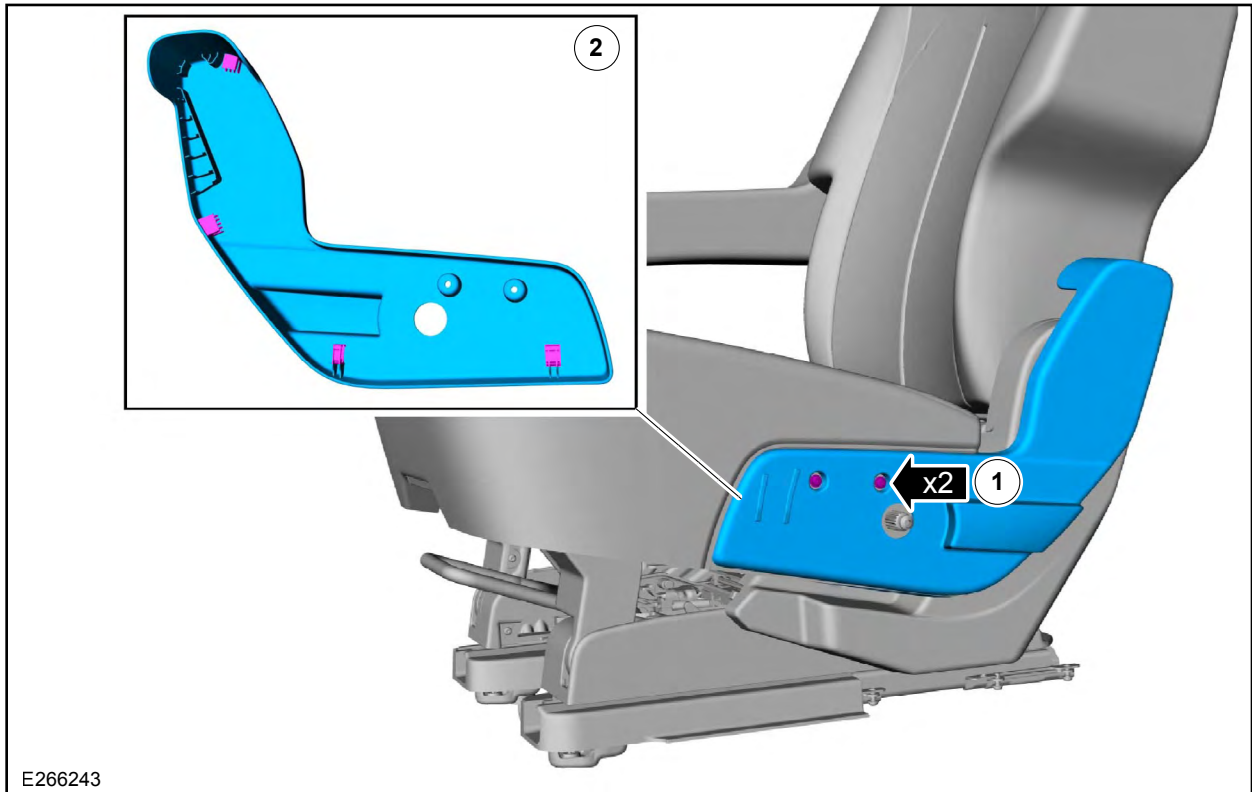
FIGURE 5

4. Remove the screws, release the retainers and remove the second row seat side shield. See Figure 5.

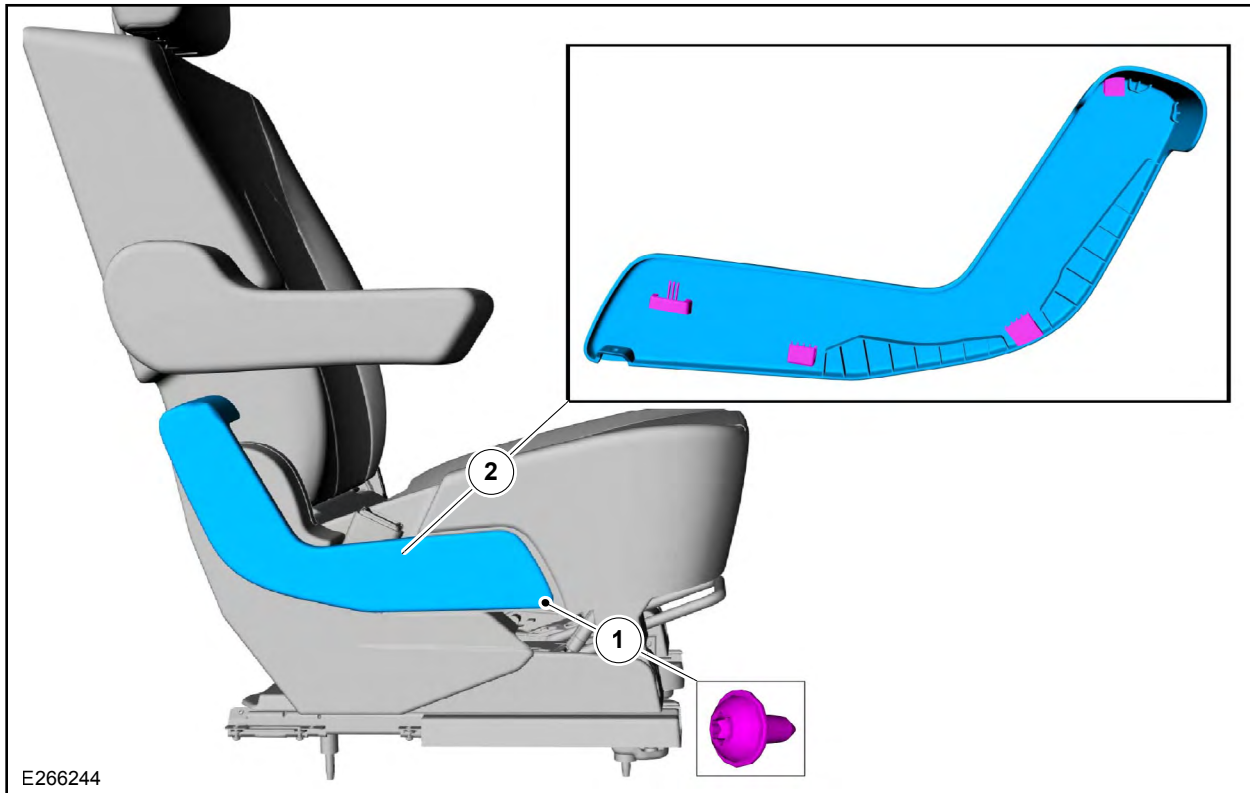
FIGURE 6

5. Remove the screws, release the retainers and remove the second row seat cushion pivot arm cover.
See Figure 6.
