# Safety Recall

## Code: 69P1

<b>Subject</b>	<b>Head Curtain Airbag Canister</b>
<b>Release Date</b>	February 02, 2017
<b>Affected Vehicles</b>	<p><b>U.S.A. &amp; CANADA: Certain 2011-2017 MY Audi Q5 with Panoramic Sunroof</b></p> <p><i>Check Campaigns/Actions screen in Elsa on the day of repair to verify that a VIN qualifies for repair under this action. Elsa is the <u>only</u> valid campaign inquiry &amp; verification source.</i></p> <ul style="list-style-type: none"><li>✓ Campaign status must show "open."</li><li>✓ If Elsa shows other open action(s), inform your customer so that the work can also be completed at the same time the vehicle is in the workshop for this campaign.</li></ul>
<b>Problem Description</b>	If the water drainage system of the sunroof becomes damaged or impaired (such as during a repair), water could saturate the foam around a side head curtain airbag canister. This could cause corrosion to form on the canister over time. If this happens, the canister could fracture without airbag deployment, propelling fragments into the passenger compartment, striking and causing serious injury to vehicle occupants.

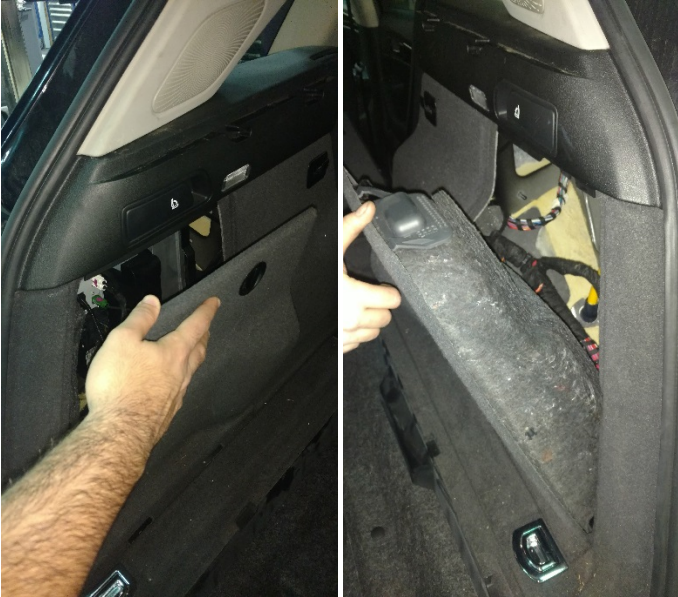
- Remove the left and right rear luggage compartment trim panel inserts.
- Disconnect the 12V outlet on the right side luggage compartment insert (if equipped).
- Inspect the wheel well areas for any signs of water ingress.
- If no water ingress is noted, proceed to the next step.
  - If, at **ANY** time during the water ingress inspection, evidence of prior water ingress is noted, **STOP** the procedure and create a Technical Assistance WEB ticket and follow the direction of the Technical Assistance Consultant.

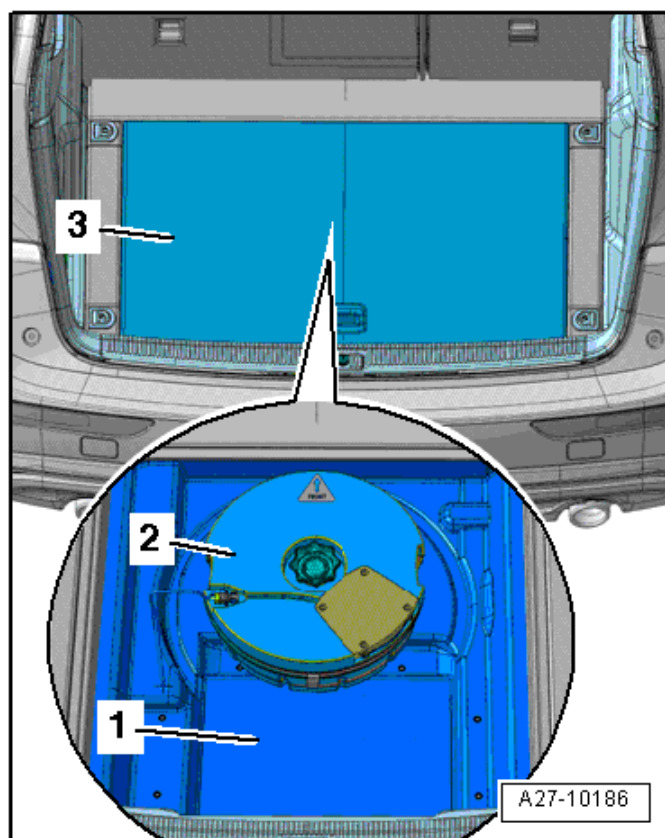
- Turn the vehicle ignition to the ON position.
- Remove the luggage compartment floor covering <3>.
- Remove the dirt tray, if applicable.
- If equipped, remove the subwoofer <2>.
- Remove the spare tire.
- Fold back the carpet <1> over the cover.
- Inspect the spare tire well and surrounding areas for any signs of water ingress.
- If no water ingress is noted, proceed to the next step.
  - If, at **ANY** time during the water ingress inspection, evidence of prior water ingress is noted, **STOP** the procedure and create a Technical Assistance WEB ticket and follow the direction of the Technical Assistance Consultant.

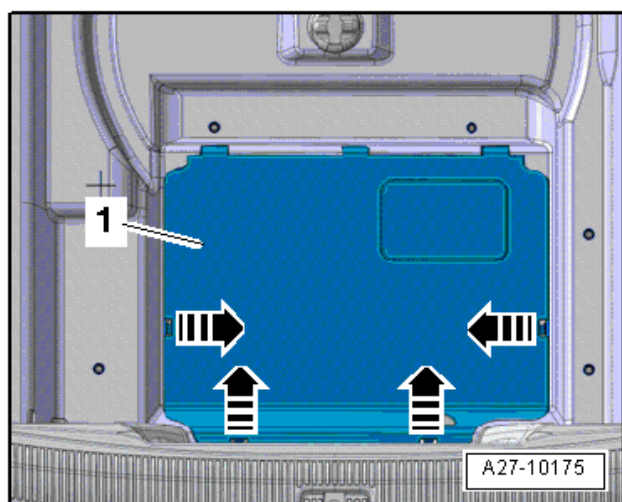
- Unlock the retaining tabs <arrows> and open the cover <1> and inspect the battery well for any water ingress.
- If no water ingress is noted, proceed to the next step.
  - If, at **ANY** time during the water ingress inspection, evidence of prior water ingress is noted, **STOP** the procedure and create a Technical Assistance WEB ticket and follow the direction of the Technical Assistance Consultant.

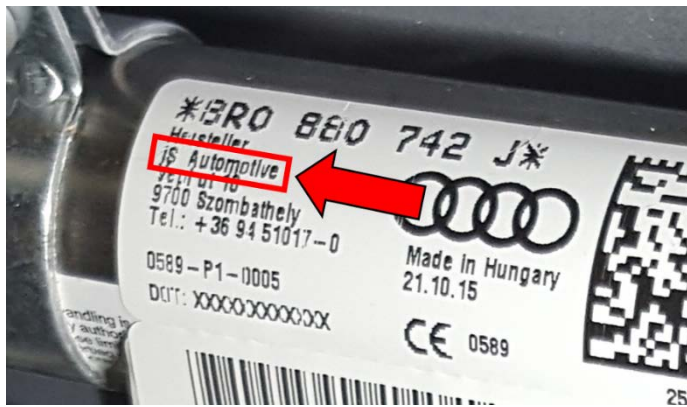
- Inspect the airbag inflator canisters for the manufacturer name on the airbag inflator canister.
- There are two manufacturers, “ISI Automotive”, and “Autoliv”.
  - If the airbag inflator canister in the vehicle is **WITHOUT** corrosion and manufactured by “Autoliv”, **Proceed to Section D** to reinstall the removed trim. (“Autoliv” inflators do NOT require the application of the protective wax.)
  - If the airbag inflator canister is **WITHOUT** corrosion and manufactured by “ISI Automotive”, **Proceed to Section C** and install the protective wax.
