Safety Recall

Code: 69P1

Subject	Head Curtain Airbag Canister
Release Date	February 07, 2017
Revision Summary	Work procedure updated.
Affected Vehicles	U.S.A. & CANADA: Certain 2011-2017 MY Audi Q5 with Panoramic Sunroof <i>Check Campaigns/Actions screen in Elsa on the day of repair to verify that a VIN qualifies for repair under this action. Elsa is the <u>only</u> valid campaign inquiry & verification source.</i> <ul style="list-style-type: none">✓ Campaign status must show "open."✓ If Elsa shows other open action(s), inform your customer so that the work can also be completed at the same time the vehicle is in the workshop for this campaign.
Problem Description	If the water drainage system of the sunroof becomes damaged or impaired (such as during a repair), water could saturate the foam around a side head curtain airbag canister. This could cause corrosion to form on the canister over time. If this happens, the canister could fracture without airbag deployment, propelling fragments into the passenger compartment, striking and causing serious injury to vehicle occupants.

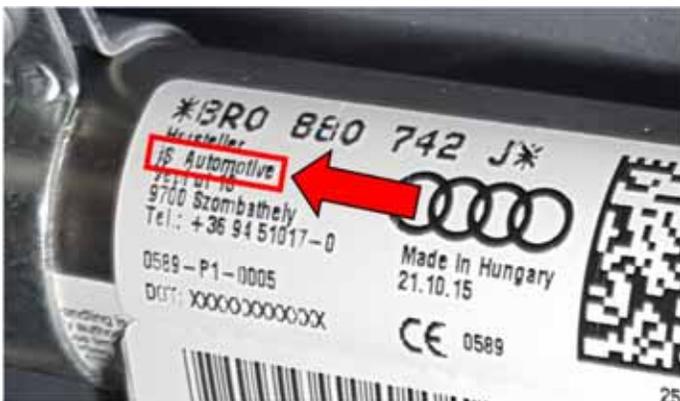
- If no corrosion was found, inspect the airbag inflator canisters for the manufacturer name on the airbag inflator canister.
- There are two manufacturers, "ISI Automotive", and "Autoliv".
 - If the airbag inflator canister in the vehicle is **WITHOUT** corrosion and manufactured by "Autoliv", **Proceed to Section D** to reinstall the removed trim. ("Autoliv" inflators do NOT require the application of the protective wax.)
 - If the airbag inflator canister is **WITHOUT** corrosion and manufactured by "ISI Automotive", **Proceed to Section C** and install the protective wax.
