## PRODUCT CAMPAIGN BULLETIN

**APPLICABILITY:** 2005-2006 model year Baja  
 2009-2012 model year Legacy  
 2009-2012 model year Outback  
 2009-2012 model year Forester  
 2006-2012 model year Tribeca  
 2006-2011 model year Impreza (including WRX and STI)  
 2012 model year WRX and STI

**NUMBERS:** TKA-17R  
 TKB-17R  
 TKC-17R

**SUBJECT:** Takata Front Passenger Airbag Inflator Replacement

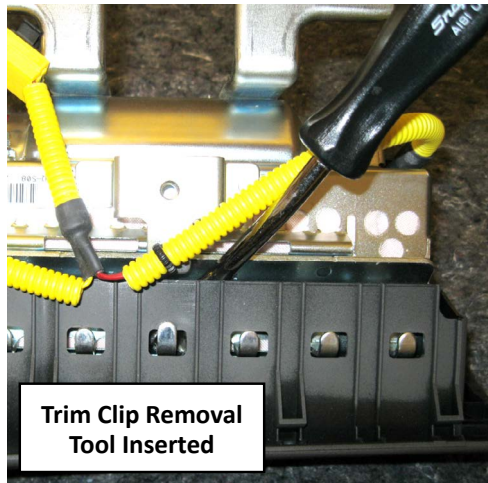
Trim Clip Removal  
Tool Inserted

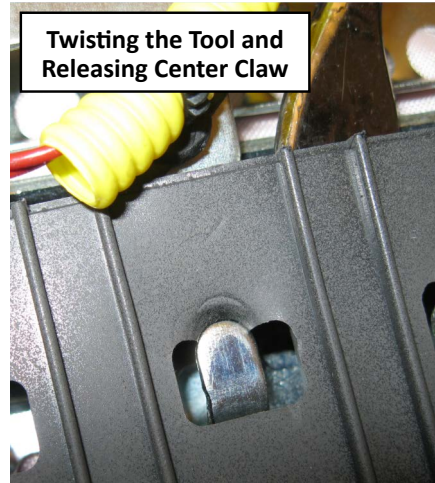
Twisting the Tool and  
Releasing Center Claw

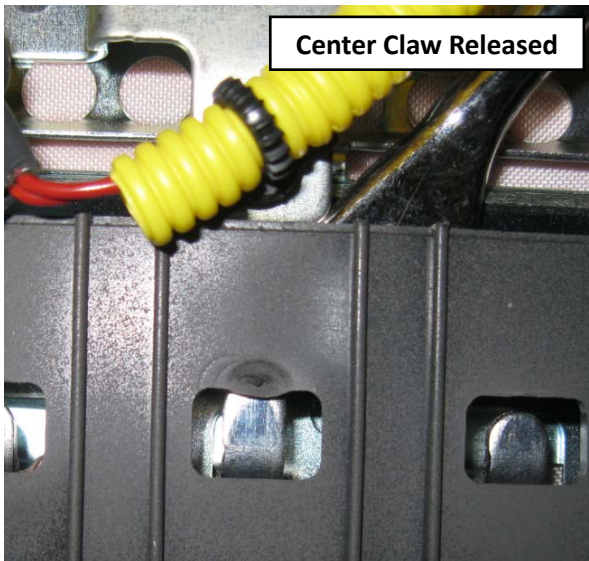
Center Claw Released

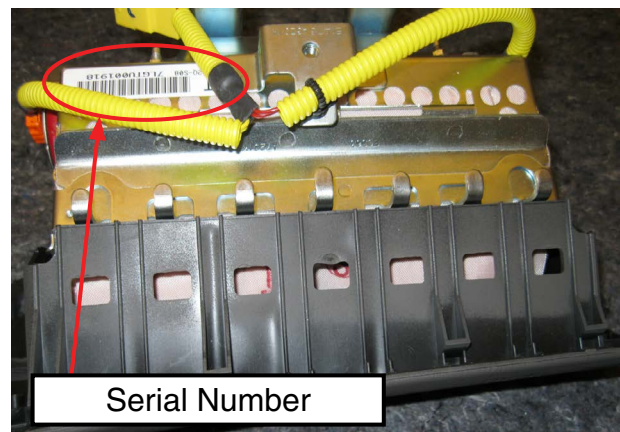
All Harness-Side Claws Released

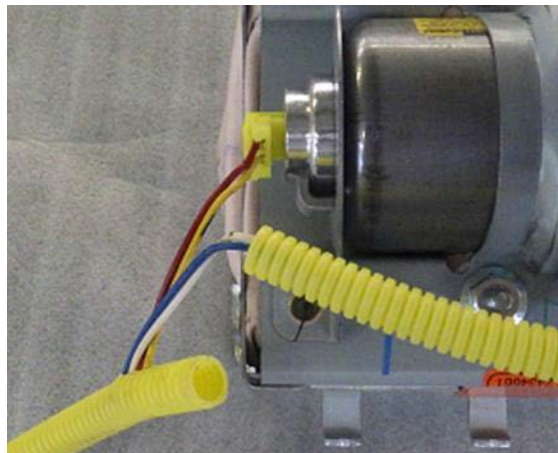
**STEP 4-** Using a scissor or wire cutter (no knives or razors) **CAREFULLY** cut the yellow harness cover tube (approximately 1 1/2 inches) enough to expose the yellow and red wires inside and provide enough room to install the Electro-Tap (shorting) connector.

**TAKE YOUR TIME AND BE CAREFUL TO NOT CUT THE 2 WIRES!**

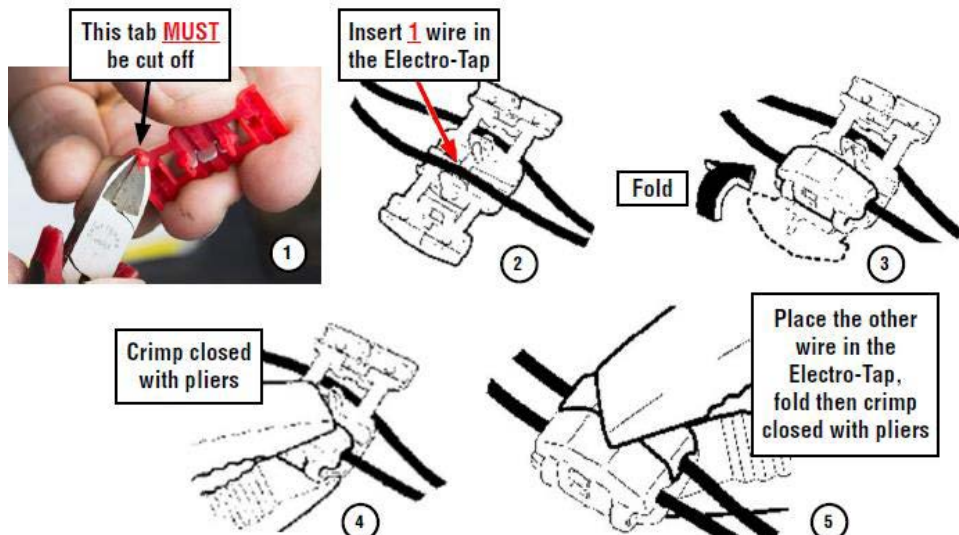
**STEP 5-** Short the yellow and red wires together by installing the Electro-Tap connector. The connector creates a short circuit which acts as a safeguard to prevent against static discharge that may deploy the removed inflator. The tab portion of the Electro-Tap connector **MUST** be cut off prior to use to insure a good short-circuit is made as shown in the illustration below. **Follow the sequence below** for installing the Electro-Tap connector. Use pliers to squeeze closed the two sections of the connector together, **one section at a time**.

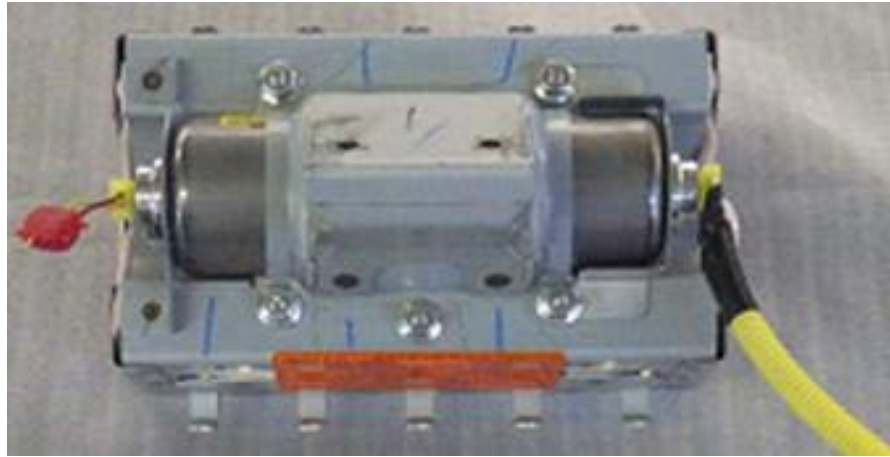
**STEP 6-** Once the Electro-Tap connector is fully crimped in place, cut the yellow and red wires **on the body harness connector side** of the Electro-Tap connector.

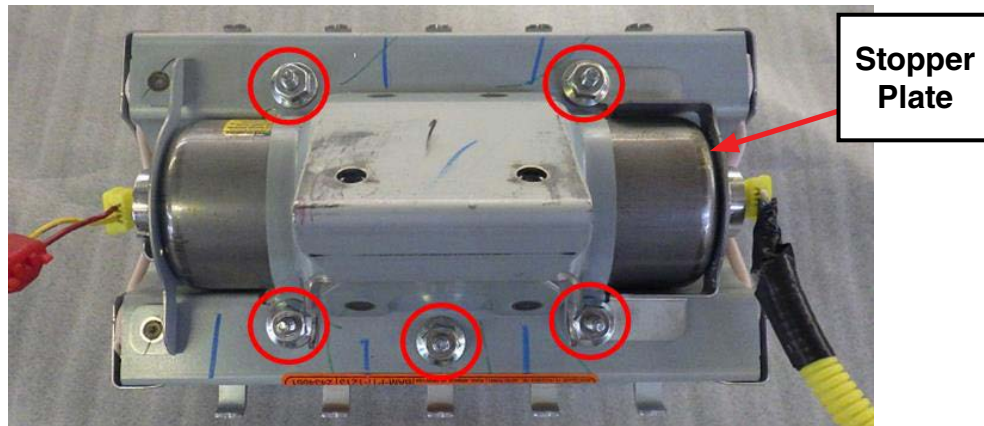
**STEP 7-** Loosen and remove the five (5) 10mm self-locking nuts along with the stopper plate. DO **NOT DISCARD** the removed stopper plate as it will be reused during reassembly. Discard the 5 10mm nuts.

**VERY IMPORTANT:** Under no circumstances should any impact or power tools be used when performing these procedures. **HAND TOOLS ONLY!**

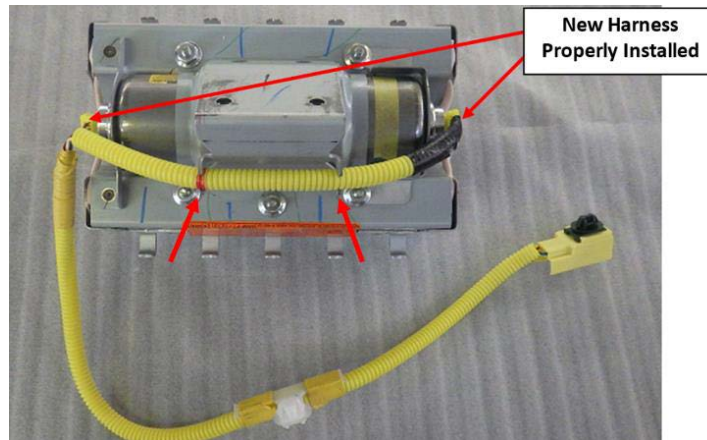
**VERY IMPORTANT:** When connecting the new harness to the inflator, **both sides MUST be routed as shown** in the “New Harness Properly Installed” photo below.

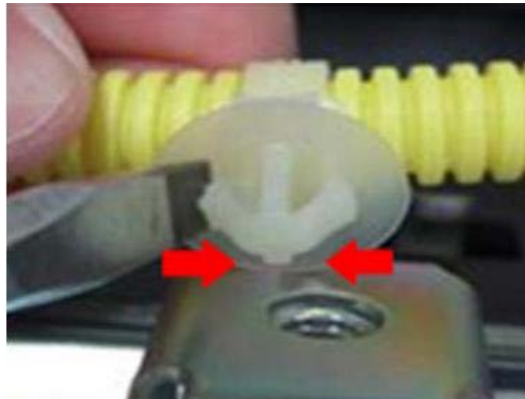
**STEP 3-** Remove the harness clip from the retainer bracket by pushing the tangs inward with a flat-blade screwdriver as shown below.

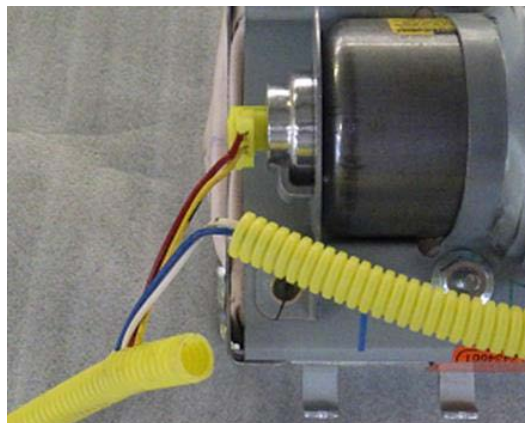
**STEP 4-** Using a scissor or wire cutter (no knives or razors) **CAREFULLY** cut the yellow harness cover tube (approximately 1 1/2 inches) enough to expose the yellow and red wires inside and provide enough room to install the Electro-Tap (shorting) connector.

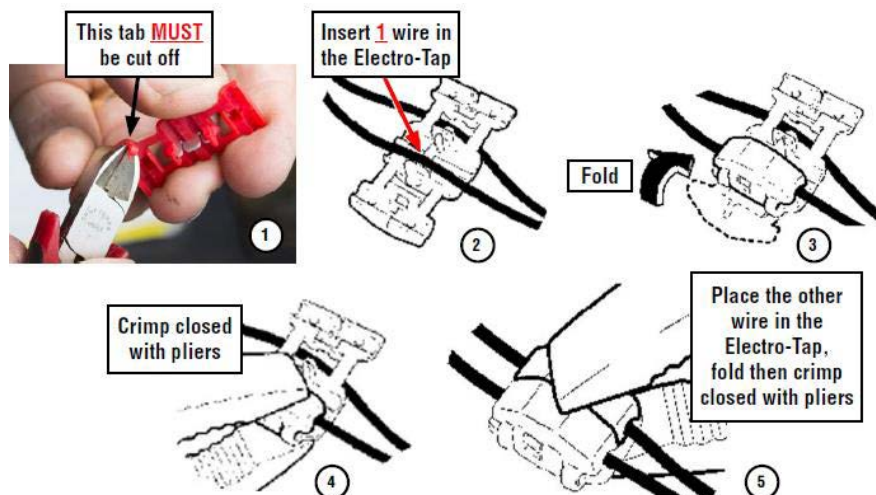
**STEP 5-** Short the yellow and red wires together by installing the Electro-Tap connector. The connector creates a short circuit which acts as a safeguard to prevent against static discharge that may deploy the removed inflator. The tab portion of the Electro-Tap connector **MUST** be cut off prior to use to insure a good short-circuit is made as shown in the illustration below. **Follow the sequence below** for installing the Electro-Tap connector. Use pliers to squeeze closed the two sections of the connector together, **one section at a time**.

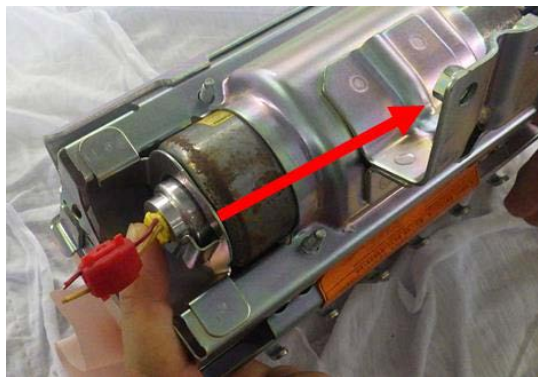
**STEP 8-** With the self-locking nuts and stopper plate removed, slide the original inflator out of the mounting bracket while feeding the cut off portion of the wiring harness under the remaining stopper plate. Place the removed original air bag inflator back into the “cradle” of the Kit Box insert.

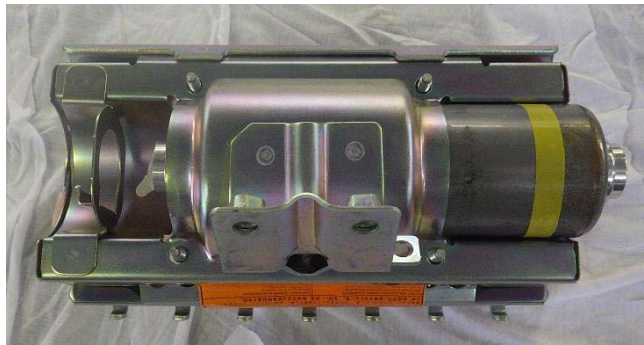
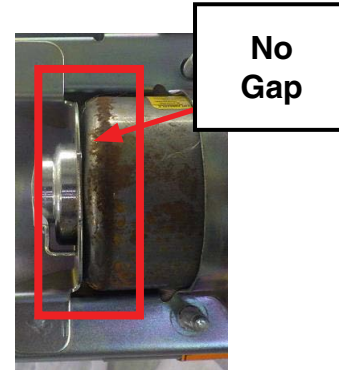
**STEP 10-** Install the new inflator into the mounting bracket so the yellow taped end will align with the stopper plate when reinstalled on the mounting bracket. When properly installed, both ends of the inflator will be seated tight against the stopper plates with no gaps.

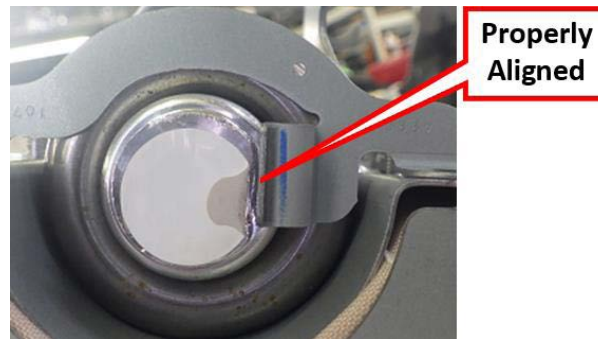
Make sure the “D-shaped” portion of the inflator harness connector boss aligns with the “D-shaped” portion of the original stopper plate as shown below. Do not peel the white harness connection dust cover at this time.

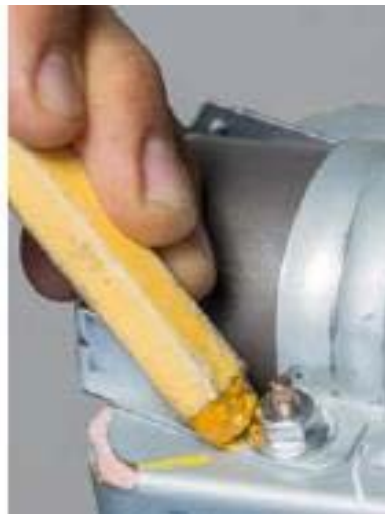
**STEP 11-** Reinstall the original stopper plate and the 4 **NEW** self-locking nuts. **SLOWLY** tighten (to prevent over-tightening) then torque the nuts to 31-38 inch-pounds. When complete, use a marker to indicate they have been fully tightened.

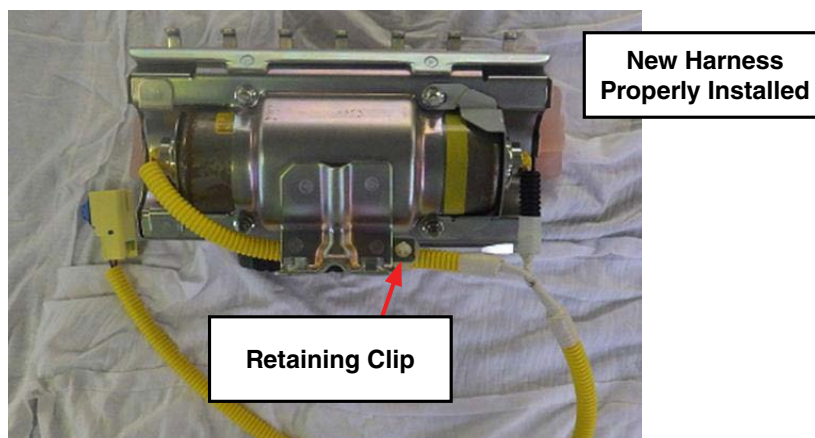
**CAREFULLY** align the pins of the inflator with the female terminals of the harness connector (red / yellow wires) as shown in the photos below. Once pin alignment is confirmed, push down firmly to engage the connector's 3 locking tangs into the locking groove inside the connector boss. Confirm the connector is locked by prying up **LIGHTLY** with a small flat-blade screwdriver. Repeat the procedure on the opposite "short" side with the blue / white wires.

**VERY IMPORTANT: When connecting the new harness to the inflator, both sides MUST be routed and the retaining clip installed** as shown in the "New Harness Properly Installed" photo below.

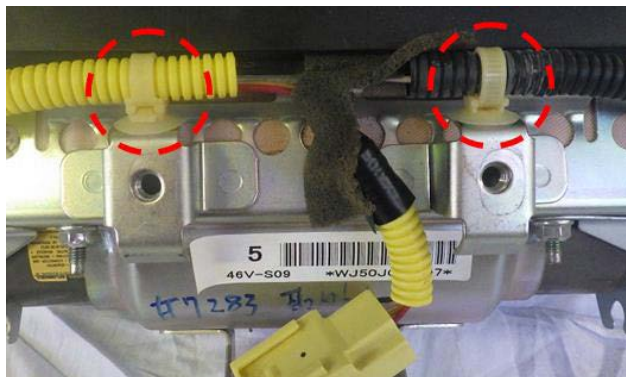
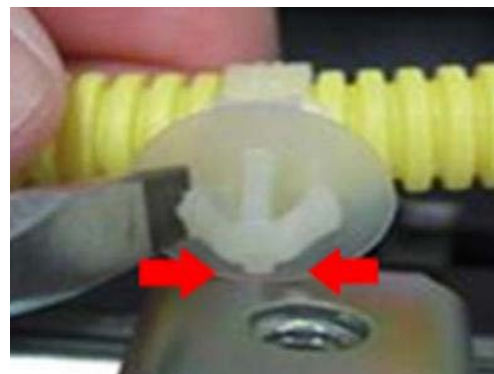
**STEP 2-** Peel the sponge tape and remove the harness clips from the retainer bracket by pushing the tangs inward with a flat-blade screwdriver as shown below. Always remove any sponge tape adhesive residue from the airbag mounting bracket using mild solvent on a clean shop cloth.

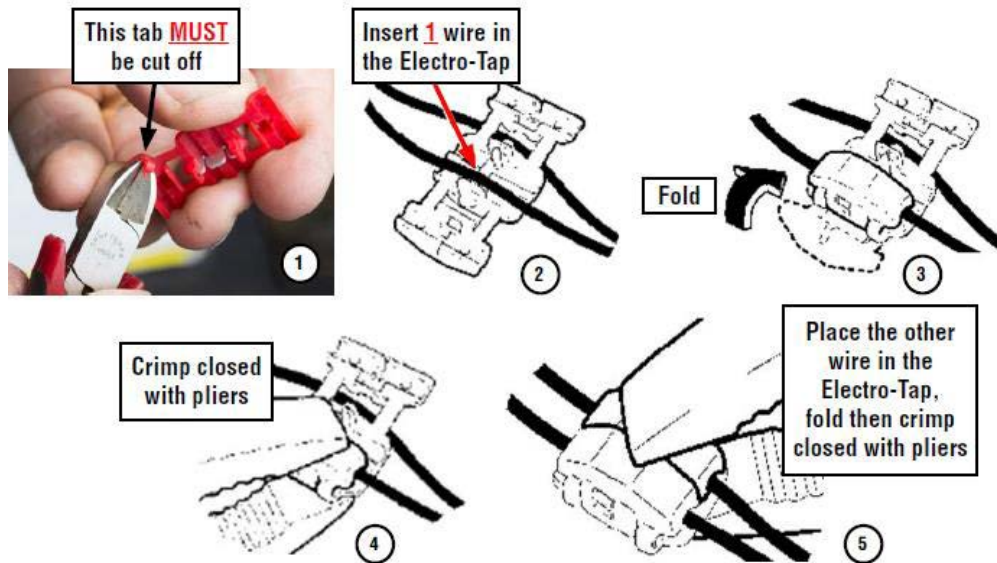
**STEP 4-** Short the yellow and red wires together by installing the Electro-Tap connector. The connector creates a short circuit which acts as a safeguard to prevent against static discharge that may deploy the removed inflator. The tab portion of the Electro-Tap connector **MUST** be cut off prior to use to insure a good short-circuit is made as shown in the illustration below. **Follow the sequence below** for installing the Electro-Tap connector. Use pliers to squeeze closed the two sections of the connector together, **one section at a time**.

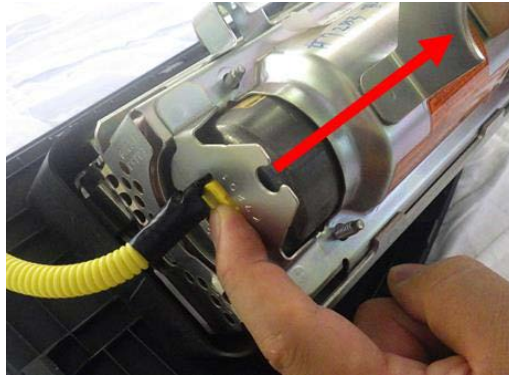
**STEP 7-** With the self-locking nuts and stopper plate removed, slide the original inflator out of the mounting bracket while feeding the cut off portion of the wiring harness under the remaining stopper plate. Place the removed original air bag inflator back into the “cradle” of the Kit Box insert.

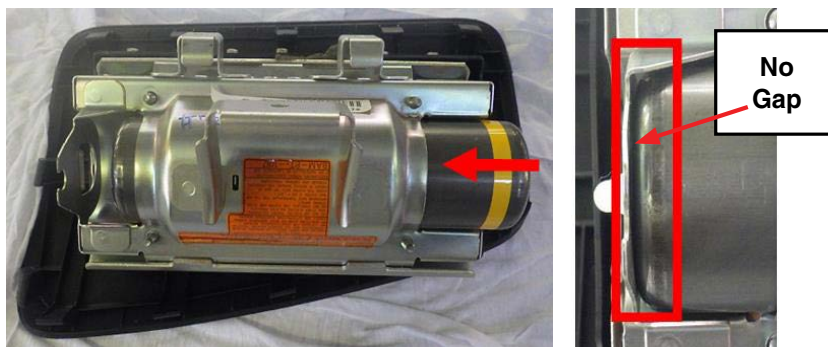
**STEP 9-** Install the new inflator into the mounting bracket so the yellow taped end will align with the stopper plate when reinstalled on the mounting bracket. When properly installed, both ends of the inflator will be seated tight against the stopper plates with no gaps.

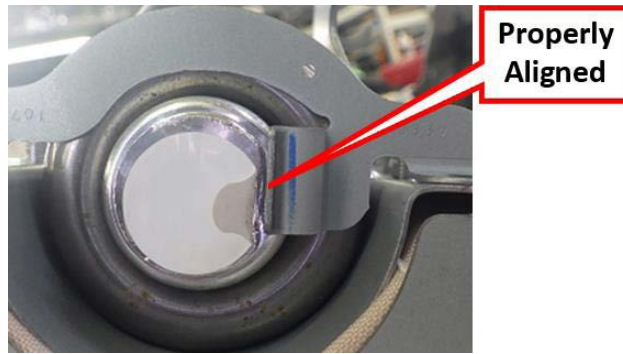
Make sure the “D-shaped” portion of the inflator harness connector boss aligns with the “D-shaped” portion of the original stopper plate as shown below. **Do not peel the white harness connection dust cover at this time.**

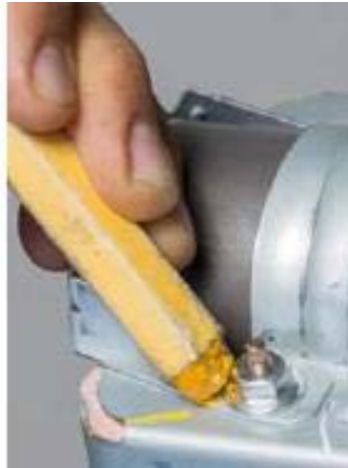
**STEP 10-** Reinstall the original stopper plate and the 4 **NEW** self-locking nuts. **SLOWLY** tighten (to prevent over-tightening) then torque the nuts to 31-38 inch-pounds. When complete, use a marker to indicate they have been fully tightened.

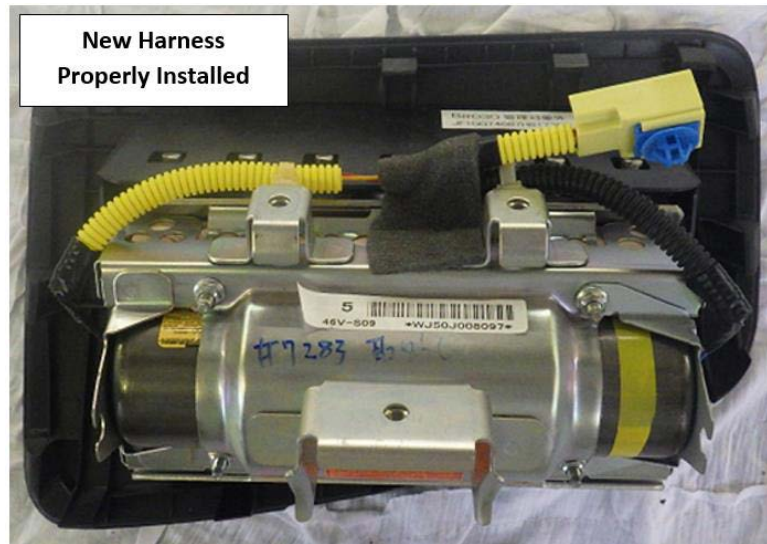
**CAREFULLY** align the pins of the inflator (end with yellow tape) with the female terminals of the harness connector (blue / white wires, **BLACK** harness tube) as shown in the photo below. Once pin alignment is confirmed, push down firmly to engage the connector's 3 locking tangs into the locking groove inside the connector boss. Confirm the connector is locked by prying up **LIGHTLY** with a small flat-blade screwdriver. Repeat the procedure on the opposite side (red / yellow wires, **YELLOW** harness tube). When complete, refit the harness retaining clips back into the mounting brackets.

**VERY IMPORTANT:** When connecting the new harness to the inflator, **both sides MUST be routed as shown** in the “New Harness Properly Installed” photo below.

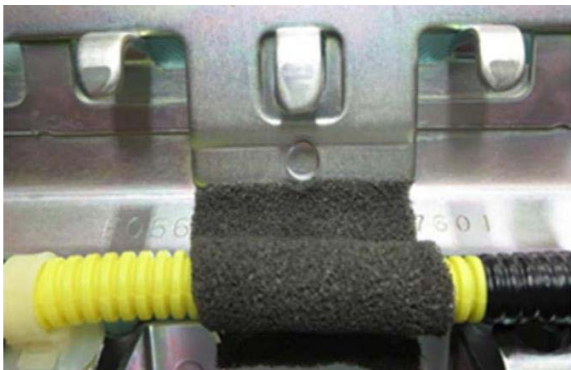
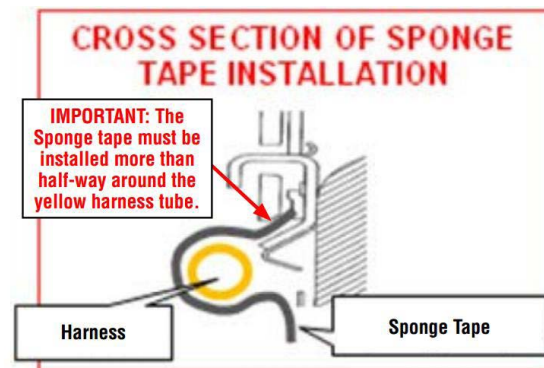
**STEP 12-** Peel the adhesive backing and install the new sponge tape onto the yellow harness tube first then adhere it to the airbag mounting bracket as shown in the illustrations below.

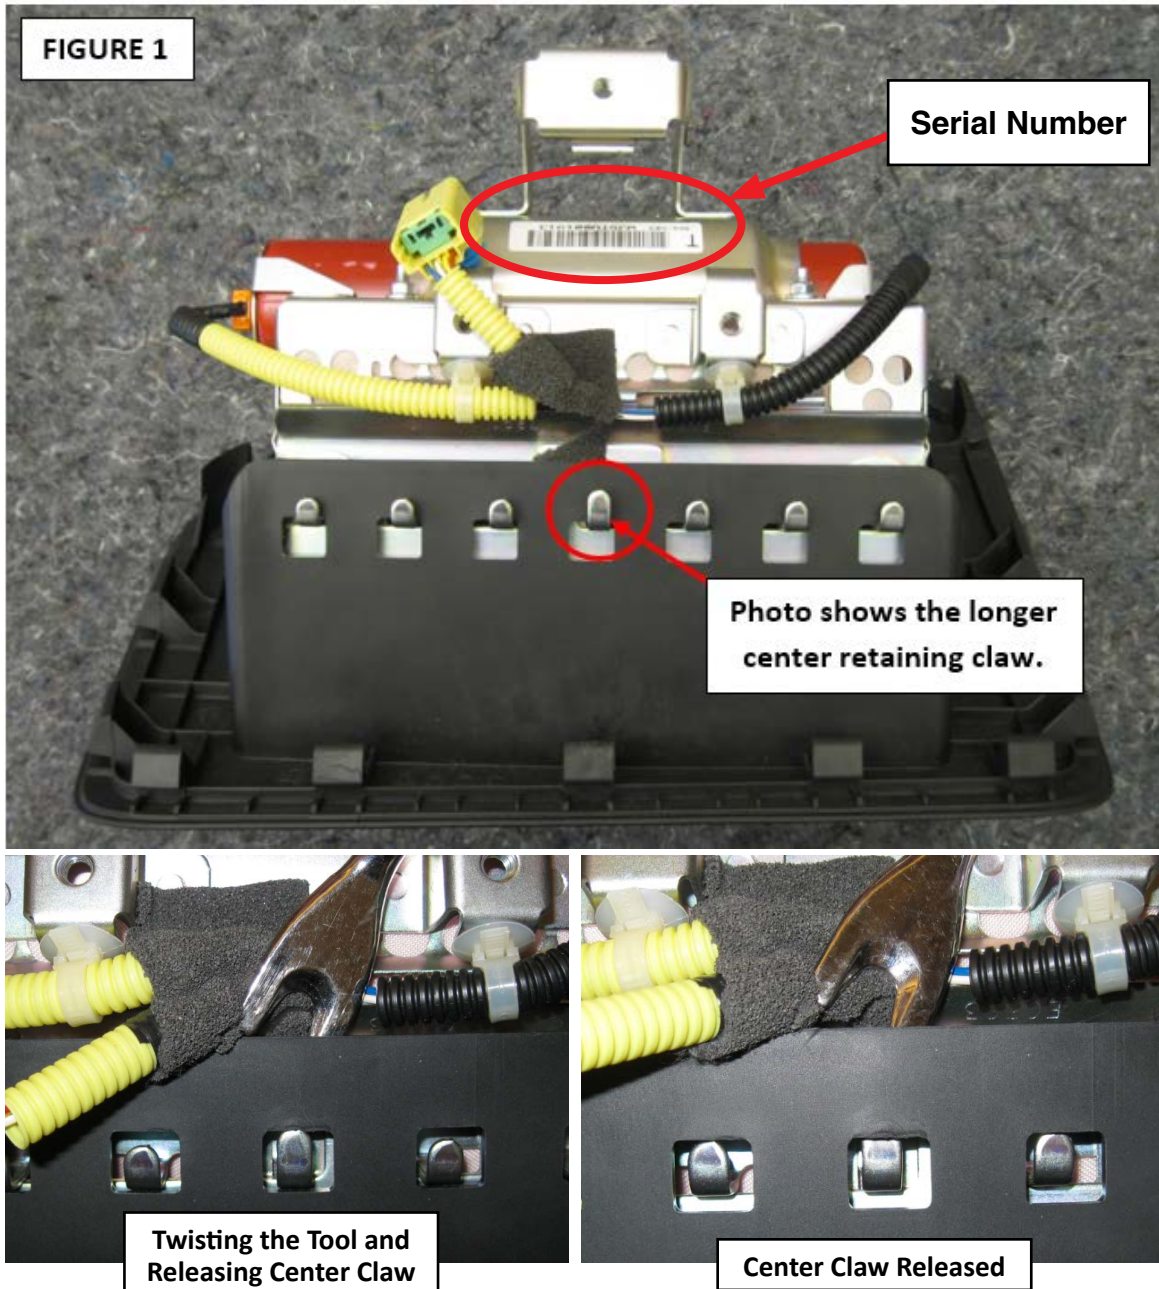
- Using a trim clip removal tool and starting on the harness-side of the module assembly as shown in photos and sequence below, **CAREFULLY** insert the tool and twist **ONLY AS MUCH AS IS REQUIRED** to release the slightly longer center retaining claw from the trim cover. Once released with the tool, the other 6 claws will release easily by hand.
- Rotate the inflator portion of the assembly outward from the cover to release the 7 label-side claws and separate the cover from the module. No tool is required as all the 7 label-side claws are the same size.

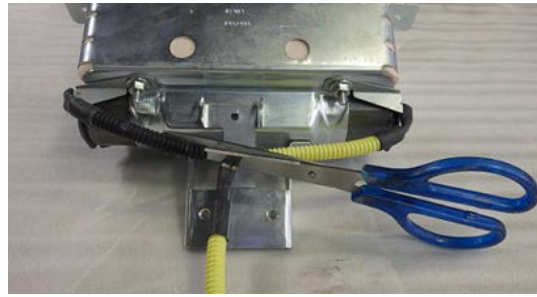
**STEP 4-** Using a scissor or wire cutter (no knives or razors) **CAREFULLY** cut the black harness cover tube (approximately 1 1/2 inches) enough to expose the blue and white wires inside. Provide enough room to install the Electro-Tap (shorting) connector.

**TAKE YOUR TIME AND BE CAREFUL TO NOT CUT THE 2 WIRES!**

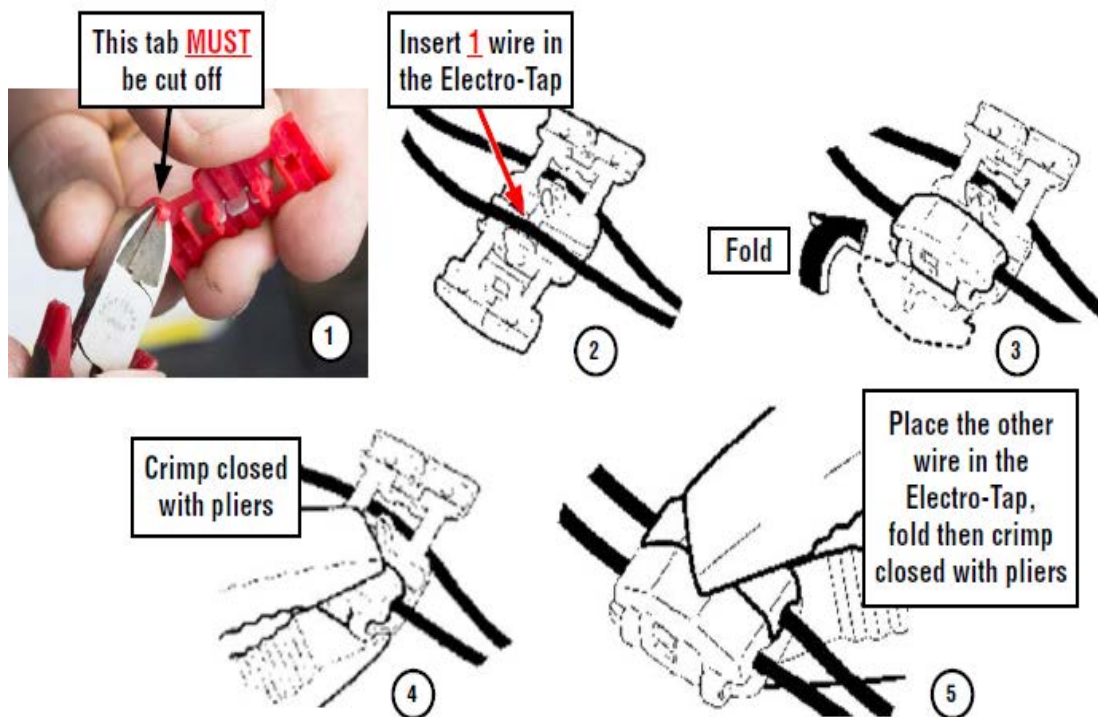
**STEP 5-** Short the blue and white wires together by installing the Electro-Tap connector. The connector creates a short circuit which acts as a safeguard to prevent against static discharge that may deploy the removed inflator. The tab portion of the Electro-Tap connector **MUST** be cut off prior to use to insure a good short-circuit is made as shown in the illustration below. **Follow the sequence below** for installing the Electro-Tap connector. Use pliers to squeeze closed the two sections of the connector together, **one section at a time**.

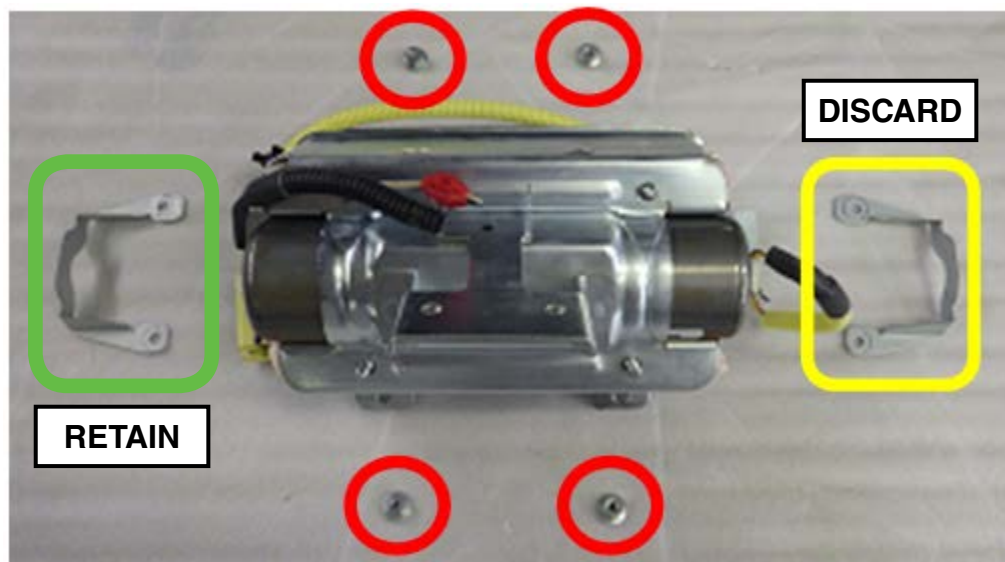
**STEP 7- USING HAND TOOLS ONLY**, loosen and remove the four (4) 10mm self-locking nuts along with both stopper plates. **RETAIN the stopper plate circled in GREEN** (Left-side bracket in image below) as it will be used during reassembly. Discard the removed stopper plate circled in **YELLOW** as it is no longer needed along with the 4 removed 10mm nuts.

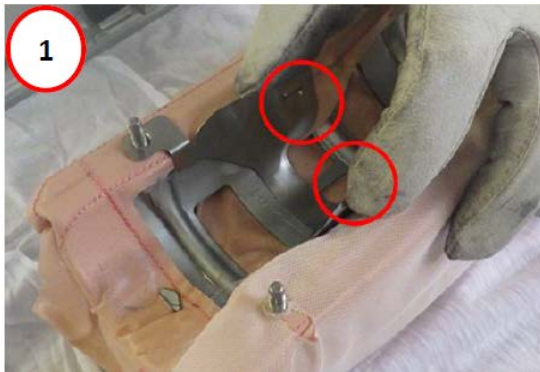
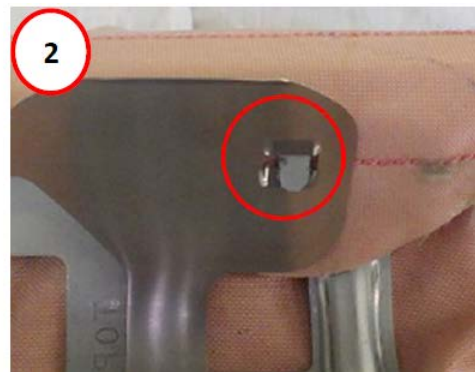
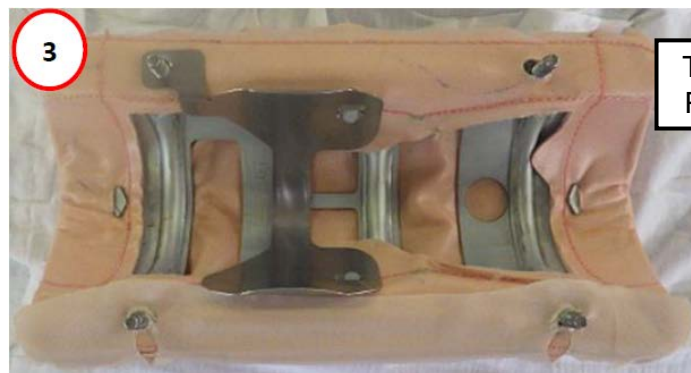
Thermal Insulator  
Properly Installed

**STEP 11- CAREFULLY** install the black thermal insulator into the back (inflator) side of the airbag as shown in photo 1 below. **CAUTION:** Gloves are recommended when doing this as edges of the thermal insulator can be very sharp. **TAKE YOUR TIME** and do not bend or twist the insulator any more than necessary to make it fit. The insulator can only be installed in one direction as shown in photo 3 otherwise, the airbag will not fit back into the module frame properly. Confirm both retaining claws come through the corresponding insulator holes like the example shown in photo 2.

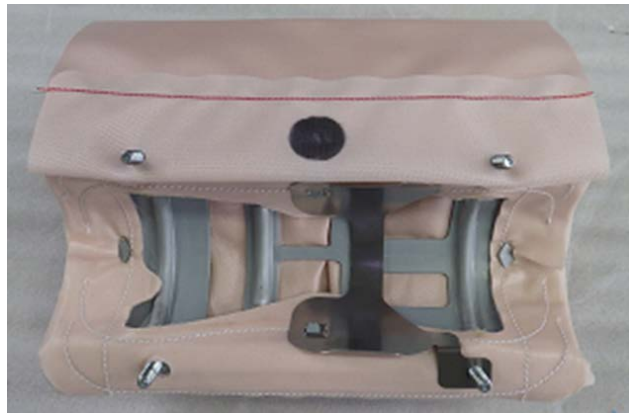
**STEP 12-** Install the protective sheet onto the studs of the airbag with the black mark in the position specified in the photo below. Due to the different spacing of the studs, the protective sheet will only fit properly when installed in this manner.

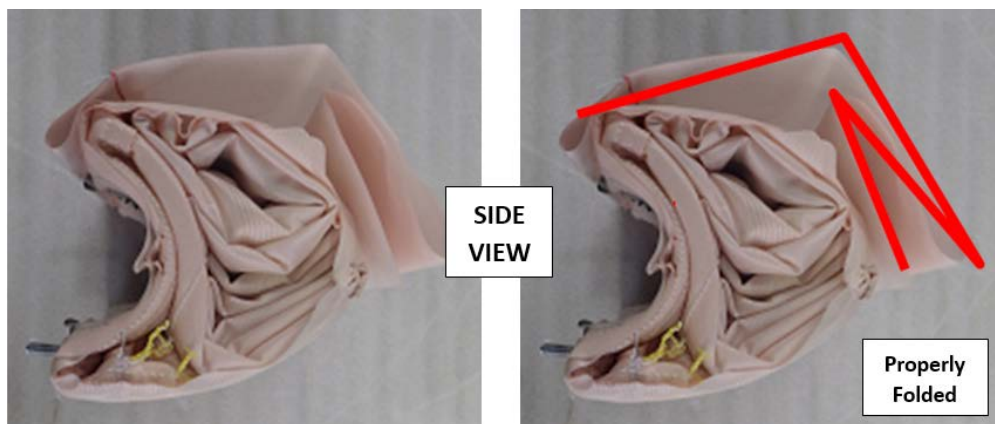
**STEP 13-** The protective sheet is properly installed when: **a)** it fits squarely on the studs, **b)** the black oval-shaped mark is facing up and **c)** the excess is laying over the top of the airbag and folded as shown in the side view photos below.

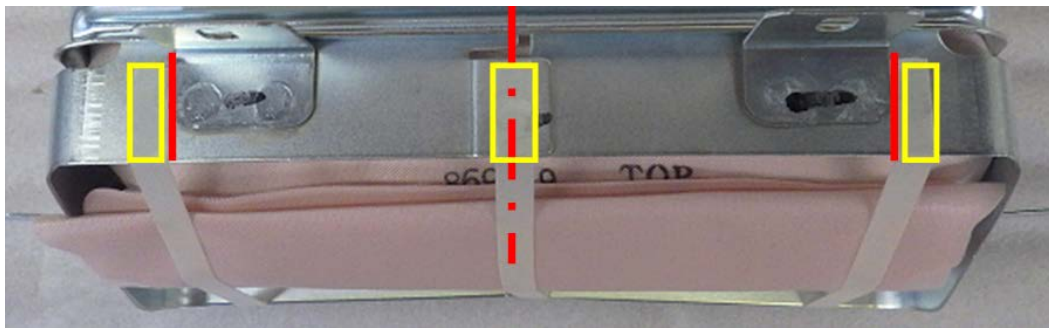
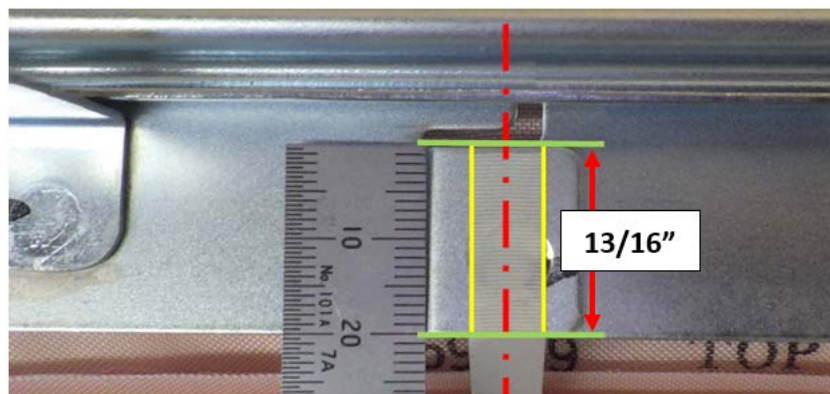
**STEP 15-** Apply the 3 anti-wrinkling tapes to the module frame as shown below to retain the protective sheet. The yellow rectangles represent the tapes and the red lines indicate where the tapes are to be positioned. Approximately 200mm (13/16") from each end of the 2tape should be applied to the module frame.

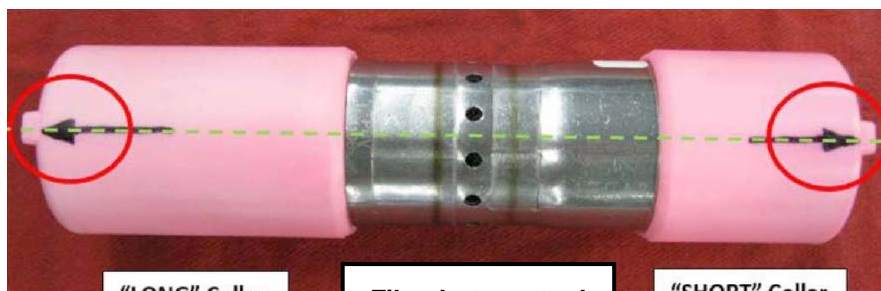
**“LONG” Collar**

**STEP 16-** Inspect the new inflator to confirm the locating protrusions on each of the pink collars are aligned as shown below. The “short” collar can be rotated as needed to align it with the protrusion on the “long” collar if necessary.

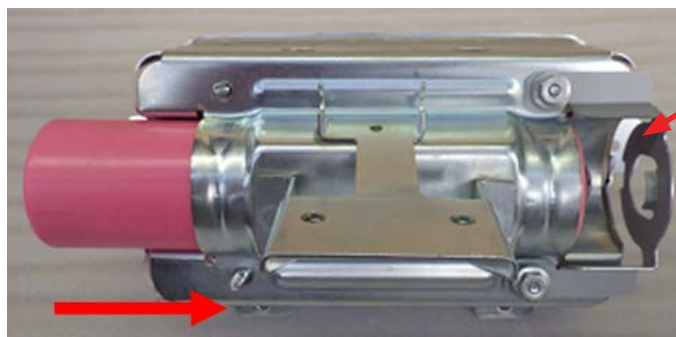
**New Stopper  
Plate Supplied  
with Kit.**

**STEP 18-** Slide the new inflator back into the mounting bracket, short collar end first. Align the tab on the new stopper plate with the notch on the end of the collar. When properly installed, the inflator will be tight against the stopper plate with no gap.

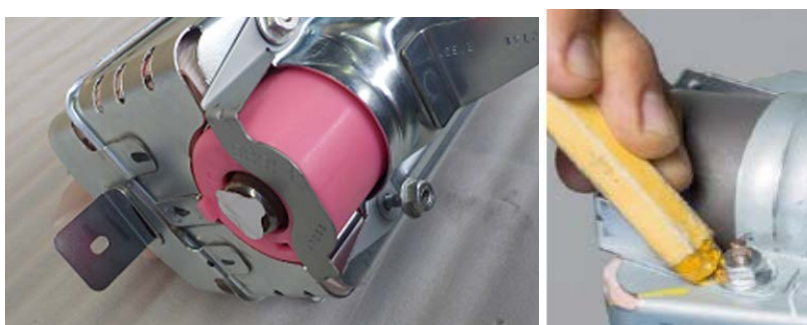
**STEP 19-** Reinstall the original (retained from **STEP 7**) stopper plate and the other 2 **NEW** self-locking nuts. **SLOWLY** tighten (to prevent over-tightening) while making sure both stopper plates stay tight against both ends of the inflator. **HAND TOOLS ONLY!** Torque the nuts to 31-38 inch-pounds. When complete, use a marker to indicate they have been fully tightened.

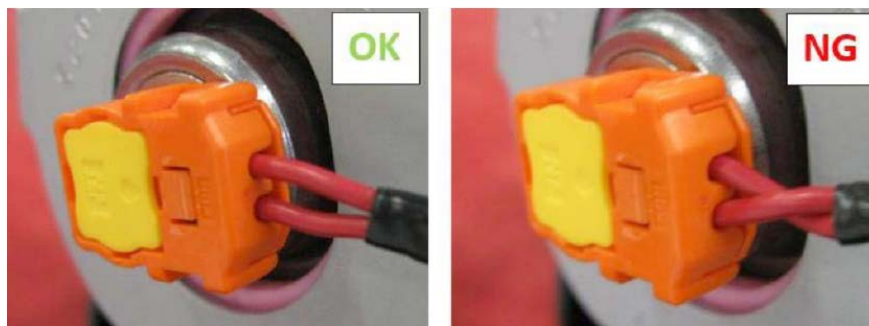
**BEFORE** connecting the harness to the inflator, make sure the harness is not twisted as shown below.

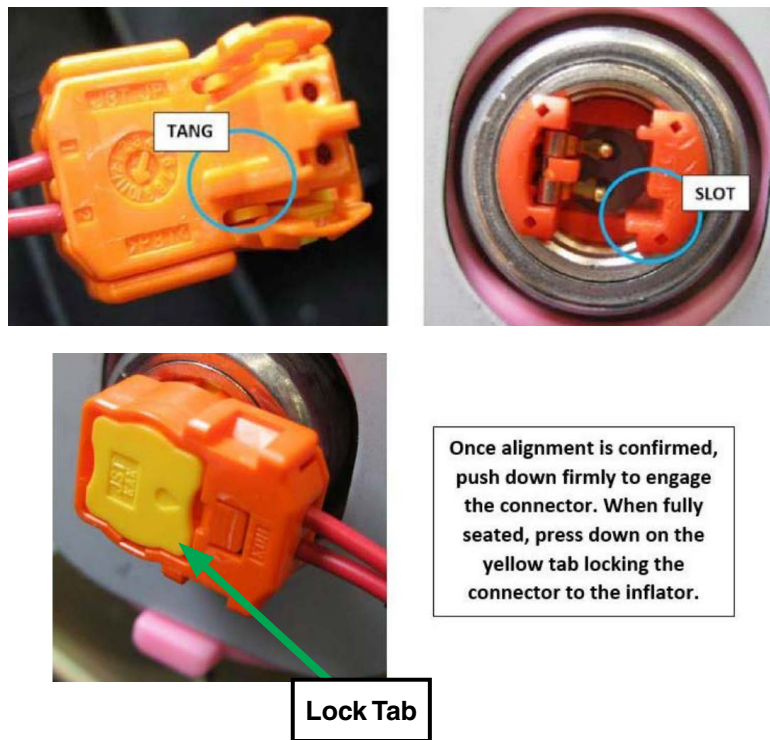
**CAREFULLY** align the tang of the inflator with the slot on the inflator harness connector as shown below. Push down firmly on the yellow lock tab to engage the connector's locking claws into the groove inside the connector boss on the inflator end. Confirm the connector is locked by prying up **LIGHTLY** with a small flat-blade screwdriver. Repeat the procedure on the opposite end.

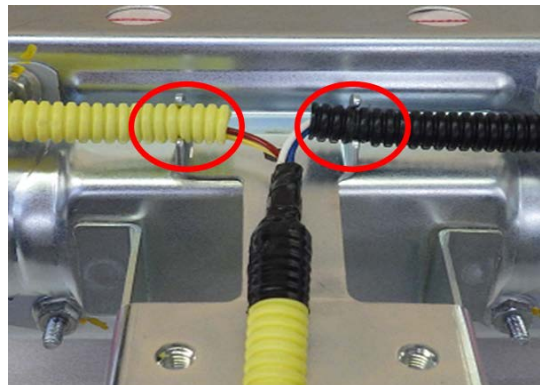
**STEP 21-** After connecting both sides of the harness, refit the harness cover tube back into the retaining bracket.
