## PRODUCT CAMPAIGN BULLETIN

**APPLICABILITY:** 2005-2006 model year Baja  
 2009-2012 model year Legacy  
 2009-2012 model year Outback  
 2009-2012 model year Forester  
 2006-2012 model year Tribeca  
 2006-2011 model year Impreza (including WRX and STI)  
 2012 model year WRX and STI

**NUMBERS:** TKA-17R  
 TKB-17R  
 TKC-17R

**SUBJECT:** Takata Front Passenger Airbag Inflator Replacement

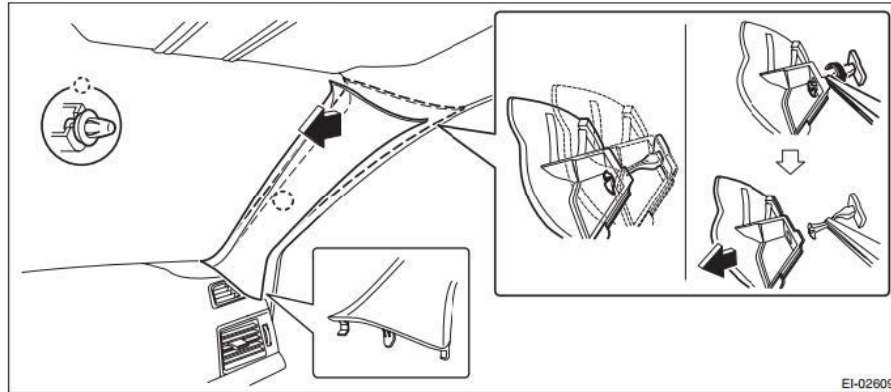
**NOTE:** When removing the “A” pillar trim, be **VERY CAREFUL** not to damage the upper trim retaining (tether) clip. The clip is located just below where the trim panel meets the head liner. If the tether clip becomes damaged, it **MUST** be replaced. The illustrations below show how to release the tether clip and remove the “A” pillar trim. **It is STRONGLY RECOMMENDED to use the release tool (p.n. SOA635147) specifically designed for tether clip removal. See pg. 8 of this bulletin for more information.**

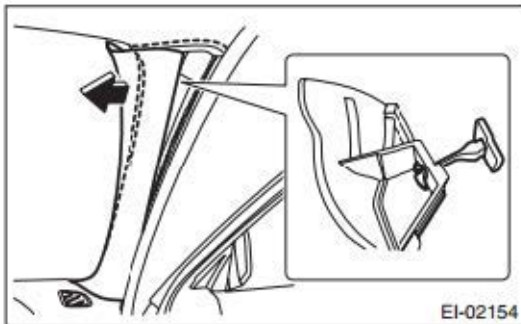
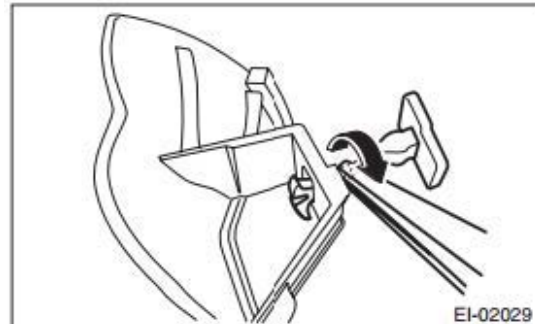
**NOTE:** On **FORESTER** models, when removing the "A" pillar trim, be **VERY CAREFUL** not to damage the upper trim retaining (tether) clip. It is **STRONGLY RECOMMENDED** to use the release tool (p.n. SOA635147) specifically designed for tether clip removal. See pg. 8 of this bulletin for more information. The clip is located just below where the trim panel meets the head liner. If the tether clip becomes damaged, it **MUST** be replaced. The illustrations below show how to release the tether clip and remove the "A" pillar trim.
