### Release Date: November 2018 Revision: 00

Condition
 It has been determined that a defect, which relates to motor vehicle safety, exists in all 2006 model year Saab 9-2X vehicles that are not currently registered and, have never been registered, in Alabama, California, Florida, Georgia, Hawaii, Louisiana, Mississippi, South Carolina, Texas, Guam, Puerto Rico, Saipan, U.S. Samoa or U.S. Virgin Islands. In these vehicles, the front passenger air bag inflator module may experience an alteration over time, which could lead to overaggressive combustion in the event of an air bag deployment. This condition could create excessive internal pressure when the air bag is deployed, which could result in the body of the inflator rupturing upon deployment. In the event of an inflator rupture, metal fragments could pass through the air bag cushion material, which may result in injury or death to vehicle occupants.
 Correction

15046 Front Passenger Air Bag Inflator

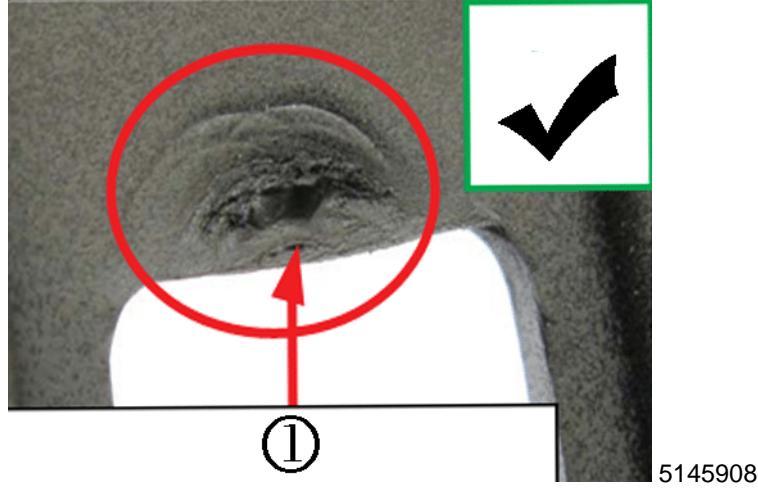
• Inspect the claw openings on the outside and inside of the cover for damage. If any found to look like the (2) the cover must be replaced.

• Once all the harness-side retaining claws are released (easily done once the center claw is released), CAREFULLY separate the inflator module from the cover. After the harness-side of the module is free from the cover (2), simply rotate it to unhook the label-side retaining claws. Remove the cover completely as shown (3).
