PRODUCT CAMPAIGN BULLETIN

APPLICABILITY: 2005-2006 model year Baja
 2009-2012 model year Legacy
 2009-2012 model year Outback
 2009-2012 model year Forester
 2006-2012 model year Tribeca
 2006-2011 model year Impreza (including WRX and STI)
 2012 model year WRX and STI

NUMBERS: TKA-17R
 TKB-17R
 TKC-17R

SUBJECT: Takata Front Passenger Airbag Inflator Replacement

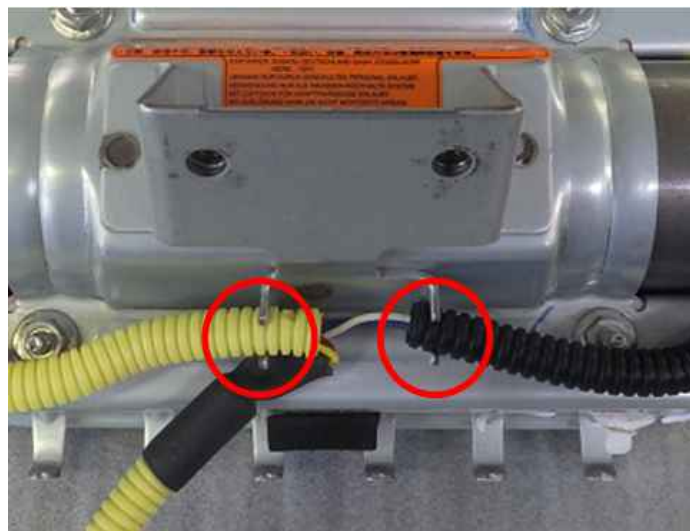
STEP 4- Using a scissor or wire cutter (no knives or razors) **CAREFULLY** cut the black harness cover tube (approximately 1 1/2 inches) enough to expose the blue and white wires inside and provide enough room to install the Electro-Tap (shorting) connector.

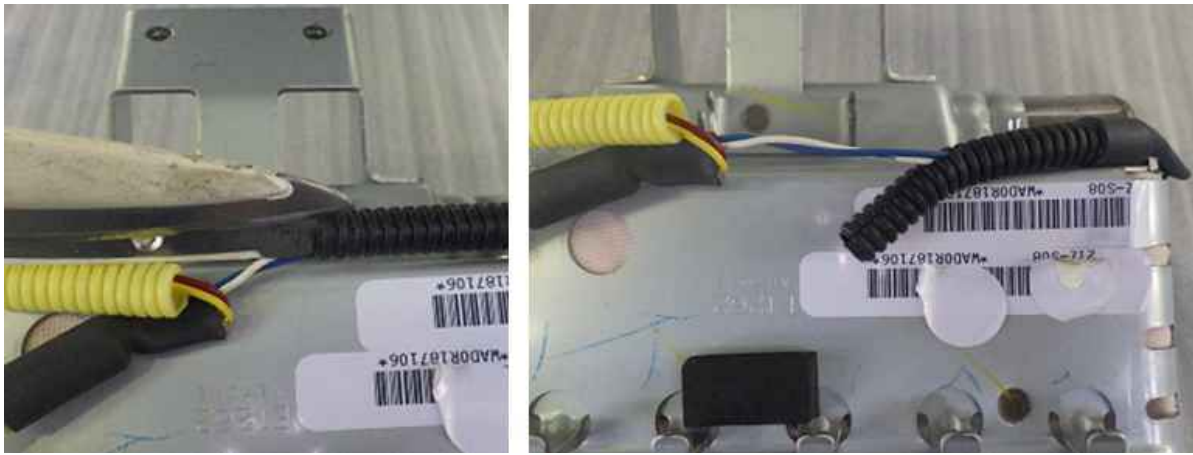
STEP 5- Short the white and blue wires together by installing the Electro-Tap connector. The connector creates a short circuit which acts as a safeguard to prevent against static discharge that may deploy the removed inflator. The tab portion of the Electro-Tap connector **MUST** be cut off prior to use to insure a good short-circuit is made as shown in the illustration below. **Follow the sequence below** for installing the Electro-Tap connector. Use pliers to squeeze closed the two sections of the connector together, **one section at a time**.

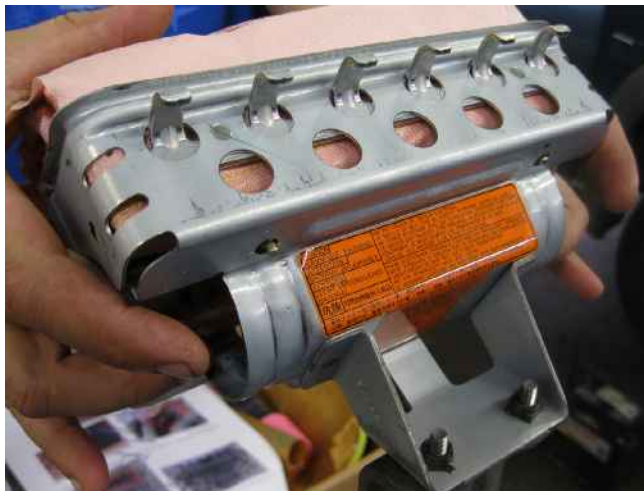
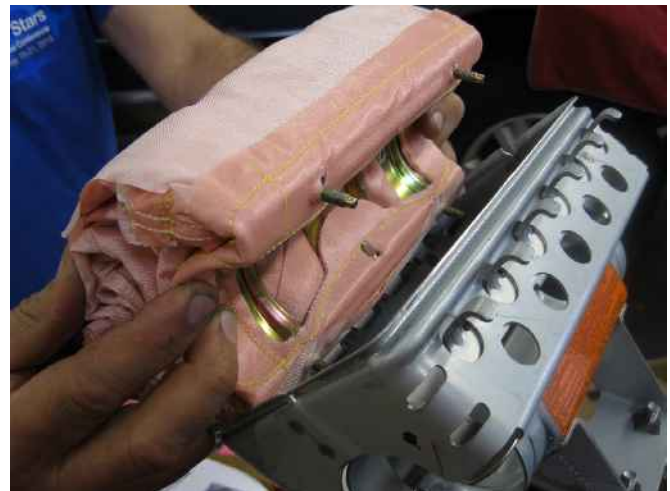
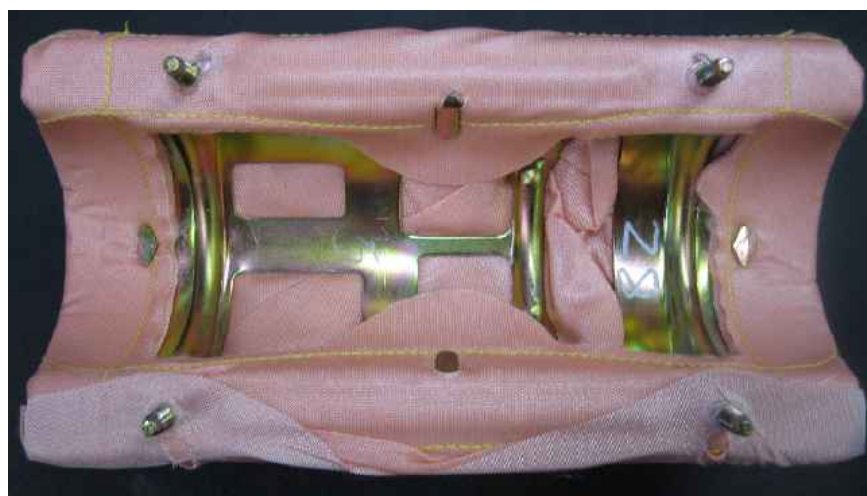
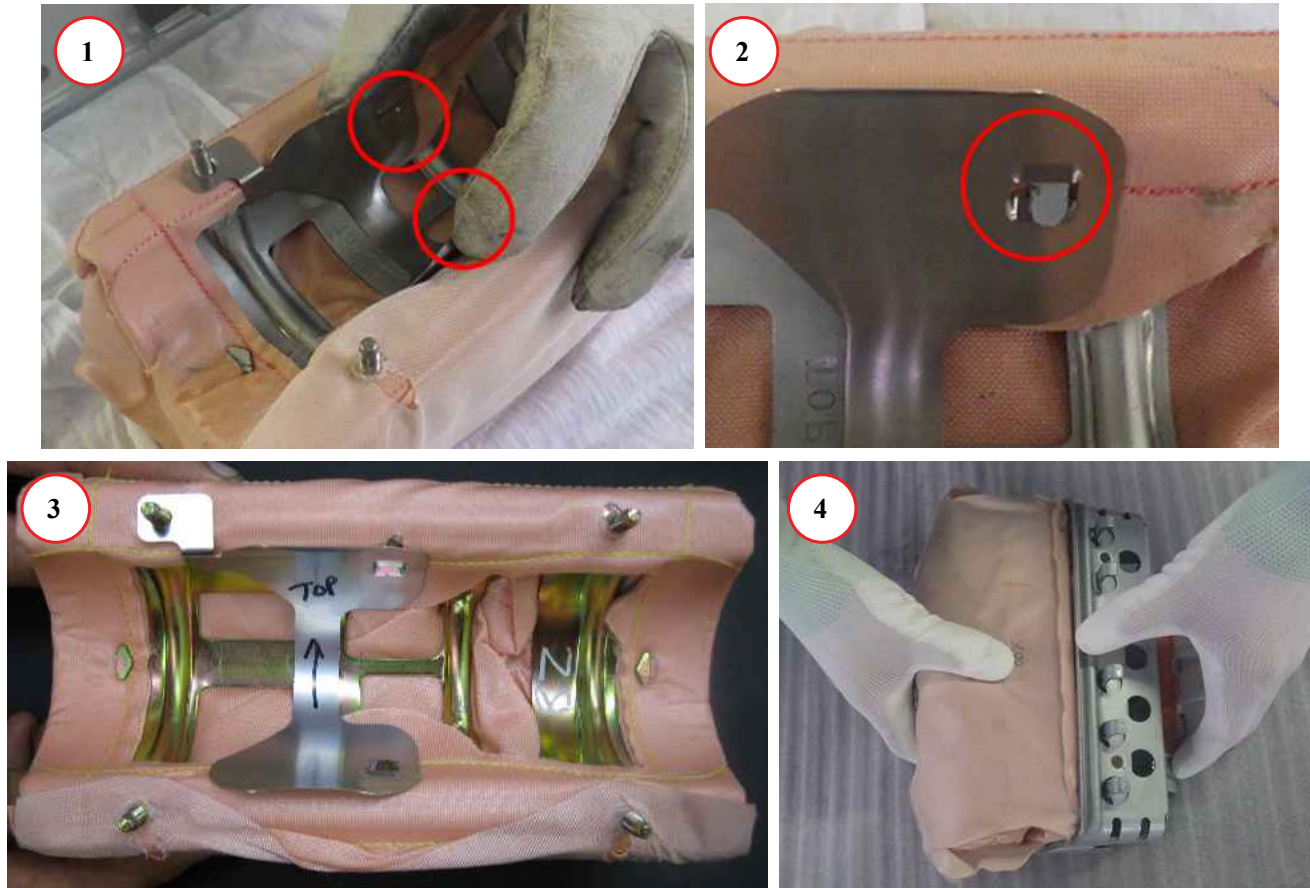
STEP 11- CAREFULLY Install the heat insulating plate into the back (inflator) side of the airbag as shown in photo 1 below. **The plate can only be installed in one direction.** Make sure the 2 retaining claws come through the corresponding holes in the insulator plate as shown in photo 2. The airbag is ready to refit to the mounting bracket in photo 3 and is being reinstalled in photo 4.

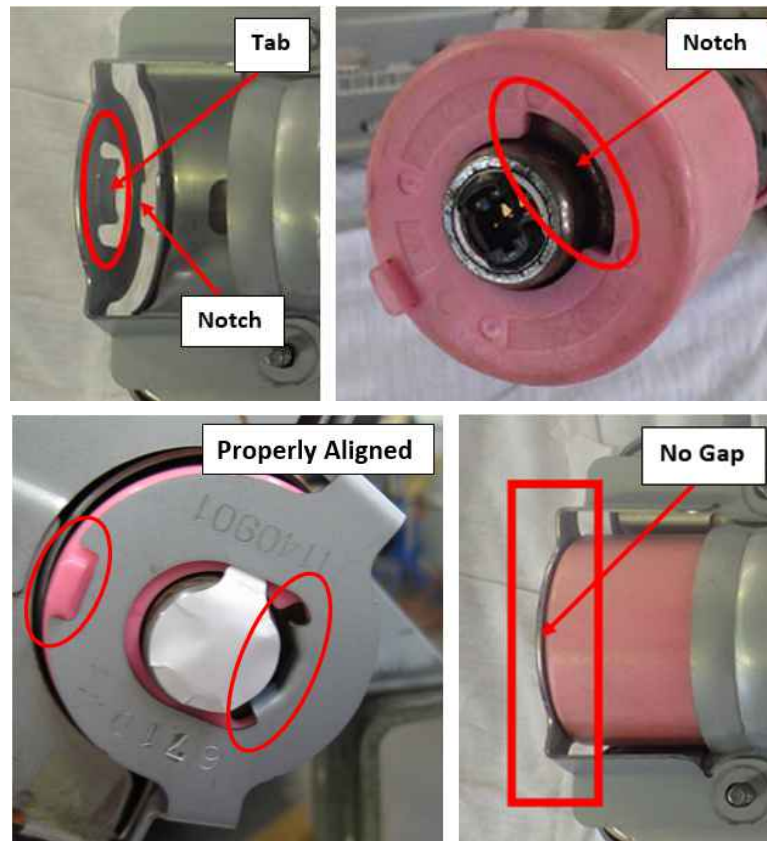
STEP 13- Install the new inflator into the mounting bracket with the short pink collar end toward the new Stopper Plate (A). Align the protrusion on the end of the collar with the notch in the stopper plate. There is also a tab on the inside of Stopper Plate (A) which will align with the notch in the end of the collar. When properly installed the collar will be tight against the plate with no gap.

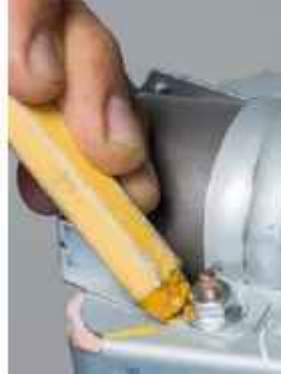
STEP 15- Reinstall the 4 **NEW** self-locking nuts. **SLOWLY** tighten (to prevent over-tightening) then torque the nuts to 31-38 inch-pounds. When complete, use a marker to indicate they have been fully tightened.

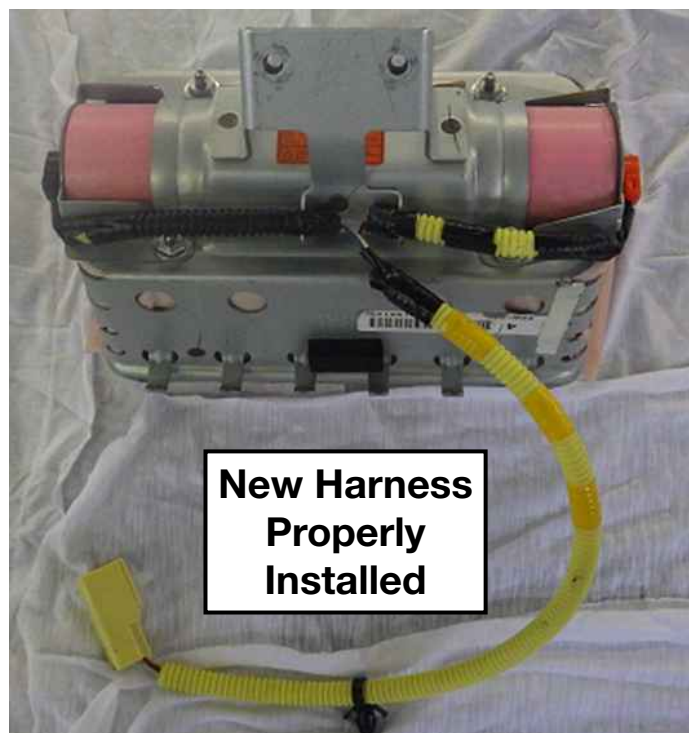
**New Harness
Properly
Installed**

VERY IMPORTANT: After connecting the new harness to the inflator, **both sides MUST be routed as shown** in the “New Harness Properly Installed” photo below.

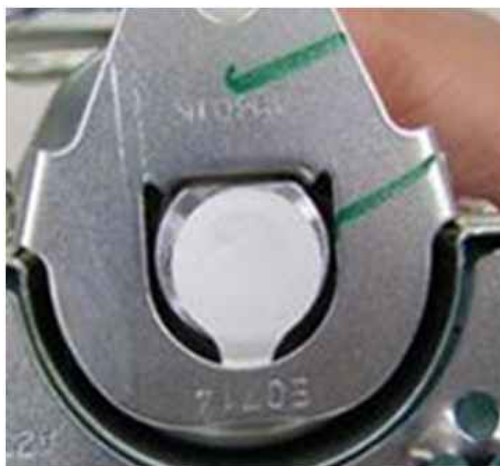
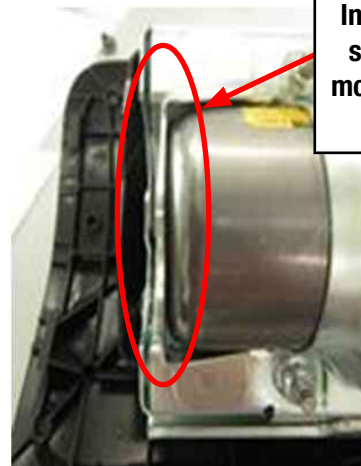
Inflator properly seated against mounting bracket (NO GAP)

STEP 9- Install the new inflator into the mounting bracket so the yellow taped end aligns with the removed stopper plate. Make sure the “D-shaped” portion of the inflator harness connector boss aligns with the “D-shaped” portion of the hole in the end of the mounting bracket as shown below. When properly installed, the end of the inflator will be seated tight against the mounting bracket. Do not peel the white harness connection dust cover at this time.

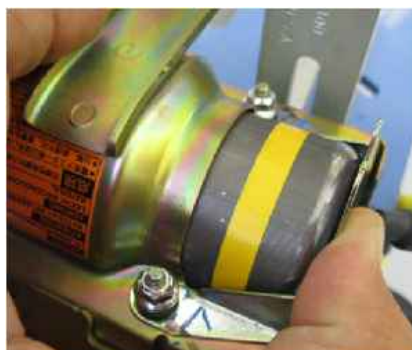
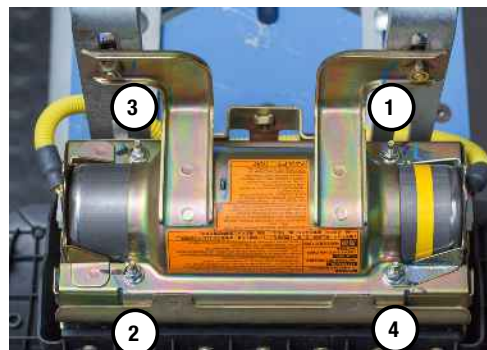
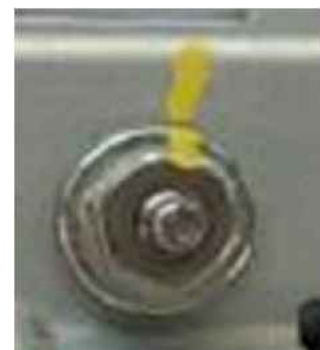
STEP 10- As shown below, install but **do not fully tighten** 2 of the **NEW** self-locking nuts while holding the stopper plate tight against the inflator. Remove the nuts still installed on the mounting bracket and replace them with 2 **NEW** self-locking nuts. Once all 4 **NEW** nuts are in place, **torque to 31 - 38 inch pounds in the sequence shown below**. Use a marker to mark the nuts after torquing to indicate they have been fully tightened.
