PRODUCT CAMPAIGN BULLETIN

<p>APPLICABILITY: 2005-2006 model year Baja 2009-2012 model year Legacy 2009-2012 model year Outback 2009-2012 model year Forester 2006-2012 model year Tribeca 2006-2011 model year Impreza (including WRX and STI) 2012 model year WRX and STI</p>	<p>NUMBERS: TKA-17R TKB-17R TKC-17R</p> <p>DATE: 01/13/17</p> <p>REVISED: 03/06/18</p> <p>NHTSA ID: 17V-014 17V-026 17V-016</p>
<p>SUBJECT: Takata Front Passenger Airbag Inflator Replacement</p>

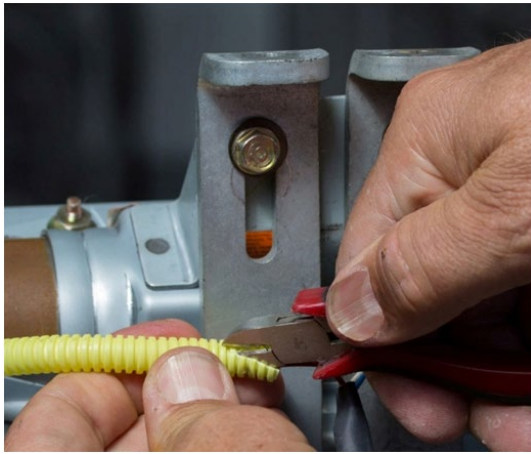
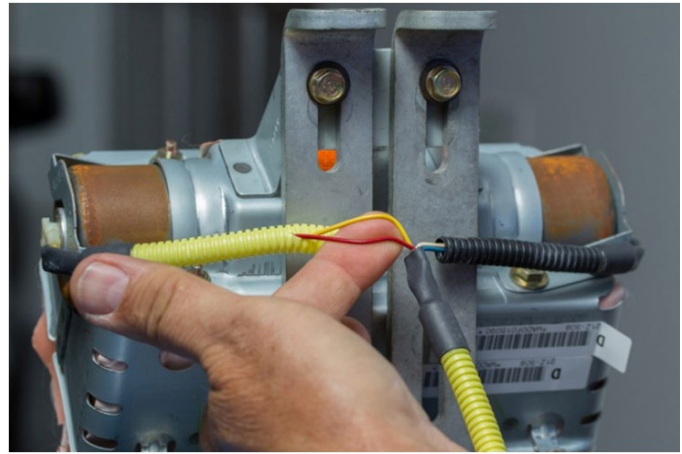
STEP 3- CAREFULLY cut the yellow harness cover (approximately 1 1/2 inches) enough to expose the 2 yellow and red wires inside and provide enough room to install the Electro-Tap (shorting) connector using a scissor or wire cutter (no knives or razors).

TAKE YOUR TIME AND BE CAREFUL TO NOT CUT THE 2 WIRES!

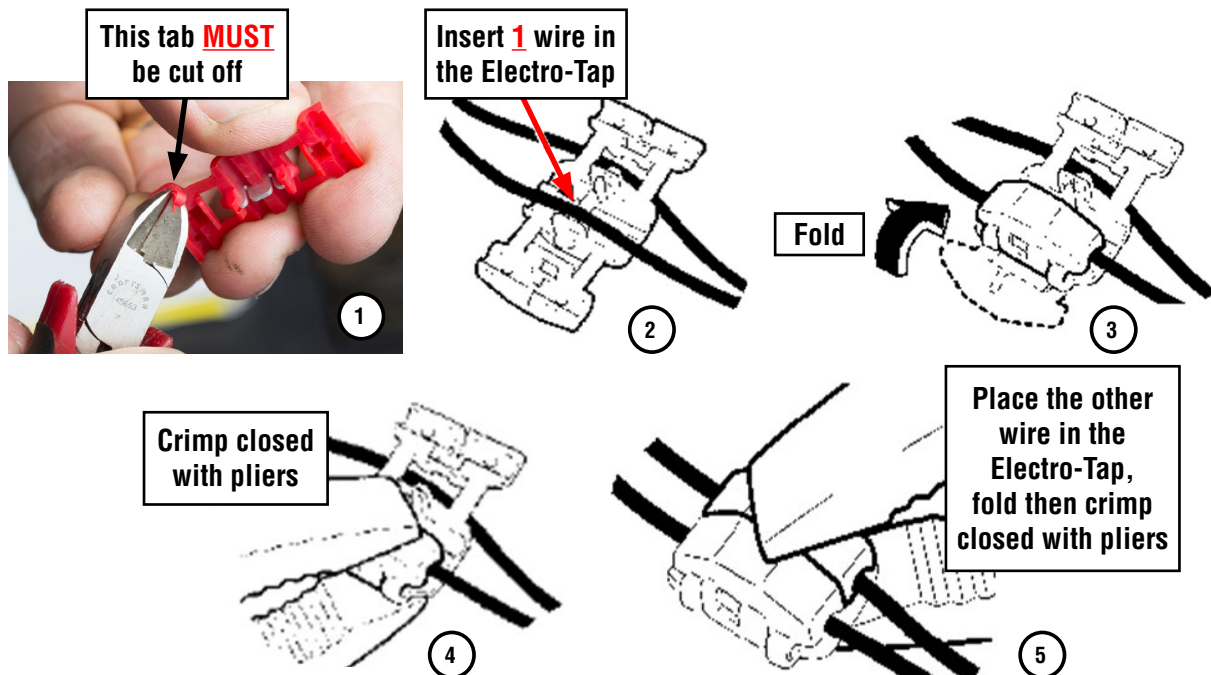
STEP 4- Short the yellow and red wires together by installing the Electro-Tap connector. The connector creates a short circuit which acts as a safeguard to prevent against static discharge that may deploy the removed inflator. The tab portion of the Electro-Tap connector **MUST** be cut off prior to use to insure a good short-circuit is made as shown in the illustration below. **Follow the sequence below** for installing the Electro-Tap connector. Use pliers to squeeze closed the two sections of the connector together, **one section at a time**.

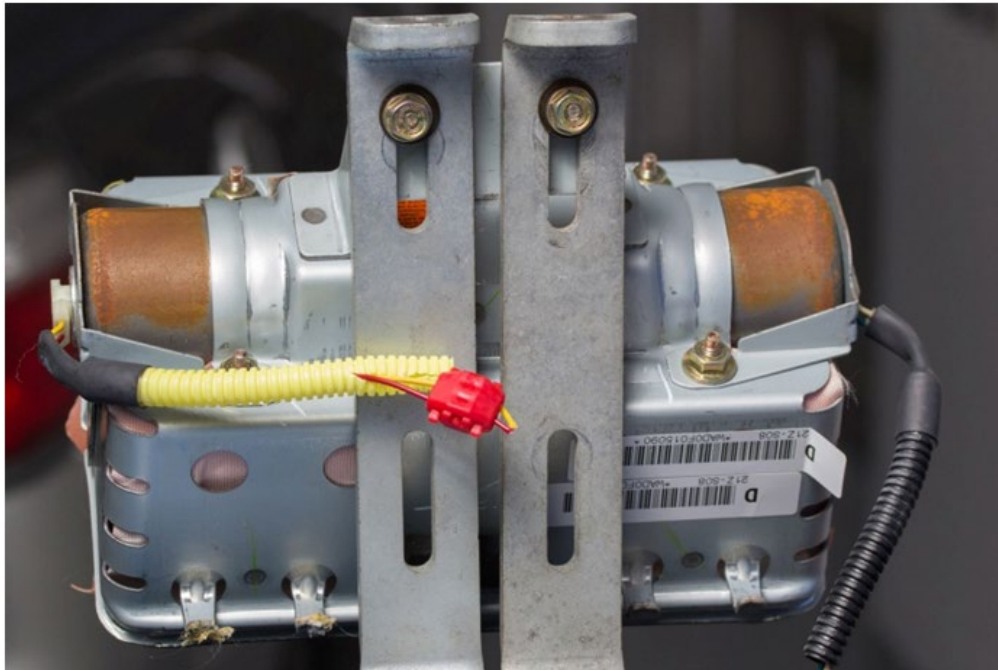
STEP 5- Once the Electro-Tap connector is fully crimped in place, cut the yellow and red wires on the **body harness connector side** of the Electro-Tap connector as shown below.

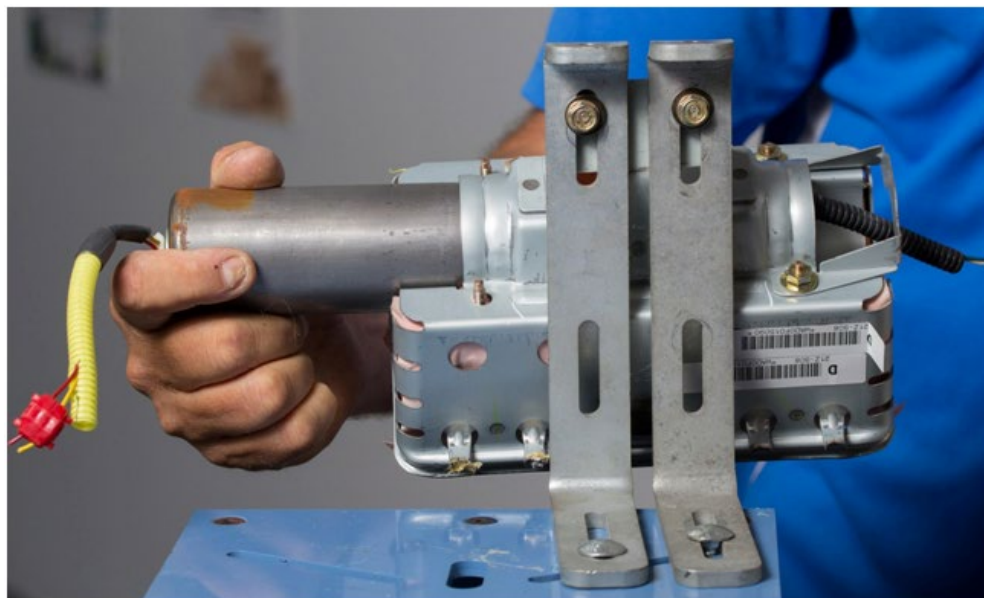
STEP 6- Loosen but **do not remove** the two 10mm self-locking nuts securing the stopper plate securing the end of the inflator with the blue and white wires as leaving them in place will help keep the airbag assembly together. Remove the two nuts and the stopper plate on the on the opposite end of the inflator mounting bracket and discard them. **NEVER ATTEMPT TO REMOVE THE HARNESS CONNECTORS FROM THE INFLATOR!** With the stopper plate removed and the other 2 self-locking nuts loosened, slide the original inflator out of the mounting bracket while feeding the cut off portion of the wiring harness under the remaining stopper plate. Place the removed original airbag inflator in the “cradle” of the Kit Box insert.

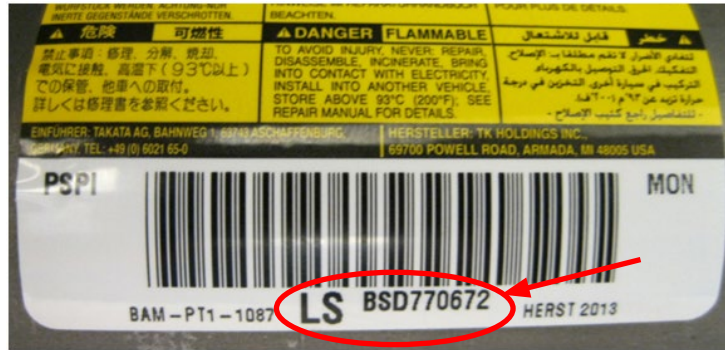
STEP 7 - VERY IMPORTANT: Record the **11-digit alpha-numeric serial number** for both the **new and the removed inflators** on the hard copy of the Repair Order. **For SOA and SDC Retailers ONLY**, this information will be required for claim approval. **For SNE retailers**, this information will be required for completion of the Part Return Notice which will be forwarded by the retailer to the PCC.

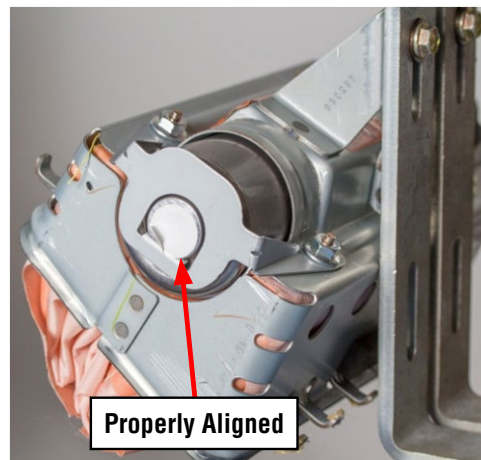
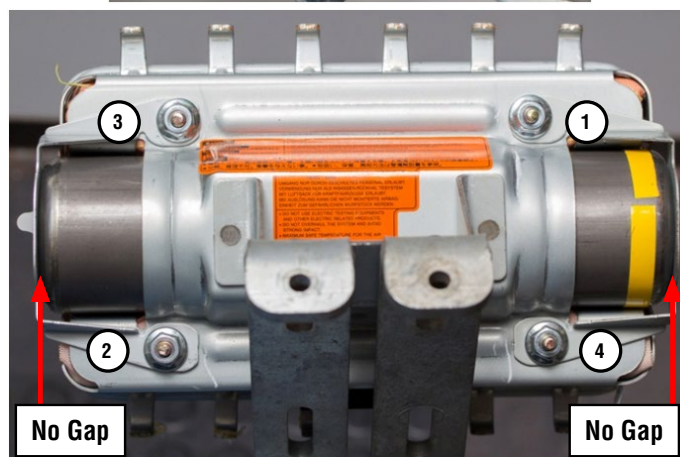
STEP 8- Install the new inflator into the mounting bracket so the yellow taped end aligns with the stopper plate still installed on the mounting bracket. Make sure the “D-shaped” portion of the inflator harness connector boss aligns with the “D-shaped” portion of the hole in the new replacement stopper plate as shown below. Do not peel the white harness connection dust cover at this time. Use 2 NEW self-locking nuts to secure the new stopper plate but do not fully tighten them. Remove the other 2 nuts securing the other stopper plate on the mounting bracket and replace them with 2 NEW self-locking nuts. When properly installed, both ends of the inflator will be seated tight against both stopper plates with no gaps.

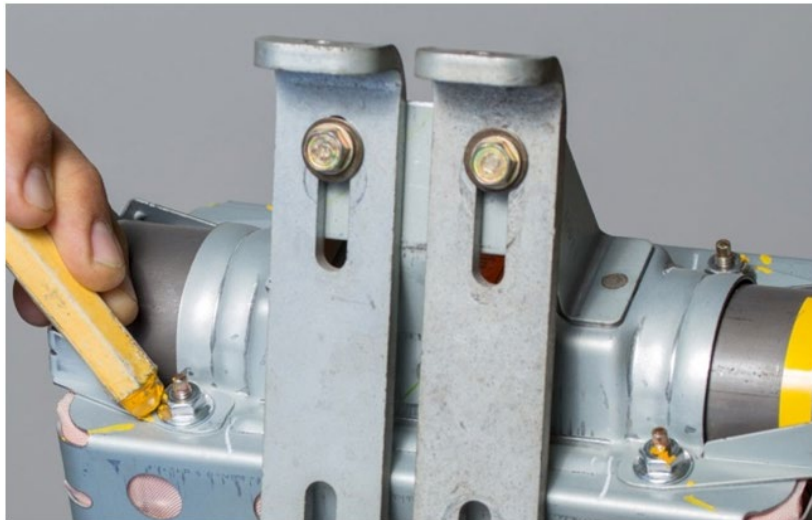
STEP 9- Once all 4 **NEW** nuts are in place, **torque to 31 - 38 inch pounds in the sequence shown above.** Use a marker to mark the nuts after torquing to indicate they have been fully tightened.

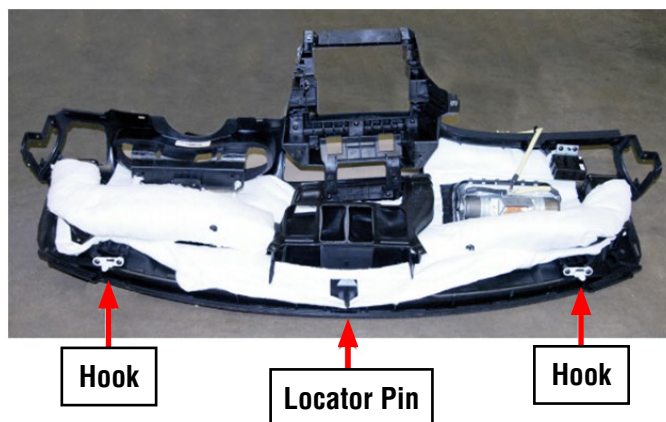
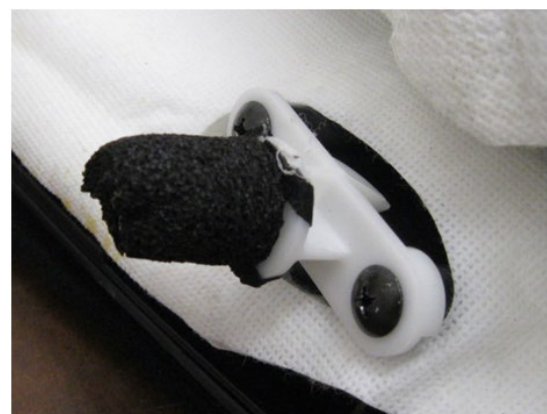
STEP 14- To eliminate a possible source of a rattling sound from the dash, wrap the 2 hooks and locator pin with non-woven material, p.n. SOA963W110 (or an equivalent self-adhesive foam) as shown below.

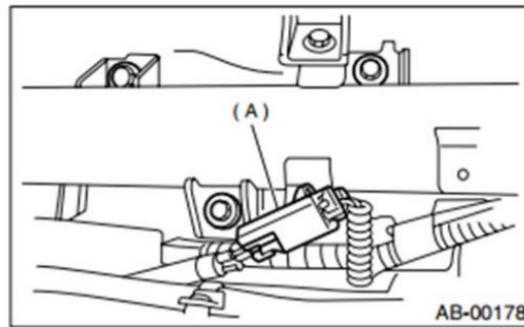
- Disconnect the airbag module harness connector (A) and release it from the support beam bracket.

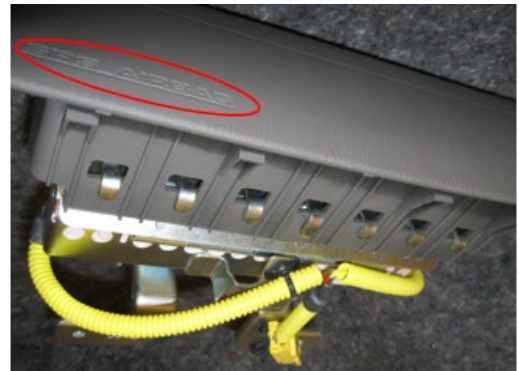
VERY IMPORTANT: Before removing the original trim cover / lid from the module, note the orientation of the cover in relation to the module as the module can be installed upside down in the cover. (TIP: The bottom or harness side goes toward the “SRS AIRBAG” side of the cover as shown.)

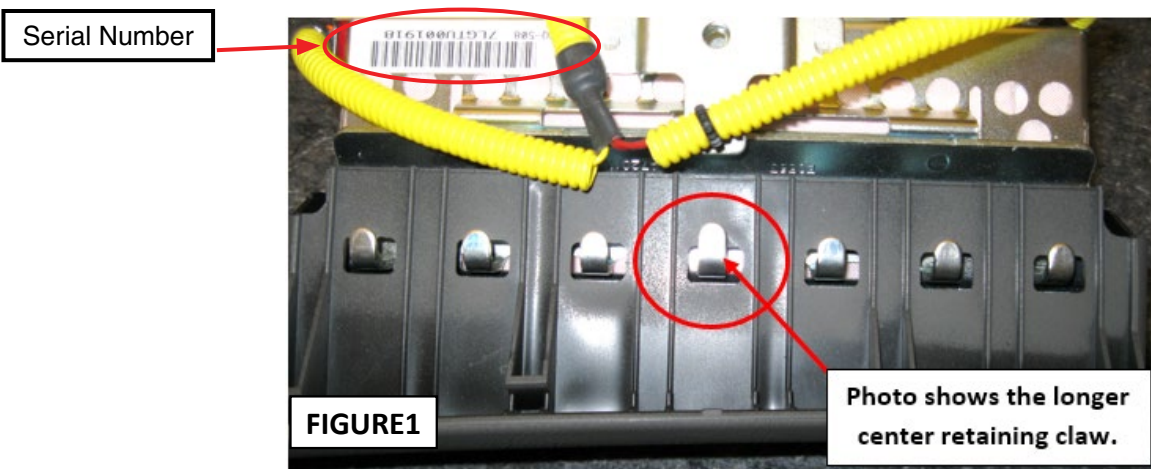
- Using a trim clip removal tool and starting on the harness-side of the module assembly as shown in the sequence below, CAREFULLY insert the tool and twist ONLY AS MUCH AS IS REQUIRED to release the slightly longer center retaining claw from the trim cover. Once released with the tool, the other 6 claws will release easily by hand.
- Rotate the inflator portion of the assembly outward from the cover to release the 7 label-side claws and separate the cover from the module. No tool is required as all the 7 label-side claws are the same size.

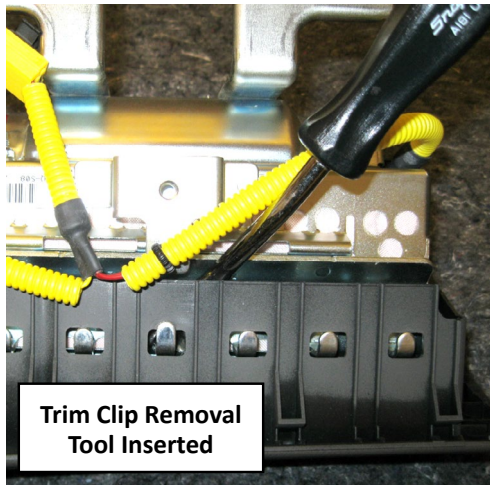
Trim Clip Removal Tool Inserted

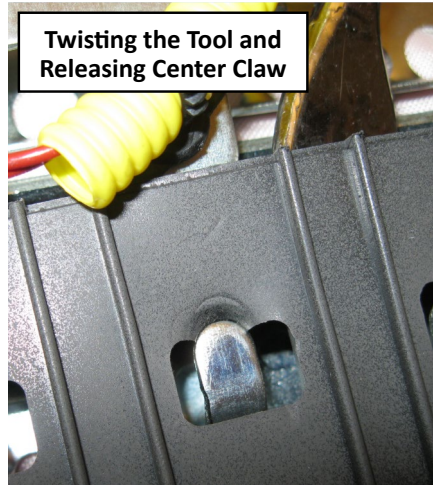
Twisting the Tool and Releasing Center Claw

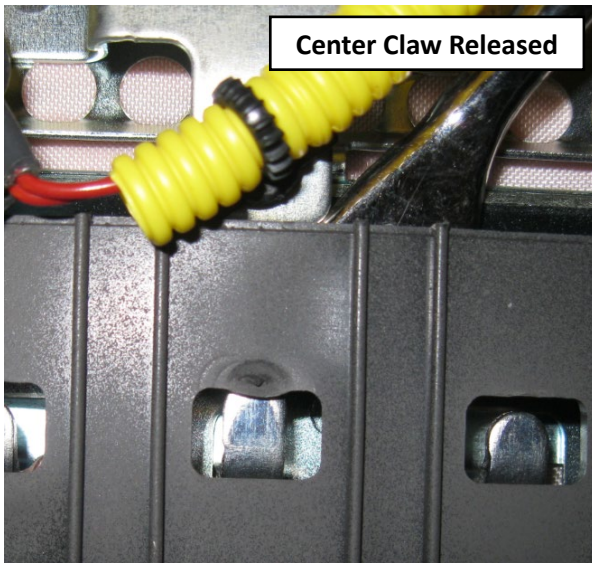
Center Claw Released

All Harness-Side Claws Released

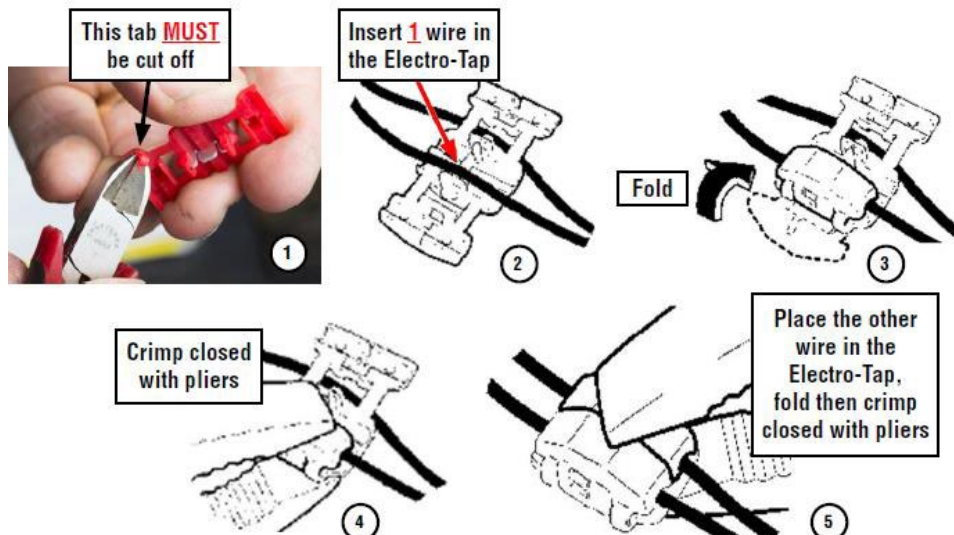
STEP 5- Short the yellow and red wires together by installing the Electro-Tap connector. The connector creates a short circuit which acts as a safeguard to prevent against static discharge that may deploy the removed inflator. The tab portion of the Electro-Tap connector **MUST** be cut off prior to use to insure a good short-circuit is made as shown in the illustration below. **Follow the sequence below** for installing the Electro-Tap connector. Use pliers to squeeze closed the two sections of the connector together, **one section at a time**.

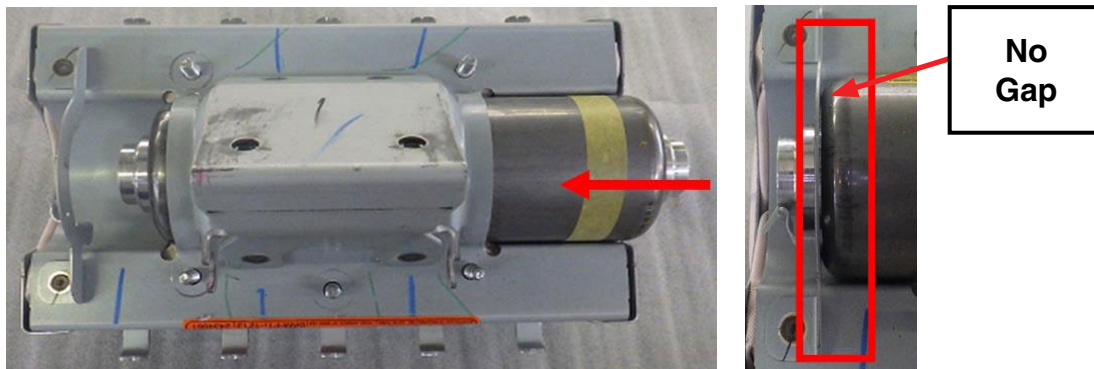
STEP 10- Install the new inflator into the mounting bracket so the yellow taped end will align with the stopper plate when reinstalled on the mounting bracket. When properly installed, both ends of the inflator will be seated tight against the stopper plates with no gaps.

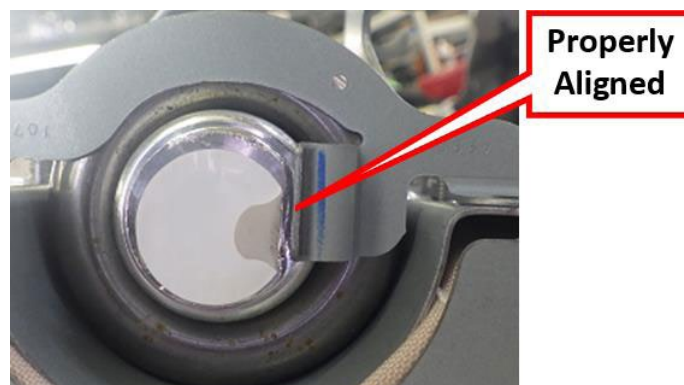
Make sure the “D-shaped” portion of the inflator harness connector boss aligns with the “D-shaped” portion of the original stopper plate as shown below. **Do not peel the white harness connection dust cover at this time.**

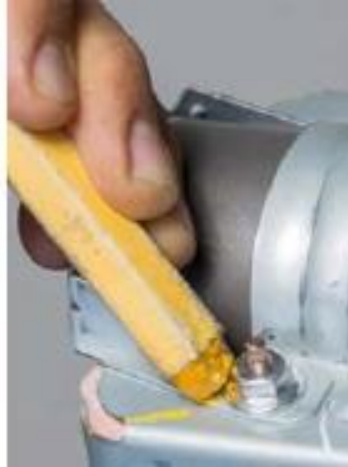
STEP 11- Reinstall the original stopper plate and the 5 **NEW** self-locking nuts. **SLOWLY** tighten (to prevent over-tightening) then torque the nuts to 31-38 inch-pounds. When complete, use a marker to indicate they have been fully tightened.

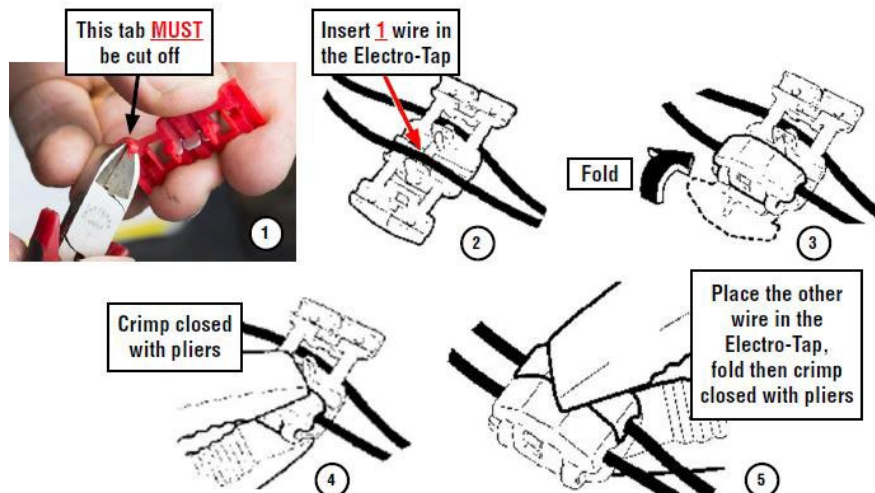
STEP 5- Short the yellow and red wires together by installing the Electro-Tap connector. The connector creates a short circuit which acts as a safeguard to prevent against static discharge that may deploy the removed inflator. The tab portion of the Electro-Tap connector **MUST** be cut off prior to use to insure a good short-circuit is made as shown in the illustration below. **Follow the sequence below** for installing the Electro-Tap connector. Use pliers to squeeze closed the two sections of the connector together, **one section at a time**.
