SIB 65 08 17

**RECALL 17V-020: PASSENGERS FRONT AIR BAG  
MODULE(EXPANSION TO 16V-364)**

This Service Information bulletin (Revision 5) replaces SI B65 08 17 dated October 2019.

BMW AG is expanding the previously announced (16V-364 / SI B65 19 16) passenger front air bag recall.. The vehicles affected by the expansion (Recall 17V-020) will be identified by **defect code 0072810100**.

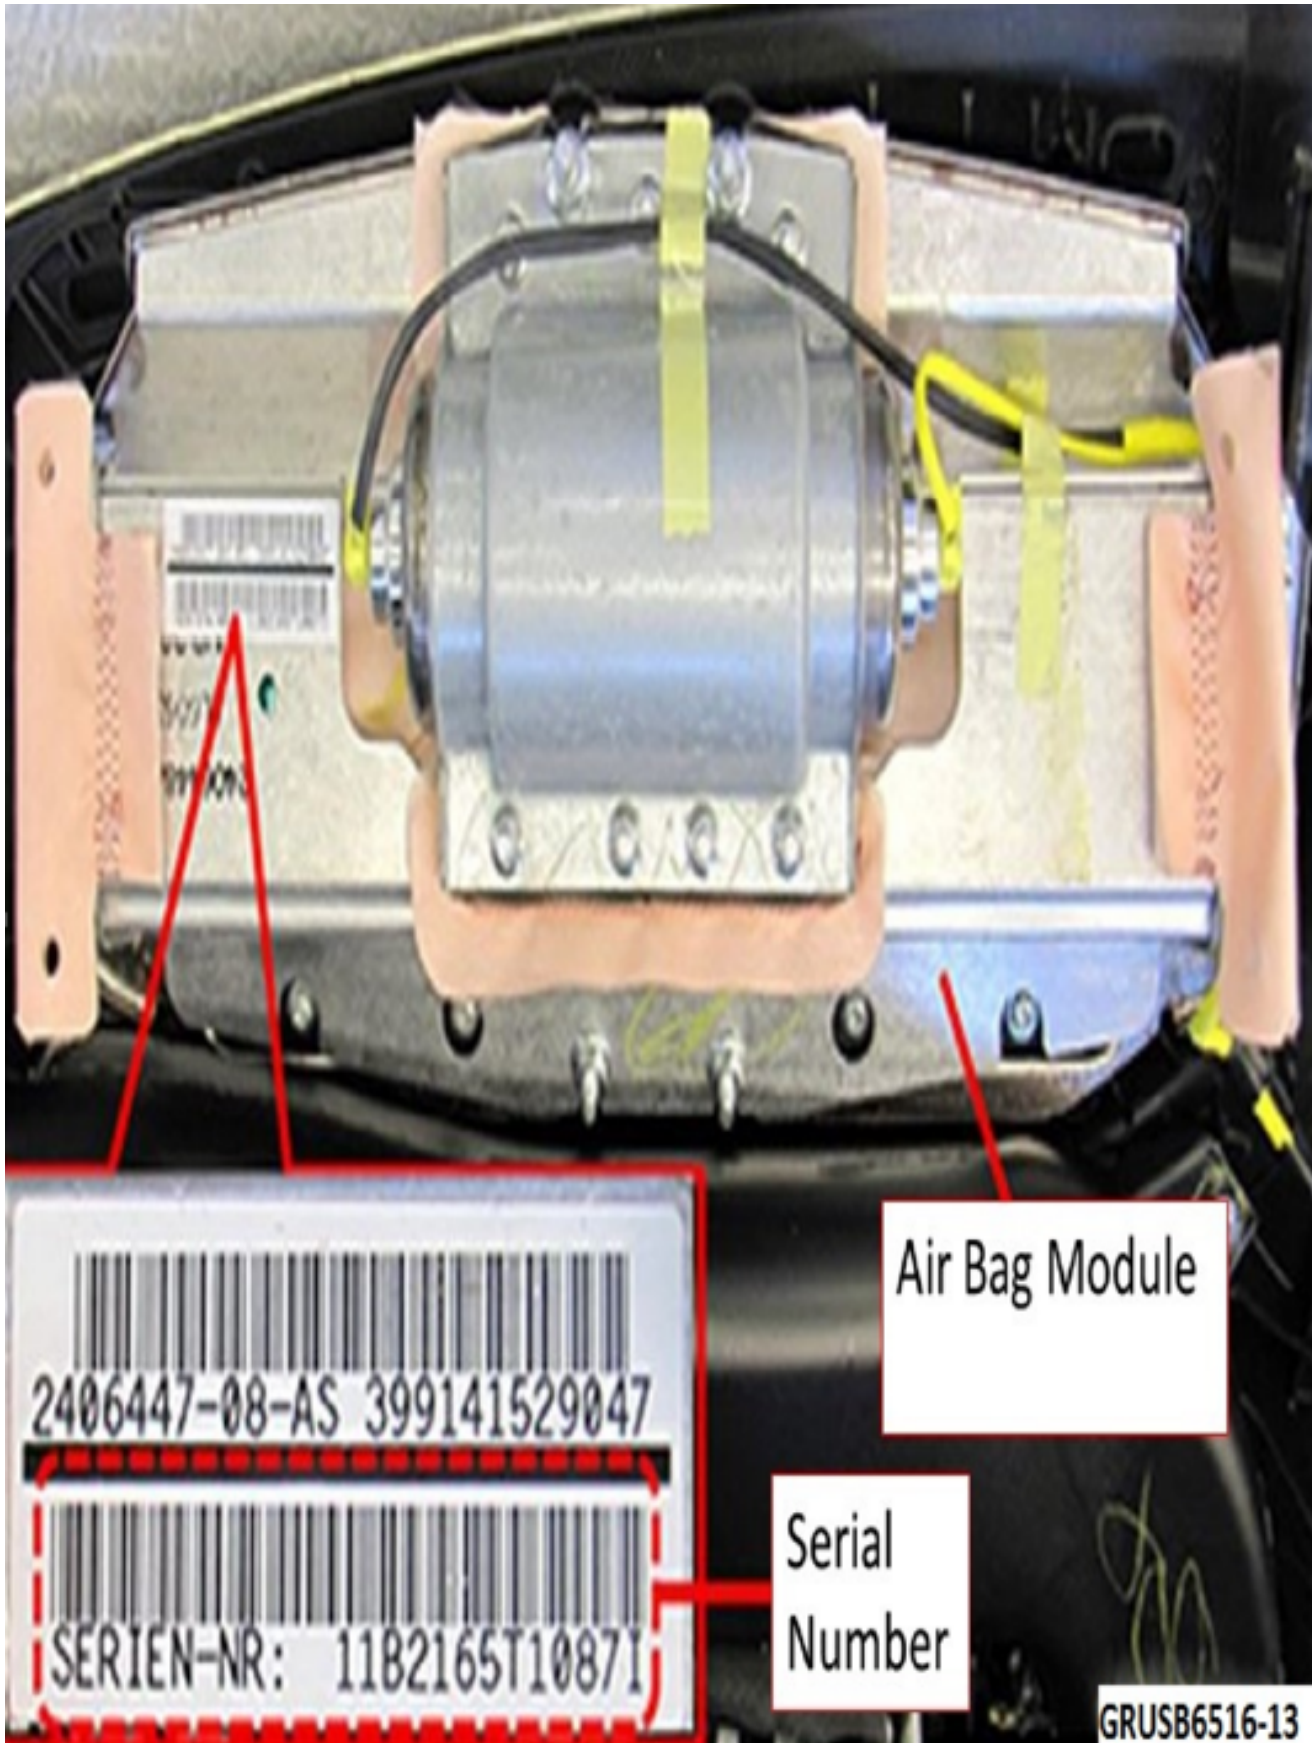
The dash cover and center console have sharp edges that can cut into the dashboard or seat during removal. Take precautions to prevent contact that can damage the interior.

Note: Please make sure the blower motor wiring is routed correctly behind the crash-pad prior to re-installation of the dashboard.
