PRODUCT CAMPAIGN BULLETIN

APPLICABILITY: 2005-2006 model year Baja
 2009-2012 model year Legacy
 2009-2012 model year Outback
 2009-2012 model year Forester
 2006-2012 model year Tribeca
 2006-2011 model year Impreza (including WRX and STI)
 2012 model year WRX and STI

NUMBERS: TKA-17R
 TKB-17R
 TKC-17R

SUBJECT: Takata Front Passenger Airbag Inflator Replacement

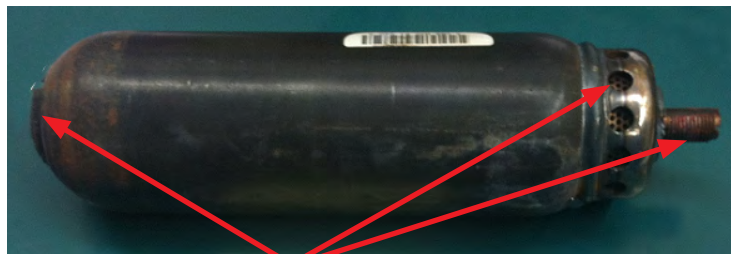
The shape, holes, and copper-colored stud indicate this not a Genuine Subaru inflator.

- **Do not proceed with this repair if your inspection reveals a non-Genuine Subaru airbag module has been installed in the vehicle.** Follow the instructions described in the “Counterfeit Airbag Information” Dealer Advisory Bulletin.

- Document the presence of the aftermarket or counterfeit device on the repair order and with photos. Report this information immediately on a Quality Monitoring Report (QMR). **IMPORTANT:** When entering a related QMR, use failure code **ULF** and **NOT** the campaign fail code.

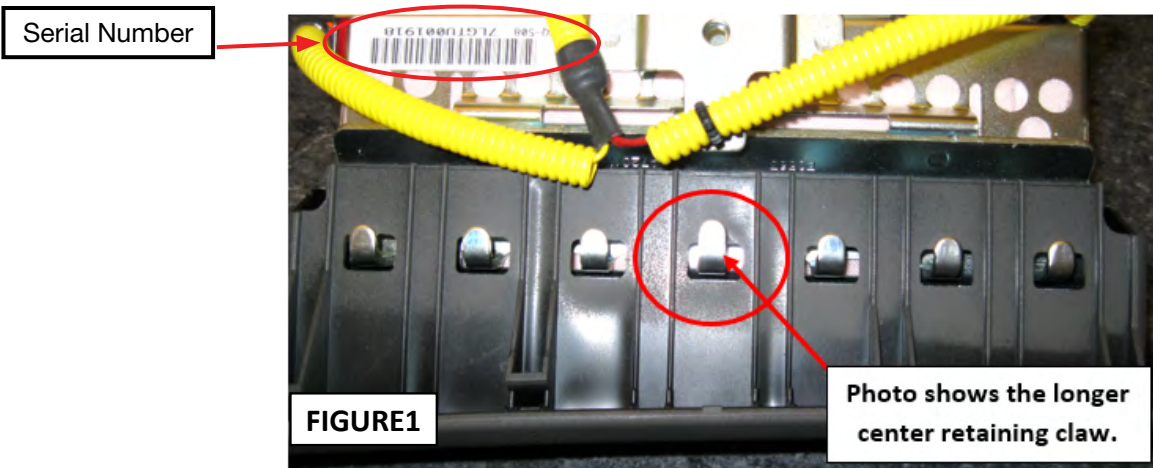
- Using a trim clip removal tool and starting on the harness-side of the module assembly as shown in the sequence below, CAREFULLY insert the tool and twist ONLY AS MUCH AS IS REQUIRED to release the slightly longer center retaining claw from the trim cover. Once released with the tool, the other 6 claws will release easily by hand.
- Rotate the inflator portion of the assembly outward from the cover to release the 7 label-side claws and separate the cover from the module. No tool is required as all the 7 label-side claws are the same size.

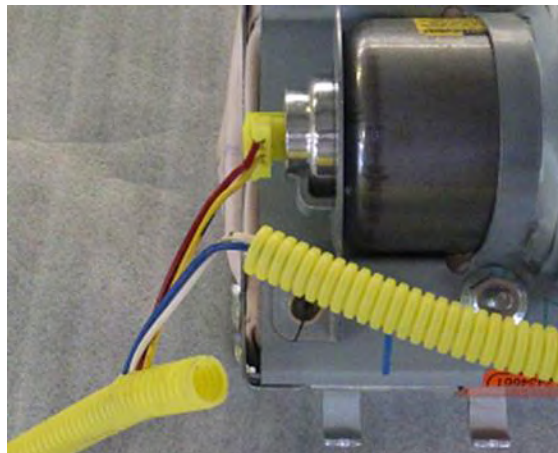
STEP 4- Using a scissor or wire cutter (no knives or razors) **CAREFULLY** cut the yellow harness cover tube (approximately 1 1/2 inches) enough to expose the yellow and red wires inside and provide enough room to install the Electro-Tap (shorting) connector.

TAKE YOUR TIME AND BE CAREFUL TO NOT CUT THE 2 WIRES!

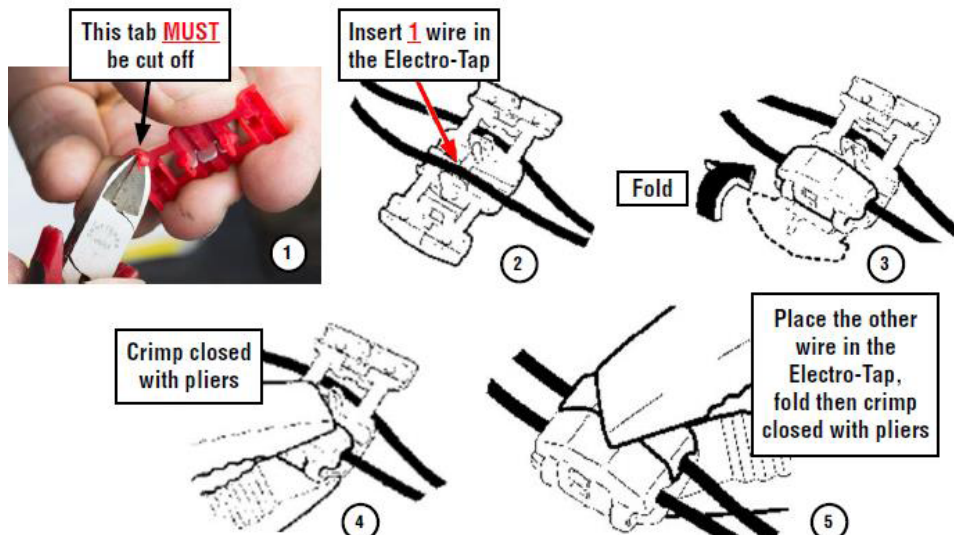
STEP 5- Short the yellow and red wires together by installing the Electro-Tap connector. The connector creates a short circuit which acts as a safeguard to prevent against static discharge that may deploy the removed inflator. The tab portion of the Electro-Tap connector **MUST** be cut off prior to use to insure a good short-circuit is made as shown in the illustration below. **Follow the sequence below** for installing the Electro-Tap connector. Use pliers to squeeze closed the two sections of the connector together, **one section at a time**.

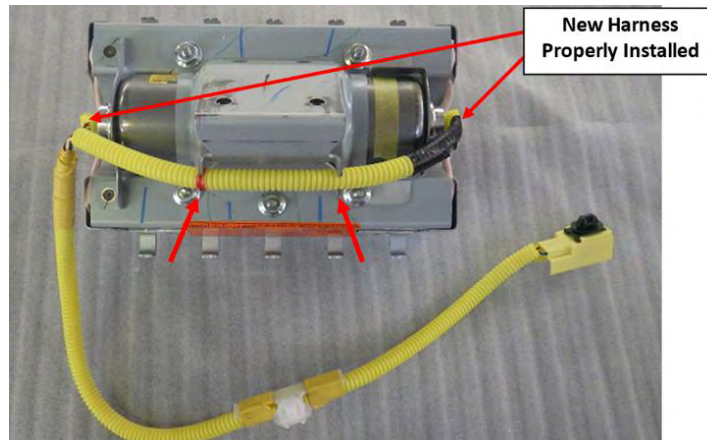
VERY IMPORTANT: When connecting the new harness to the inflator, **both sides MUST be routed as shown** in the “New Harness Properly Installed” photo below.

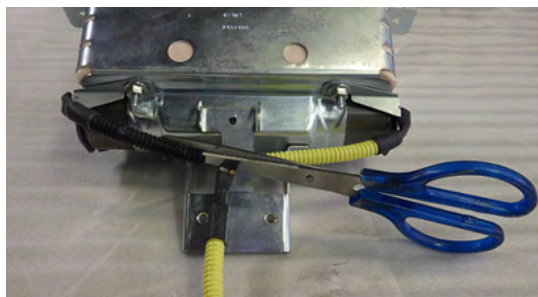
STEP 4- Using a scissor or wire cutter (no knives or razors) **CAREFULLY** cut the black harness cover tube (approximately 1 1/2 inches) enough to expose the blue and white wires inside. Provide enough room to install the Electro-Tap (shorting) connector.

TAKE YOUR TIME AND BE CAREFUL TO NOT CUT THE 2 WIRES!

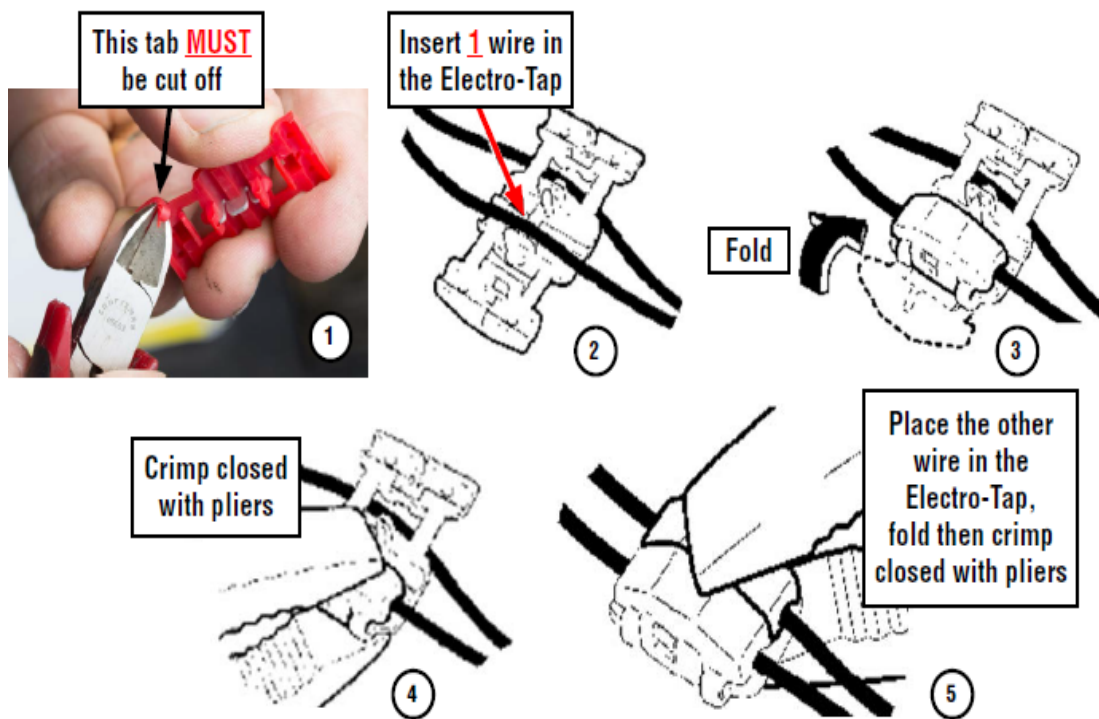
STEP 5- Short the blue and white wires together by installing the Electro-Tap connector. The connector creates a short circuit which acts as a safeguard to prevent against static discharge that may deploy the removed inflator. The tab portion of the Electro-Tap connector **MUST** be cut off prior to use to insure a good short-circuit is made as shown in the illustration below. **Follow the sequence below** for installing the Electro-Tap connector. Use pliers to squeeze closed the two sections of the connector together, **one section at a time**.

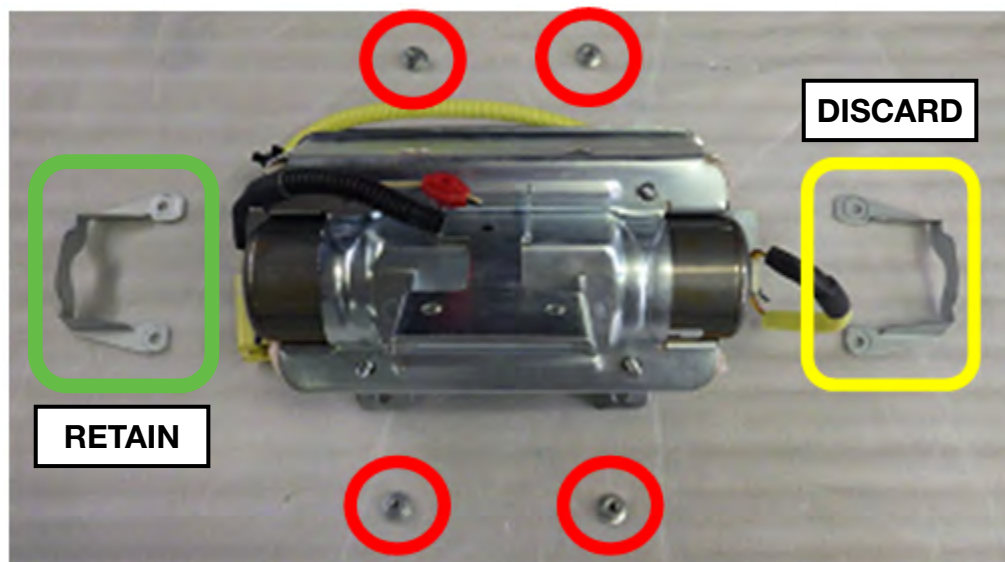
STEP 7- USING HAND TOOLS ONLY, loosen and remove the four (4) 10mm self-locking nuts along with both stopper plates. **RETAIN the stopper plate circled in GREEN** (Left-side bracket in image below) as it will be used during reassembly. Discard the removed stopper plate circled in **YELLOW** as it is no longer needed along with the 4 removed 10mm nuts.

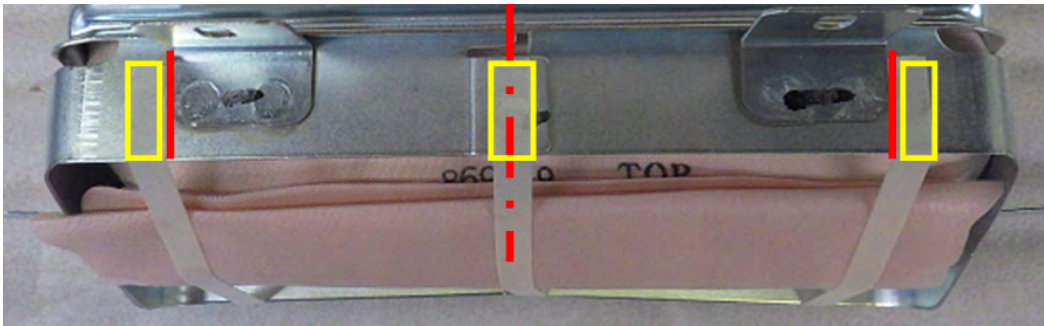
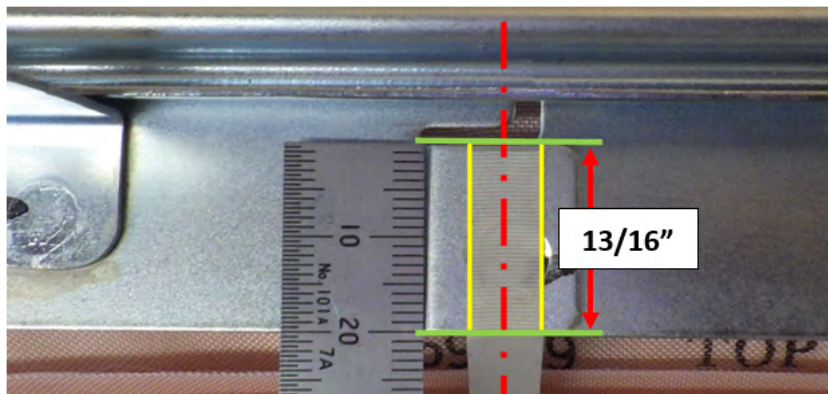
STEP 15- Apply the 3 anti-wrinkling tapes to the module frame as shown below to retain the protective sheet. The yellow rectangles represent the tapes and the red lines indicate where the tapes are to be positioned. Approximately 200mm (13/16") from each end of the 2tape should be applied to the module frame.

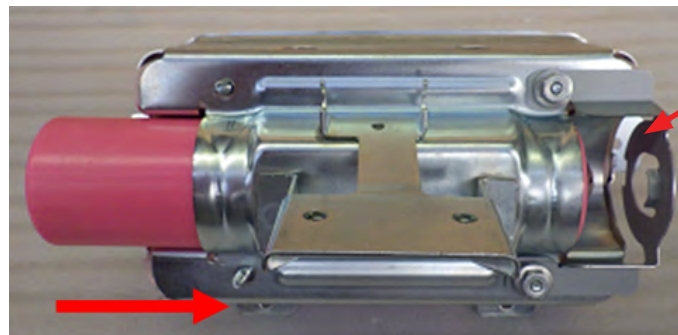
New Stopper Plate Supplied with Kit.

STEP 18- Slide the new inflator back into the mounting bracket, short collar end first. Align the tab on the new stopper plate with the notch on the end of the collar. When properly installed, the inflator will be tight against the stopper plate with no gap.

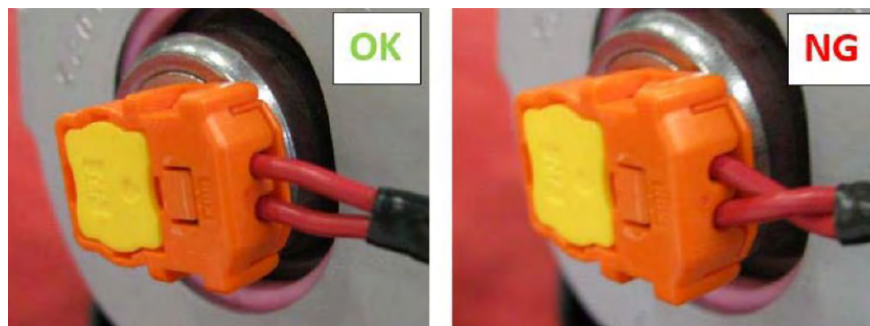
BEFORE connecting the harness to the inflator, make sure the harness is not twisted as shown below.

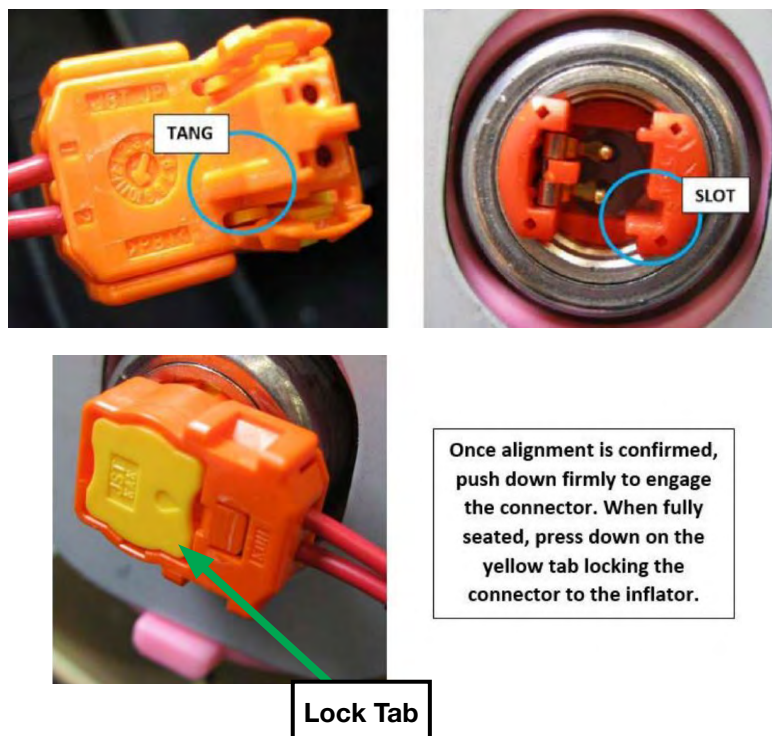
CAREFULLY align the tang of the inflator with the slot on the inflator harness connector as shown below. Push down firmly on the yellow lock tab to engage the connector's locking claws into the groove inside the connector boss on the inflator end. Confirm the connector is locked by prying up **LIGHTLY** with a small flat-blade screwdriver. Repeat the procedure on the opposite end.
