PRODUCT CAMPAIGN BULLETIN

<p>APPLICABILITY: 2005-2006 model year Baja 2009-2012 model year Legacy 2009-2012 model year Outback 2009-2012 model year Forester 2006-2012 model year Tribeca 2006-2011 model year Impreza (including WRX and STI) 2012 model year WRX and STI</p>	<p>NUMBERS: TKA-17R TKB-17R TKC-17R</p> <p>DATE: 01/13/17</p> <p>REVISED: 07/20/18</p> <p>NHTSA ID: 17V-014 17V-026 17V-016</p>
<p>SUBJECT: Takata Front Passenger Airbag Inflator Replacement</p>

SUBARU OF AMERICA, INC. has determined that a defect, which relates to motor vehicle safety, exists in certain Subaru vehicles listed above, equipped with a non-desiccated Takata-sourced passenger side frontal airbag containing the propellant Phase Stabilized Ammonium Nitrate (certain specific vehicles only).

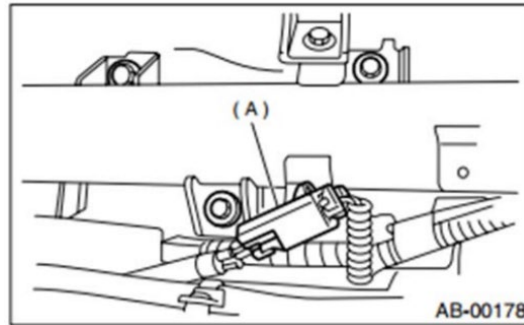
- Disconnect the airbag module harness connector (A) and release it from the support beam bracket.

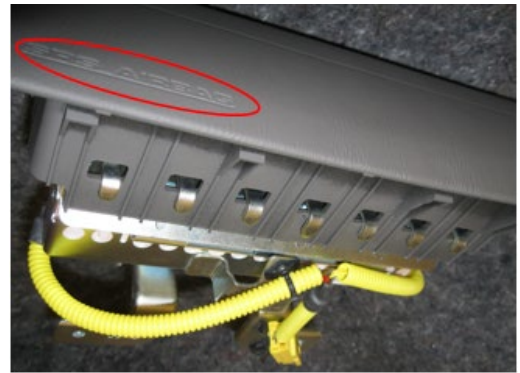
VERY IMPORTANT: Before removing the original trim cover / lid from the module, note the orientation of the cover in relation to the module as the module can be installed upside down in the cover. (TIP: The bottom or harness side goes toward the “SRS AIRBAG” side of the cover as shown.)

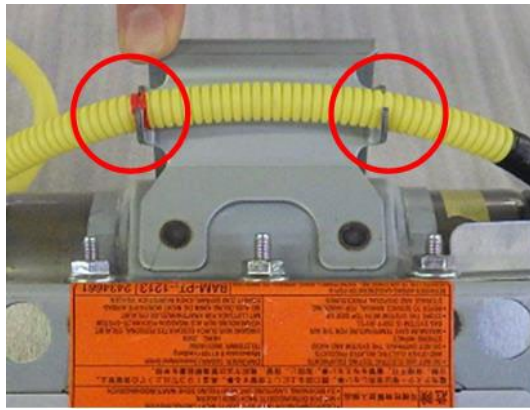
STEP 3- Remove the harness tube from the retainer bracket holders.

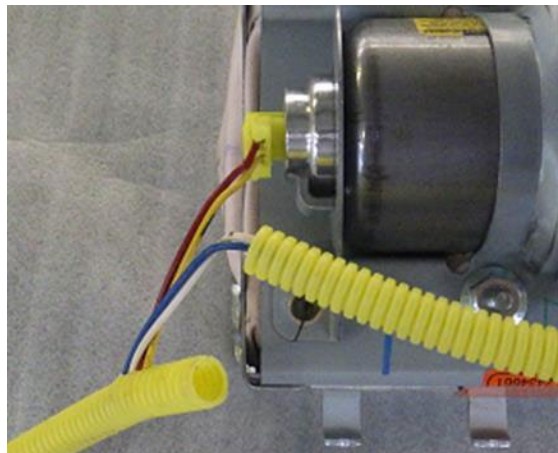
STEP 4- Using a scissor or wire cutter (no knives or razors) **CAREFULLY** cut the yellow harness cover tube (approximately 1 1/2 inches) enough to expose the yellow and red wires inside and provide enough room to install the Electro-Tap (shorting) connector.

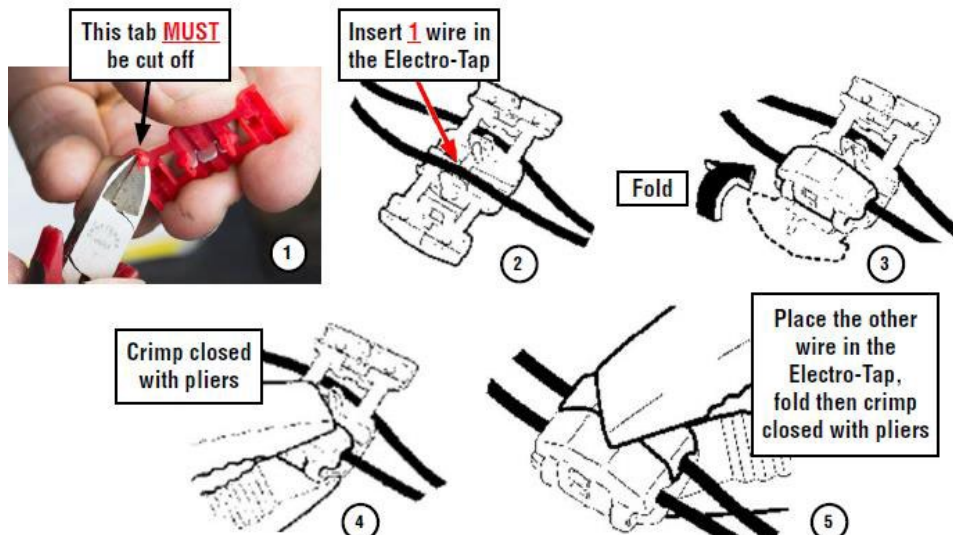
STEP 5- Short the yellow and red wires together by installing the Electro-Tap connector. The connector creates a short circuit which acts as a safeguard to prevent against static discharge that may deploy the removed inflator. The tab portion of the Electro-Tap connector **MUST** be cut off prior to use to insure a good short-circuit is made as shown in the illustration below. **Follow the sequence below** for installing the Electro-Tap connector. Use pliers to squeeze closed the two sections of the connector together, **one section at a time**.

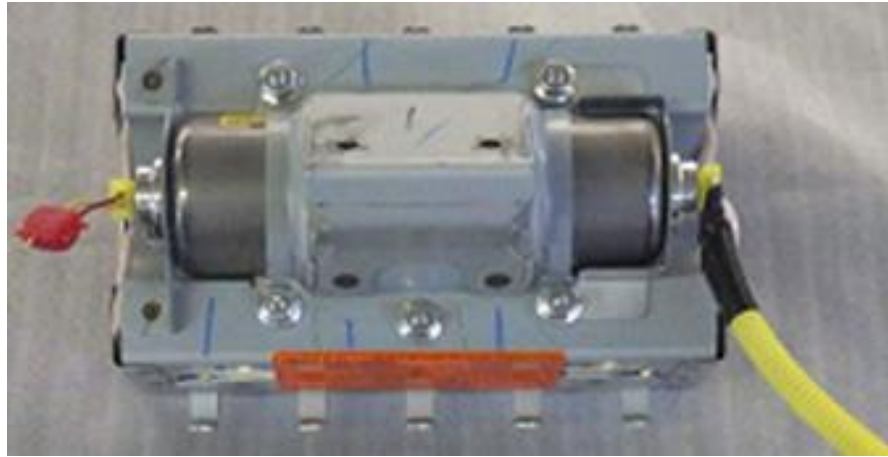
STEP 6- Once the Electro-Tap connector is fully crimped in place, cut the yellow and red wires **on the body harness connector side** of the Electro-Tap connector.

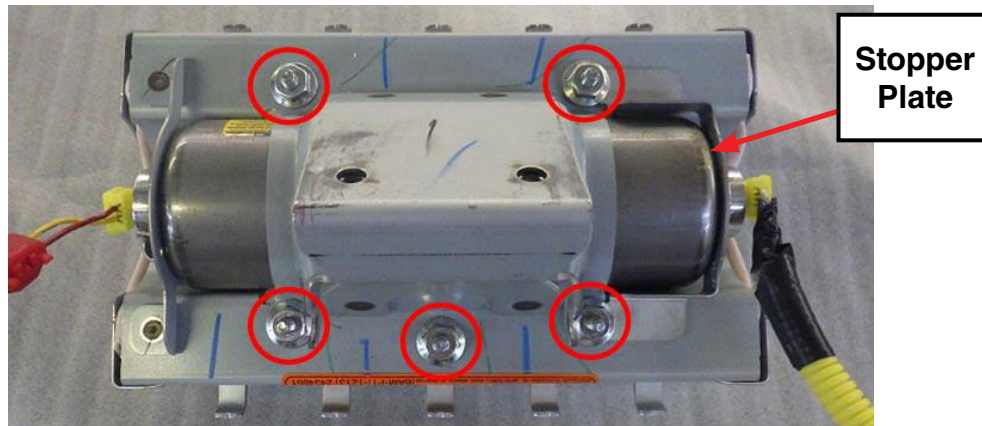
STEP 7- Loosen and remove the five (5) 10mm self-locking nuts along with the stopper plate. DO **NOT DISCARD** the removed stopper plate as it will be reused during reassembly. Discard the 5 10mm nuts.

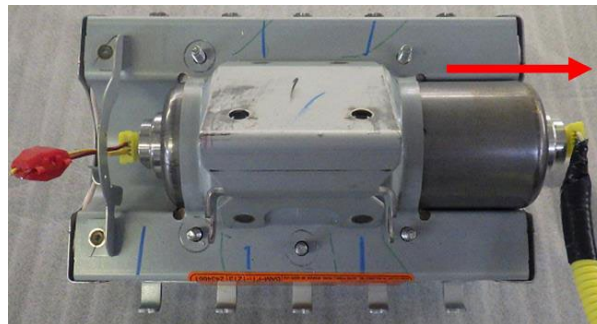
STEP 8- With the self-locking nuts and stopper plate removed, slide the original inflator out of the mounting bracket while feeding the cut off portion of the wiring harness under the remaining stopper plate. Place the removed original air bag inflator back into the “cradle” of the Kit Box insert.

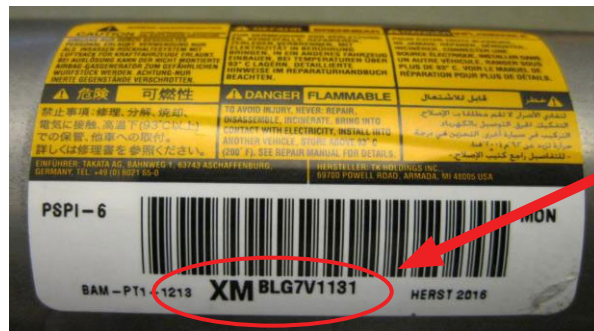
STEP 9 - VERY IMPORTANT: Record the **11-digit alpha-numeric serial number** for both the **new and the removed inflators** on the hard copy of the Repair Order. **For SOA and SDC Retailers ONLY**, this information will be required for claim approval. **For SNE retailers**, this information will be required for completion of the Part Return Notice which will be forwarded by the retailer to the PCC.

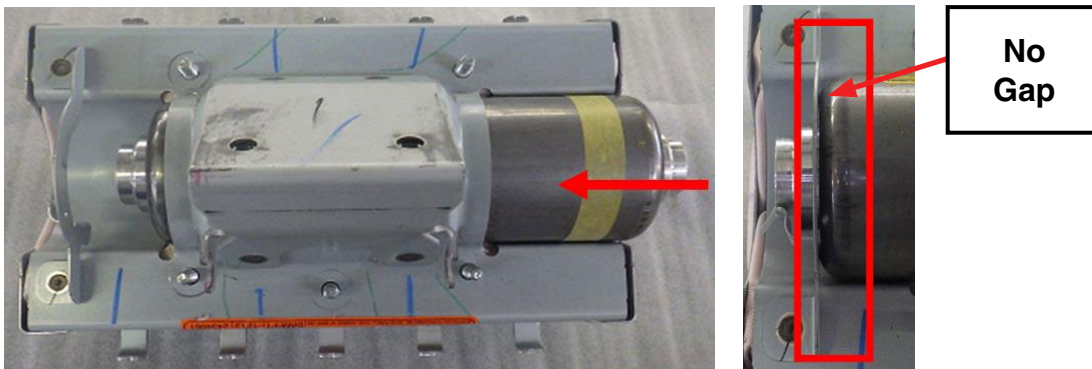
STEP 10- Install the new inflator into the mounting bracket so the yellow taped end will align with the stopper plate when reinstalled on the mounting bracket. When properly installed, both ends of the inflator will be seated tight against the stopper plates with no gaps.

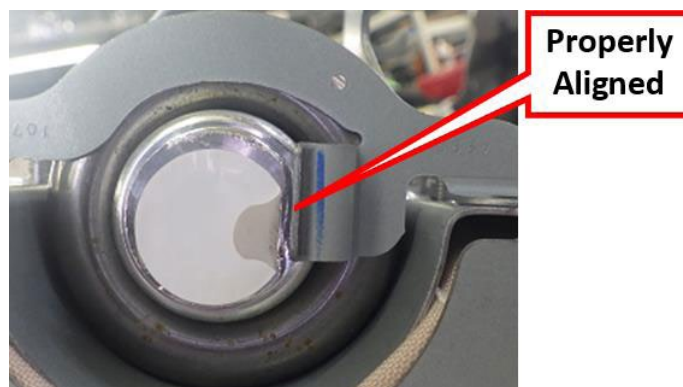
Make sure the “D-shaped” portion of the inflator harness connector boss aligns with the “D-shaped” portion of the original stopper plate as shown below. **Do not peel the white harness connection dust cover at this time.**

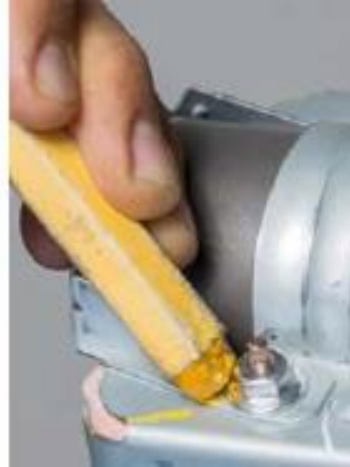
STEP 11- Reinstall the original stopper plate and the 5 **NEW** self-locking nuts. **SLOWLY** tighten (to prevent over-tightening) then torque the nuts to 31-38 inch-pounds. When complete, use a marker to indicate they have been fully tightened.

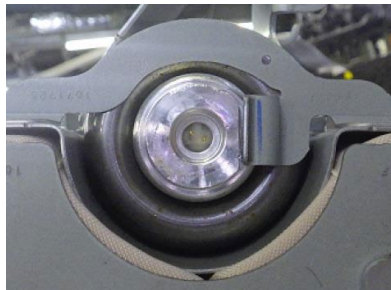
STEP 12- Peel the white dust cover from the d-shaped end of the new inflator. The new inflator wiring harness has 2 “sides” with round 2-pin connectors on both ends. The “short” side with the yellow tape and red / yellow wires will connect to the end of the inflator with the D-Shaped wiring harness connector boss as shown below. Peel the white dust cover from the D-Shaped end of the inflator **ONLY**.

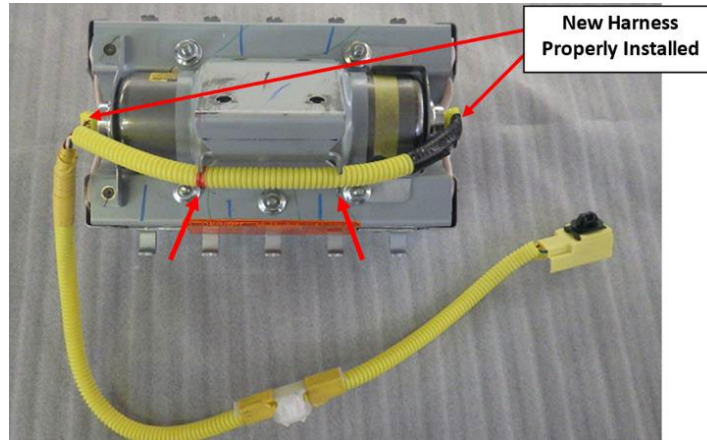
VERY IMPORTANT: When connecting the new harness to the inflator, **both sides MUST be routed as shown** in the “New Harness Properly Installed” photo below.

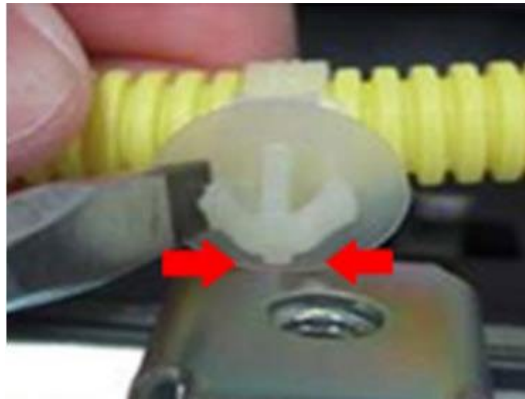
STEP 3- Remove the harness clip from the retainer bracket by pushing the tangs inward with a flat-blade screwdriver as shown below.

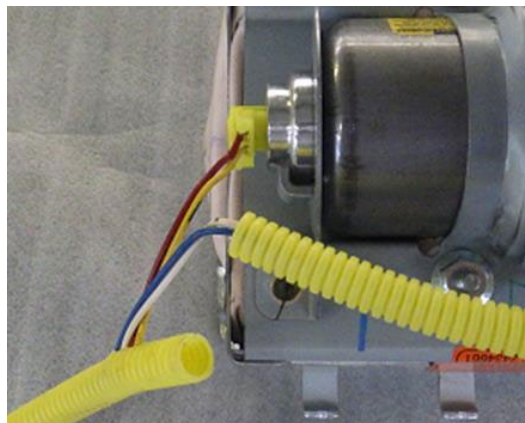
STEP 4- Using a scissor or wire cutter (no knives or razors) **CAREFULLY** cut the yellow harness cover tube (approximately 1 1/2 inches) enough to expose the yellow and red wires inside and provide enough room to install the Electro-Tap (shorting) connector.

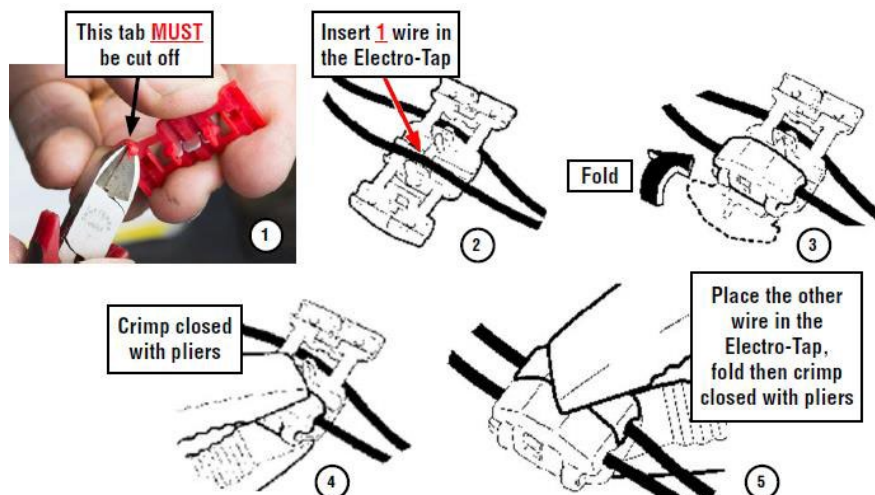
STEP 5- Short the yellow and red wires together by installing the Electro-Tap connector. The connector creates a short circuit which acts as a safeguard to prevent against static discharge that may deploy the removed inflator. The tab portion of the Electro-Tap connector **MUST** be cut off prior to use to insure a good short-circuit is made as shown in the illustration below. **Follow the sequence below** for installing the Electro-Tap connector. Use pliers to squeeze closed the two sections of the connector together, **one section at a time**.

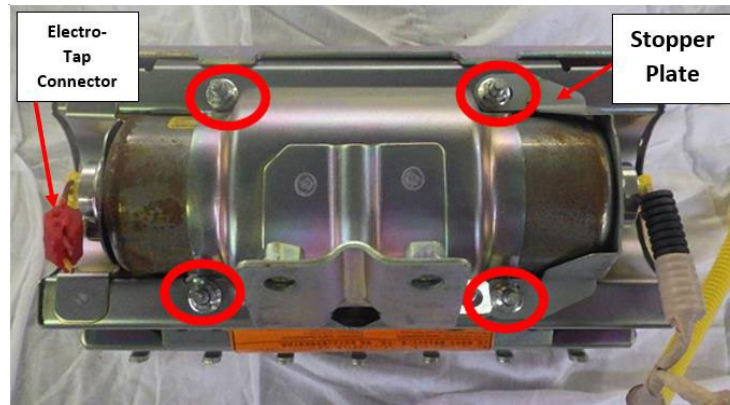
STEP 6- Once the Electro-Tap connector is fully crimped in place, cut the yellow and red wires **on the body harness connector side** of the Electro-Tap connector.

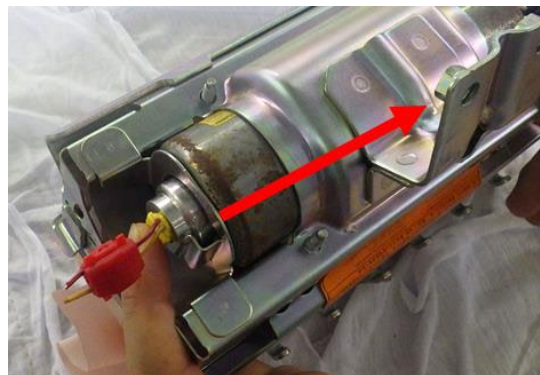
STEP 8- With the self-locking nuts and stopper plate removed, slide the original inflator out of the mounting bracket while feeding the cut off portion of the wiring harness under the remaining stopper plate. Place the removed original air bag inflator back into the “cradle” of the Kit Box insert.

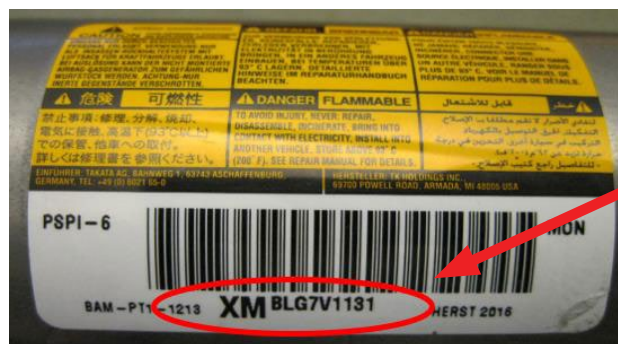
STEP 9 - VERY IMPORTANT: Record the **11-digit alpha-numeric serial number for both the new and the removed inflators** on the hard copy of the Repair Order. **For SOA and SDC Retailers ONLY**, this information will be required for claim approval. **For SNE retailers**, this information will be required for completion of the Part Return Notice which will be forwarded by the retailer to the PCC.

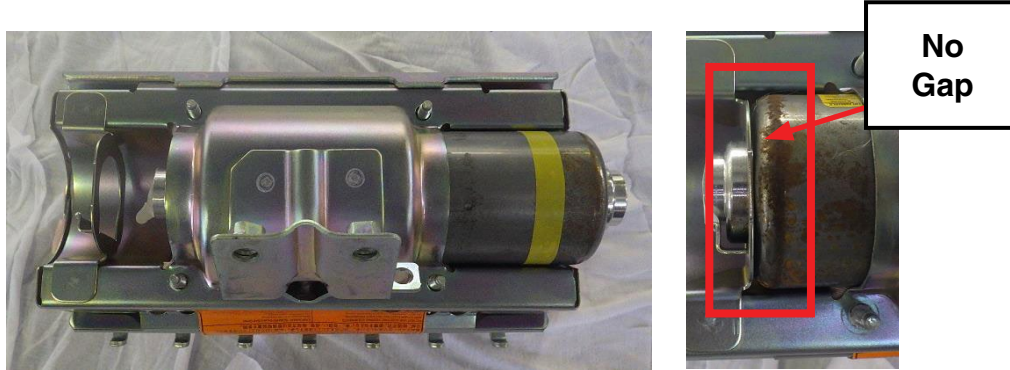
STEP 10- Install the new inflator into the mounting bracket so the yellow taped end will align with the stopper plate when reinstalled on the mounting bracket. When properly installed, both ends of the inflator will be seated tight against the stopper plates with no gaps.

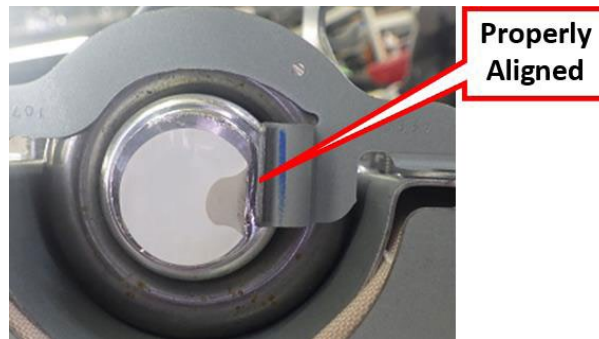
Make sure the “D-shaped” portion of the inflator harness connector boss aligns with the “D-shaped” portion of the original stopper plate as shown below. Do not peel the white harness connection dust cover at this time.

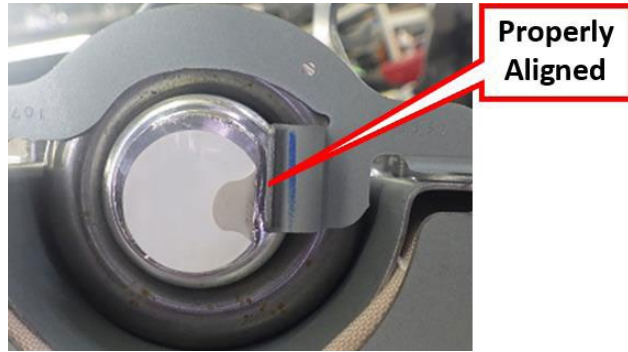
Make sure the “D-shaped” portion of the inflator harness connector boss aligns with the “D-shaped” portion of the original stopper plate as shown below. **Do not peel the white harness connection dust cover at this time.**
