SIB 65 02 17

## RECALL 17V-047: DRIVER'S FRONT AIR BAG MODULE - PRIOR PARTS REPLACEMENT

This Service Information Bulletin (Revision 6) replaces SI B65 02 17 **dated February 2022**.

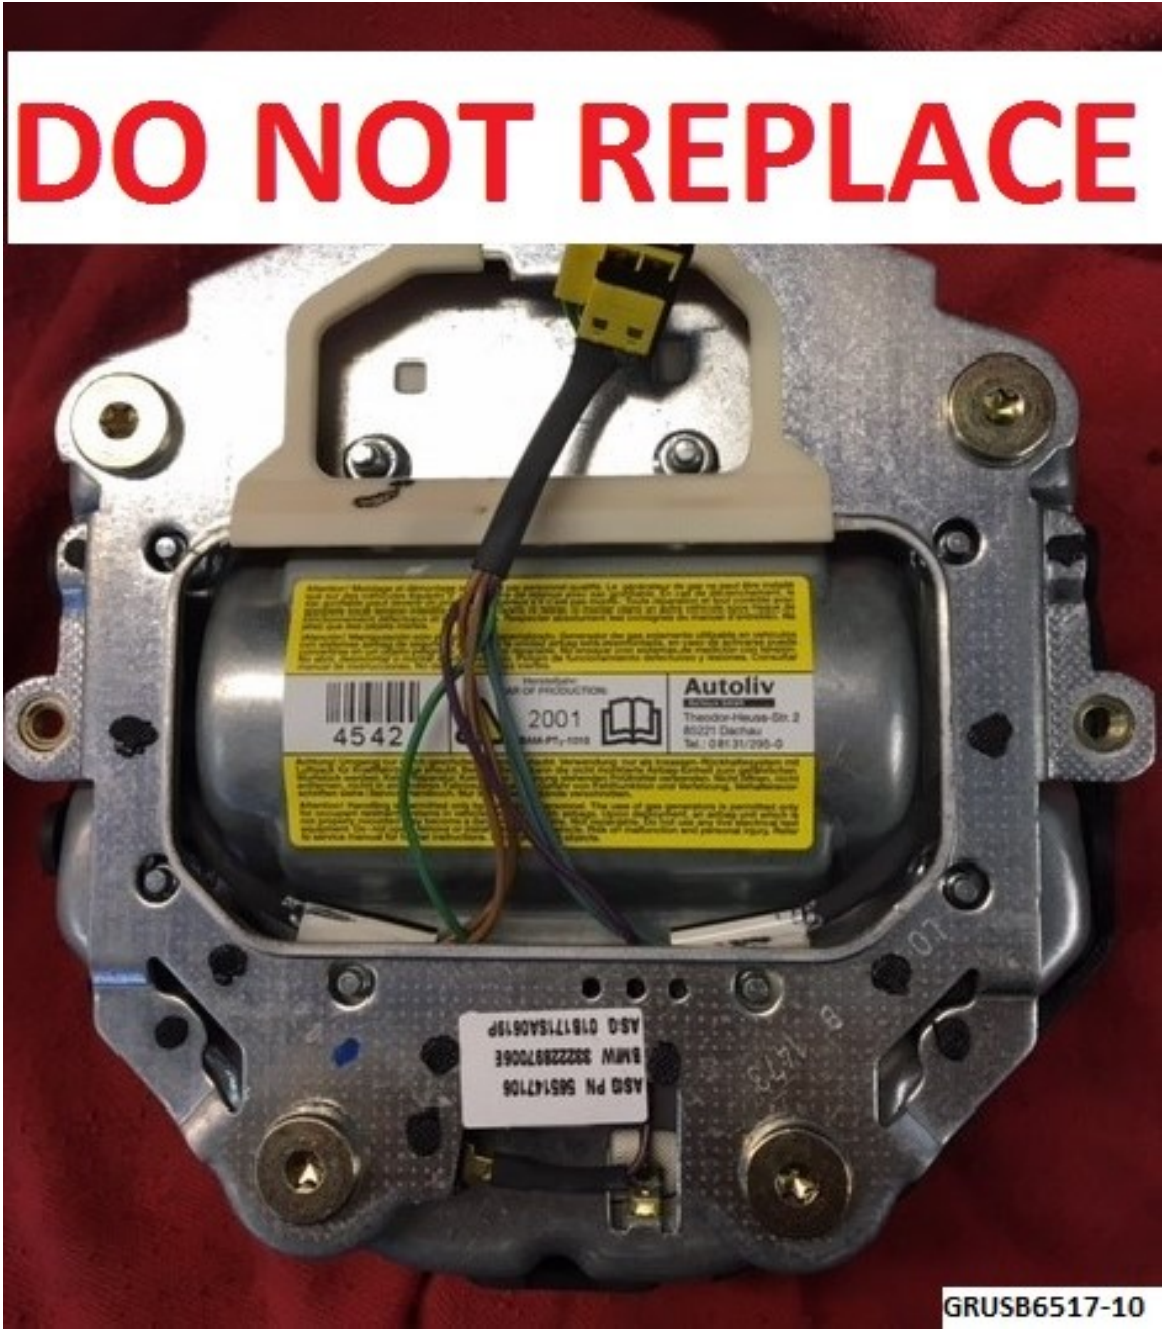
1. Remove the driver's air bag in accordance with repair instructions **REP 32 34 020** "Removing and installing/replacing air bag units".
2. Check the label on the back of the driver's air bag.

**YES-** replace air bag per the attached procedure.

**NO** - the driver's air bag is not affected.

Air bags from other manufacturers (non-Takata), or Takata air bags with different chemical compositions (white label) are not affected by this recall and **DO NOT** need to be replaced.
