RECALL CAMPAIGN 17V-062: FRONT PASSENGER AIR BAG

This Service Information bulletin replaces SI B51 17 17 dated April 2017

F48 (X1)

Vehicles produced June 2016 to February 2017

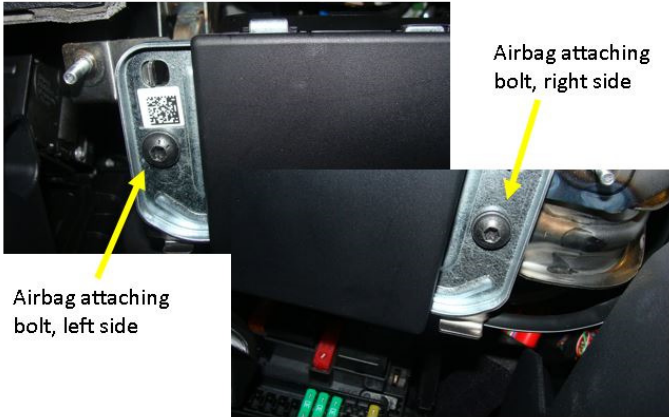
<p>Airbag attaching bolt, right side</p> <p>Airbag attaching bolt, left side</p>	<p>10. Once the dashboard inspection is complete, reassemble vehicle in the reverse order of removal.</p> <p>Note: When reinstalling passenger side knee airbag, the screws must be replaced. Follow proper torque specifications when reinstalling bolts.</p>

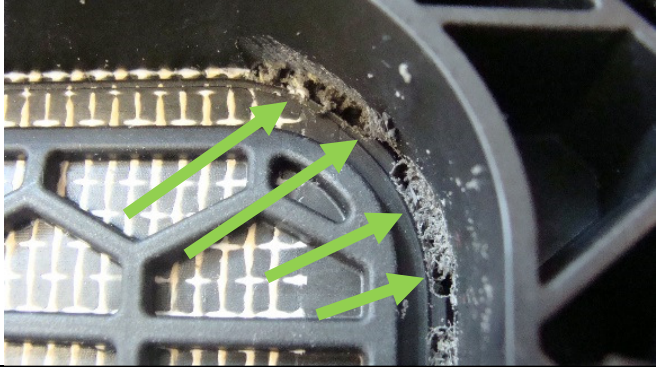
<p data-bbox="311 1171 758 1209">Green areas show correct milling</p>	<p>The image at left shows the milling marks (green arrow) with the airbag removed from the dashboard (this is for reference only).</p>

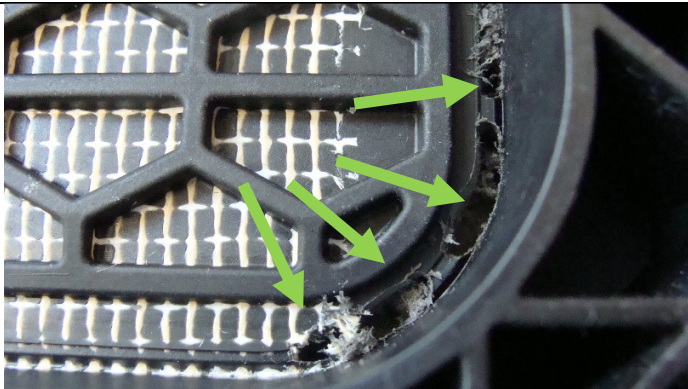
<p>The image at left shows the milling marks (green arrow) with the airbag removed from the dashboard (this is for reference only).</p>
