RECALL CAMPAIGN 17V-XXX: FRONT PASSENGER AIR BAG

This Service Information bulletin replaces SI B51 01 17 **dated April 2017**

F48 (X1 SAV)

RE: Delivery Stop & Recall 17V-XXX: Check and Replace Instrument Panel B51 17 17

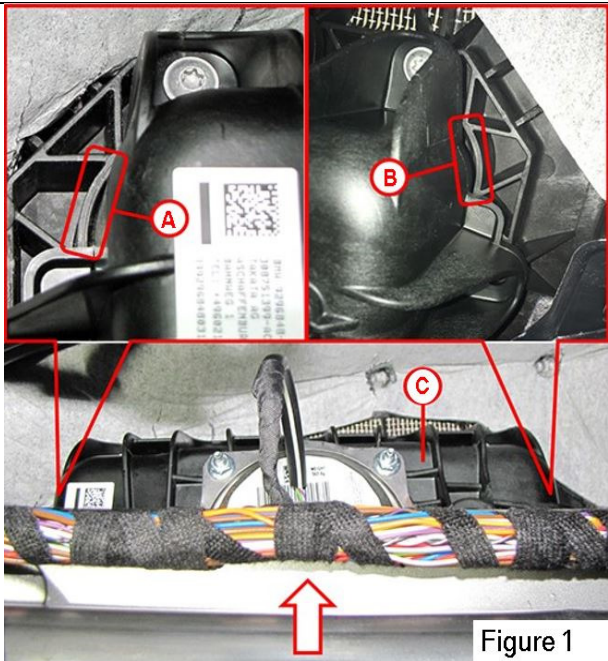
<p>Figure 1</p>		<p>1. Overview:</p> <p>Once the glovebox has been removed, the rear of the passenger side airbag will be visible (C). At points A and B, there are gaps through which the milling points can be viewed using a borescope.</p> <p>Note: The inspection must be performed on both sides of the instrument panel at points A and B.</p>

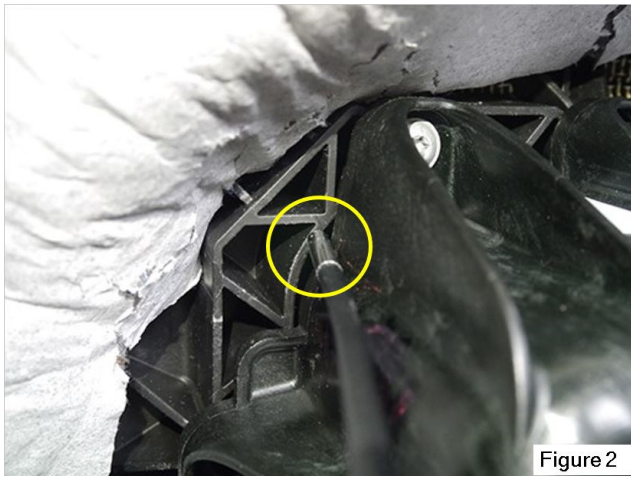
<p>Figure 2</p>		<p>2. Position the camera head of the endoscope as shown in Fig. 2 at the gap and, if necessary, rotate camera head until a useful image is displayed.</p> <p>

Note: Due to manufacturing tolerances, the gap on the right and left can be of different sizes. When using borescope, move the camera head to the largest part of the gap. The camera head of the endoscope does not fit entirely into the gap.</p>

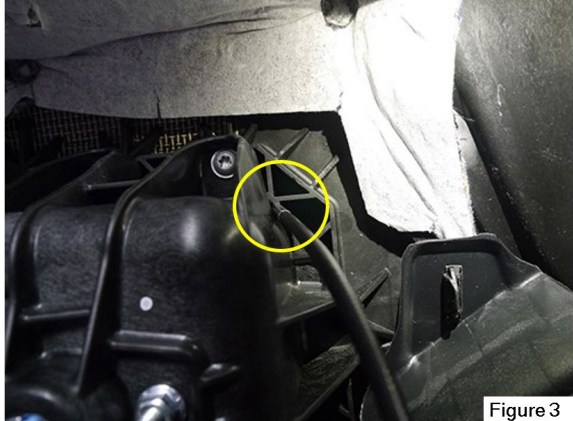
<p>Figure 3</p>	<p>3. Move borescope to the other side and test at the largest part of the gap. Rotate camera head until a useful image is displayed (The image should be similar to Figure 5 or 6).</p>

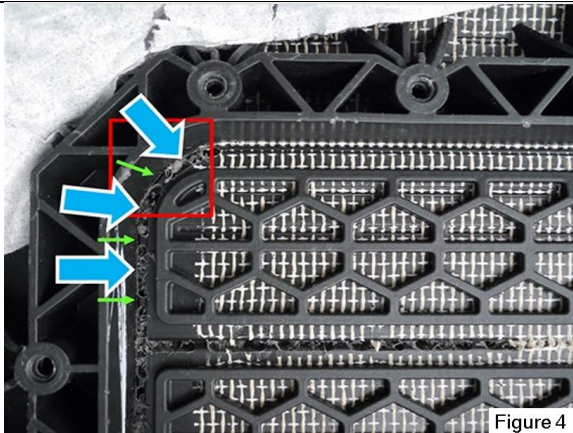
<p>Figure 4</p>	<p>4. Figure 4 shows the correct milling of the instrument panel. The area in the red square is the approximate area which will be viewable with the borescope. Blue arrows showing milling and the green arrows show milling jigs.</p> <p>

Note: Figure 4 shows the underside of the instrument panel with the passenger side airbag removed. Your view will be what is shown in Figure 5.</p>

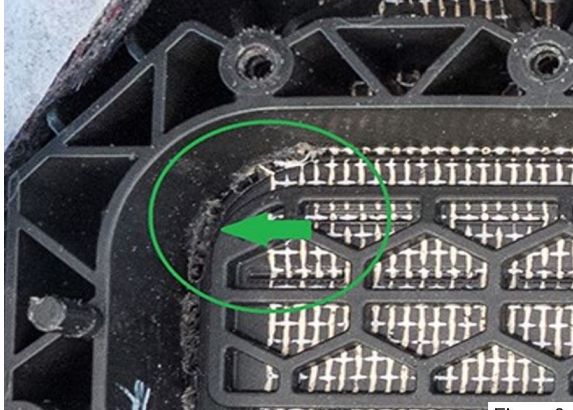
<p>Figure 8</p>	<p>5. Figure 8 shows a closer view of the area to be inspected.</p>

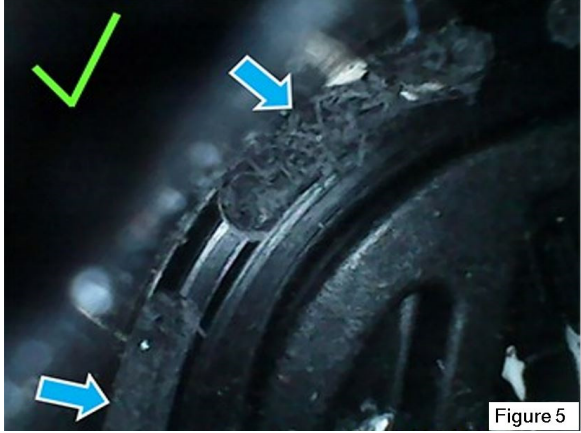
<p>Figure 5</p>	<p>6. In figure 5, the image shows the view via the borescope. The milling area shown (indicated by the blue arrows) is correctly done. If the milling is correct on both side, the vehicle can be reassembled and no further actions is needed. Refer to repair instructions 51 16 366 "Installing the glove box on the right with the housing".</p>
<p>x</p>

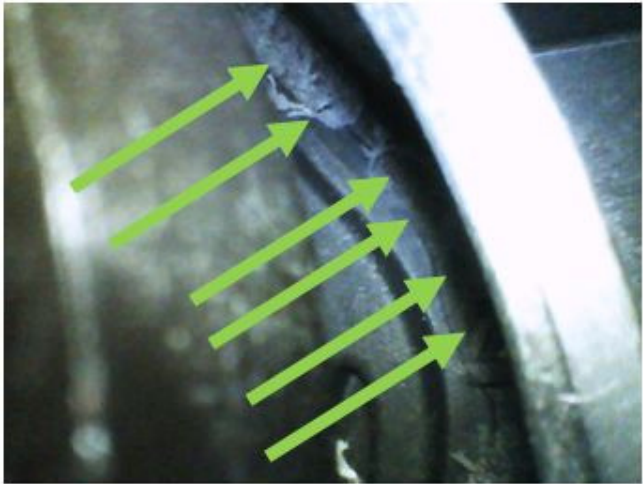
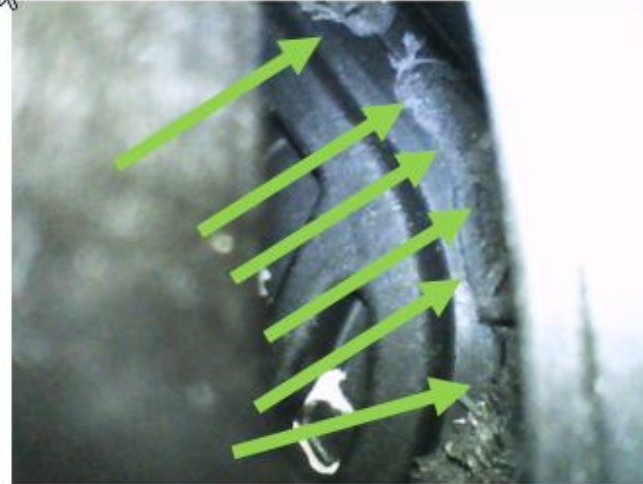
<p data-bbox="215 790 861 828">Evidence of correct milling – Green arrow</p>	<p data-bbox="997 286 1390 387">8. The following pictures are for clarification to help interpret your borescope images.</p>

<p data-bbox="215 1395 901 1433">Evidence of correct milling – Green arrow</p>

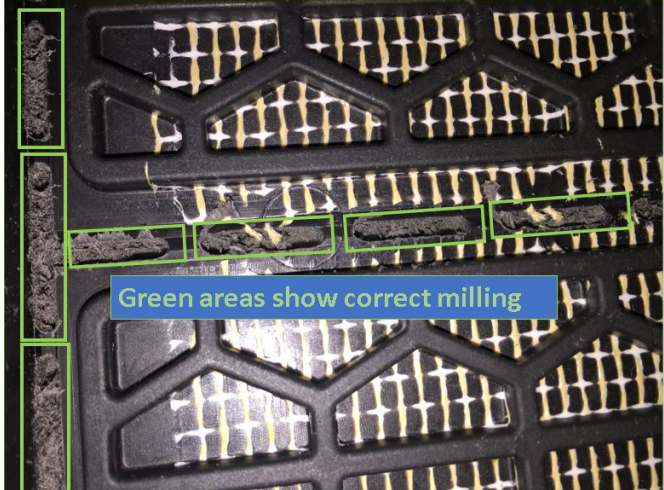
<p data-bbox="311 1176 758 1209">Green areas show correct milling</p>	<p data-bbox="997 896 1364 1064">10. The image at left shows the milling marks (green arrow) with the airbag removed from the dashboard (this is for reference only).</p>

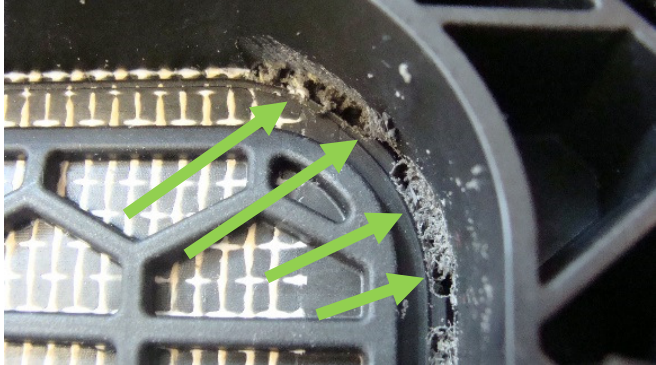
<p data-bbox="997 1433 1364 1601">11. The image at left shows the milling marks (green arrow) with the airbag removed from the dashboard (this is for reference only).</p>

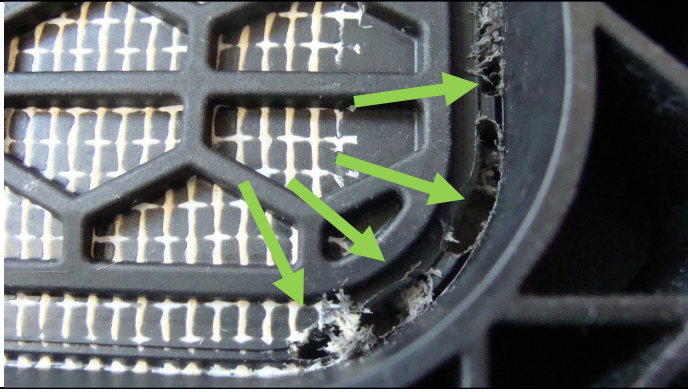
<p>12. The image at left shows the milling marks (green arrow) with the airbag removed from the dashboard (this is for reference only).</p>
