**Campaign code.**  
L73X-R.01.17

**Campaign description.**  
Evap system upgrade

**Model.**  
Aventador Coupe and Roadster.

L73X-R.01.17	<b>To:</b> <b>Subject:</b> <b>Date:</b> <b>Pages</b>	<b>Official Lamborghini Service Network</b> <b>Update of fuel vapor circuit</b> <b>February 24, 2017</b> <b>58</b>

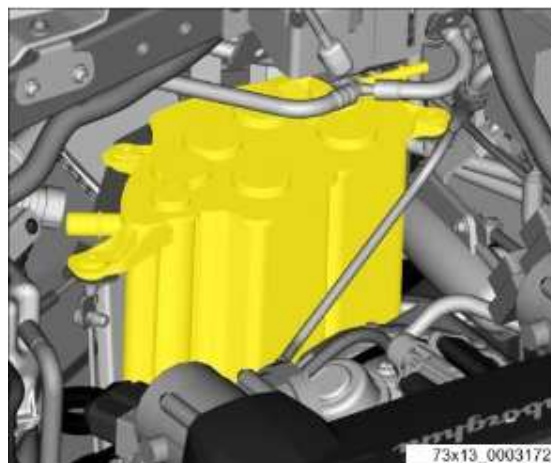
### 34. ACC filter removal.

Unscrew the 3 fixing screws, disconnect the 3 hoses then remove the vehicle's AKF filter.

The ACC filter must be replaced after disassembly.

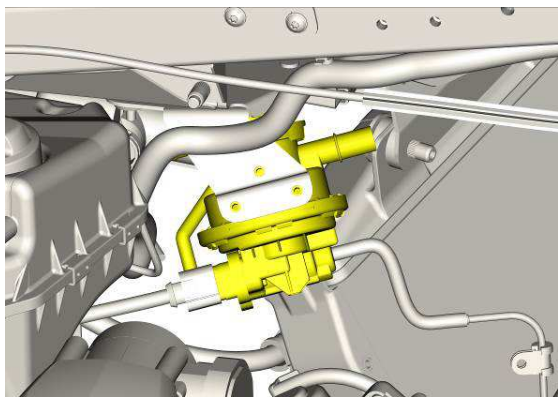
### 36. Disassembly of the LDP diagnosis pump

Remove the connector and the pneumatic hoses, unscrew the 3 screws then remove the component from the vehicle.

The LDP diagnosis pump must be replaced after disassembly.

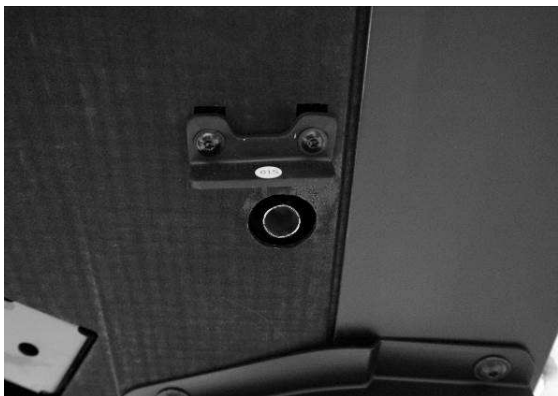
Position the floor panel in the vehicle and check that the opening made on the component coincides with the fuel vapor exhaust pipe position.

The breather tube must be in the center of the opening made on the floor panel and must not be obstructed.

If the fuel vapor exhaust pipe is obstructed by the floor panel, widen the opening made under point 60 of this procedure.

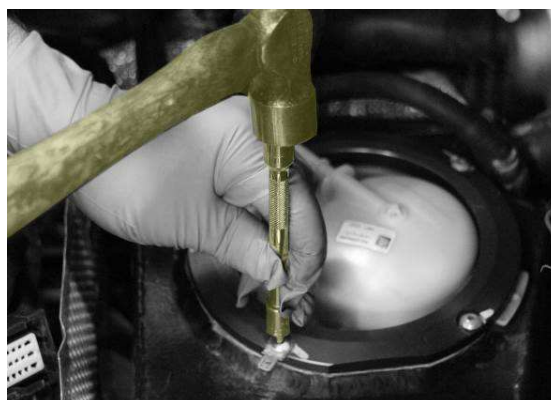
The screws have been fastened using threadlocker. Before removing them dislodge them with a hammer of suitable proportions. Use a hammer with a 200gr. maximum impact mass. Be careful not to damage the screw heads.

If the tank threads are damaged the entire component must be replaced.

After removing the hoses and electric wiring, unscrew the 5 screws securing the fastening ring.

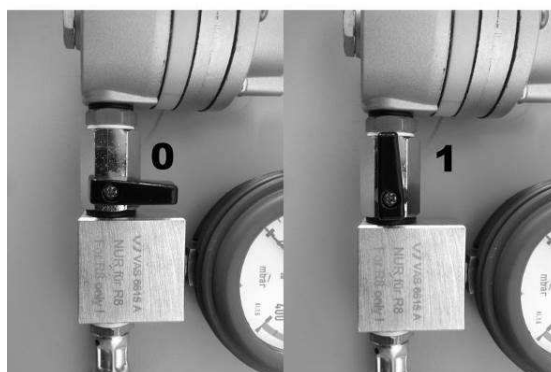
If the pressure goes below the set value, the tank system has one or more leaks: it will therefore be necessary to look for leaks in the system with a leak detector spray. If, on the other hand, the pressure remains stable at the set value, this means that the system has no leaks.

- g) Close the shut-off valve (position 0) and check that in the next two minutes the pressure doesn't drop below the previous reading of 0.02 bar (0.3 psi)

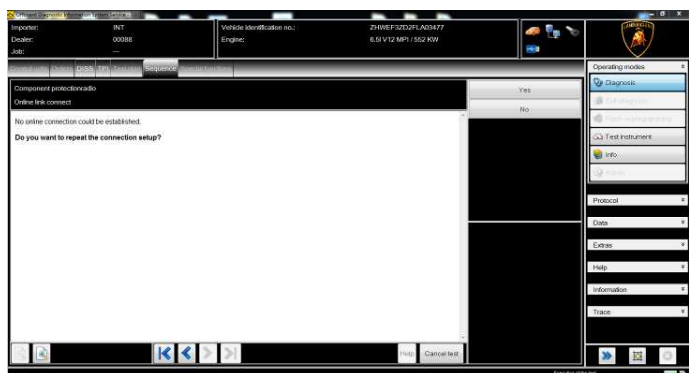
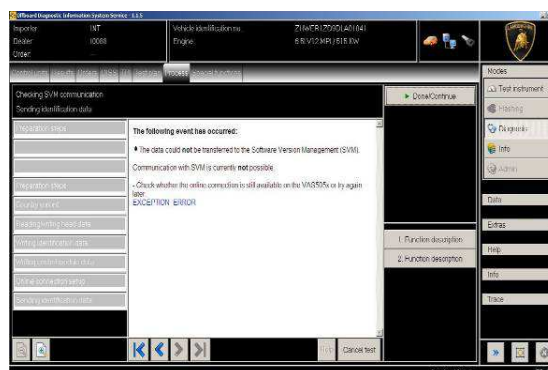
B. If one of the connection error screens is shown as in the pictures below:

- it is not possible to establish a connection with the central server. Please check carefully that the diagnosis laptop is properly connected to the internet network and retry clicking “Yes” or “Done/Continue”.

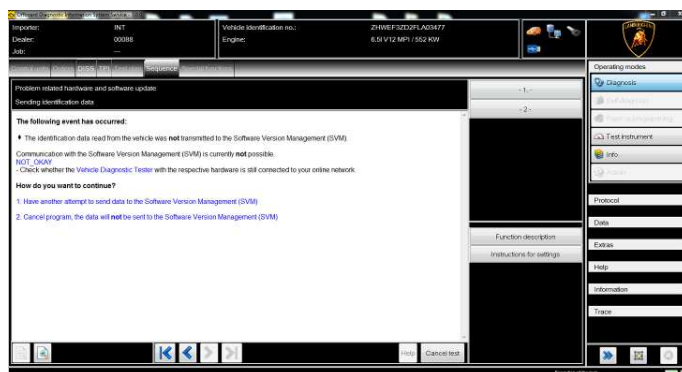
C. If the loss of connection happens during the target/actual comparison during SVM procedure:

- It is not possible to connect to central server, check the working connection of internet and retry by clicking “1”.

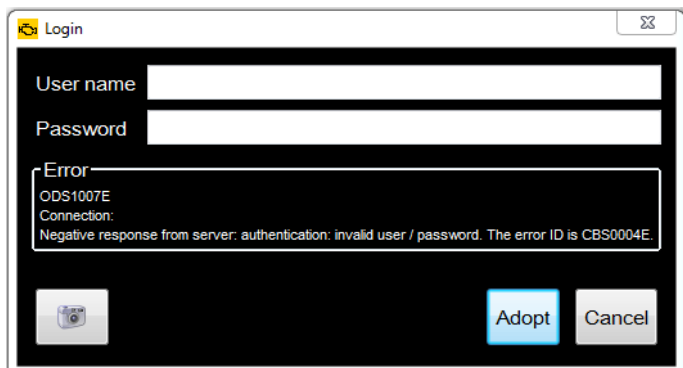
D. If the incorrect identification message is shown as in the picture below (error code: ODS1007E):

- be sure that your Geko account is valid;

E. be sure that the label “Geko” is written on the token that you are using for the authentication;

- be sure the Password inserted is correct;
- click on Cancel and perform the application test (see document “ODIS\_Checking\_ConnectionServer\_SVM\_2.0” (\*)).

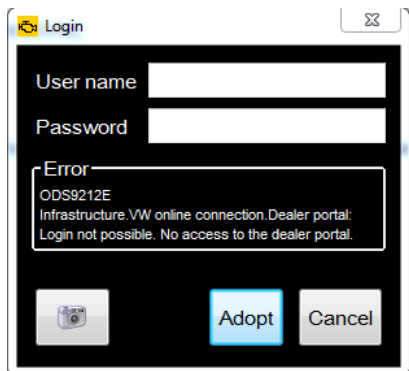
**F.** If the infrastructure error message is shown as in the picture below (error code: ODS9212E):

- be sure that your Geko account is valid
- be sure that the label “Geko” is written on the token that you are using for the authentication
- verify in ODIS settings you have “Internet” instead of “CPN” (see document “ODIS\_Initial\_Setup\_2.0” (\*))
- click on Cancel and perform the application test (see document “ODIS\_Checking\_ConnectionServer\_SVM\_2.0” (\*))
