Campaign code.
L73X-R.01.17

Campaign description.
Evap system upgrade

Model.
Aventador Coupe and Roadster.

L73X-R.01.17	To: Official Lamborghini Service Network Subject: Update of fuel vapor circuit Date: February 24, 2017 Pages: 58	 
--------------	---	---

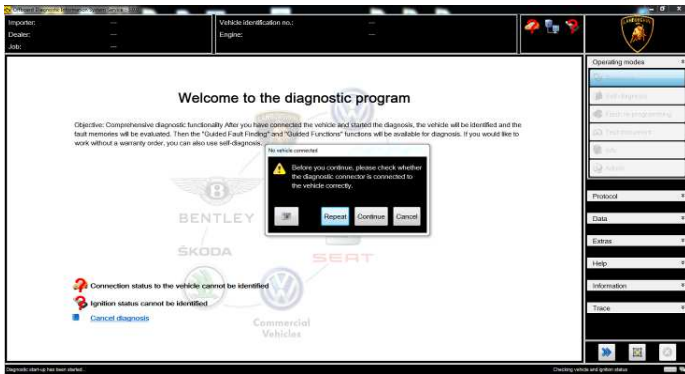
A. If the error message regarding the VAS5054 interface and the two icons for status of on board connection and key ON are shown as in the picture below:

- Click “Cancel”;
- Repeat the VAS5054 HW interface installation following the procedure (*) “VCI Manager v2.0”, by entering in the menu “Extras” on the right side and clicking on “Diagnostic interface”.

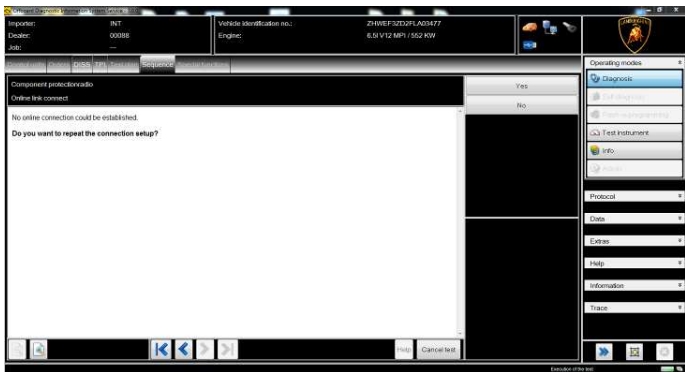
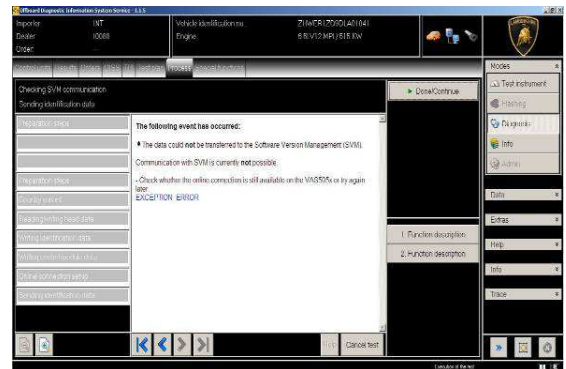
B. If one of the connection error screens is shown as in the pictures below:

- it is not possible to establish a connection with the central server. Please check carefully that the diagnosis laptop is properly connected to the internet network and retry clicking “Yes” or “Done/Continue”.

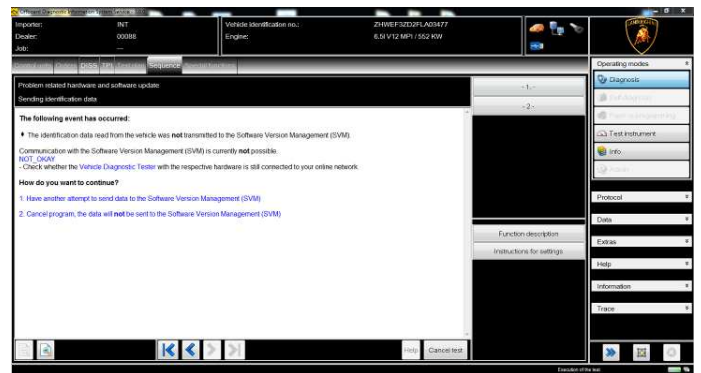
C. If the loss of connection happens during the target/actual comparison during SVM procedure:

- It is not possible to connect to central server, check the working connection of internet and retry by clicking “1”.

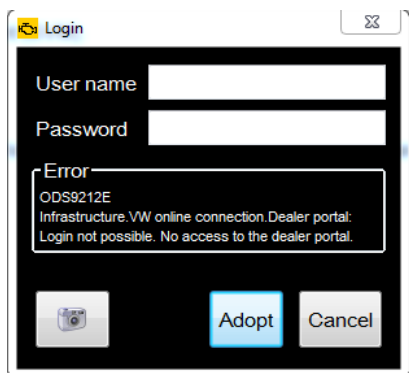
F. If the infrastructure error message is shown as in the picture below (error code: ODS9212E):

- be sure that your Geko account is valid
- be sure that the label “Geko” is written on the token that you are using for the authentication
- verify in ODIS settings you have “Internet” instead of “CPN” (see document “ODIS_Initial_Setup_2.0” (*))
- click on Cancel and perform the application test (see document “ODIS_Checking_ConnectionServer_SVM_2.0” (*))
