RECALL CAMPAIGN 17V-088: CHECK TANK VENTILATION LINE AND REPLACE IT IF REQUIRED I01 REX

**Fuel Tank Vent Line
Safety Recall 17V-xxx
Model Year 2014 – 2017
BMW i3 REx
*Last Updated 02/09/2017***

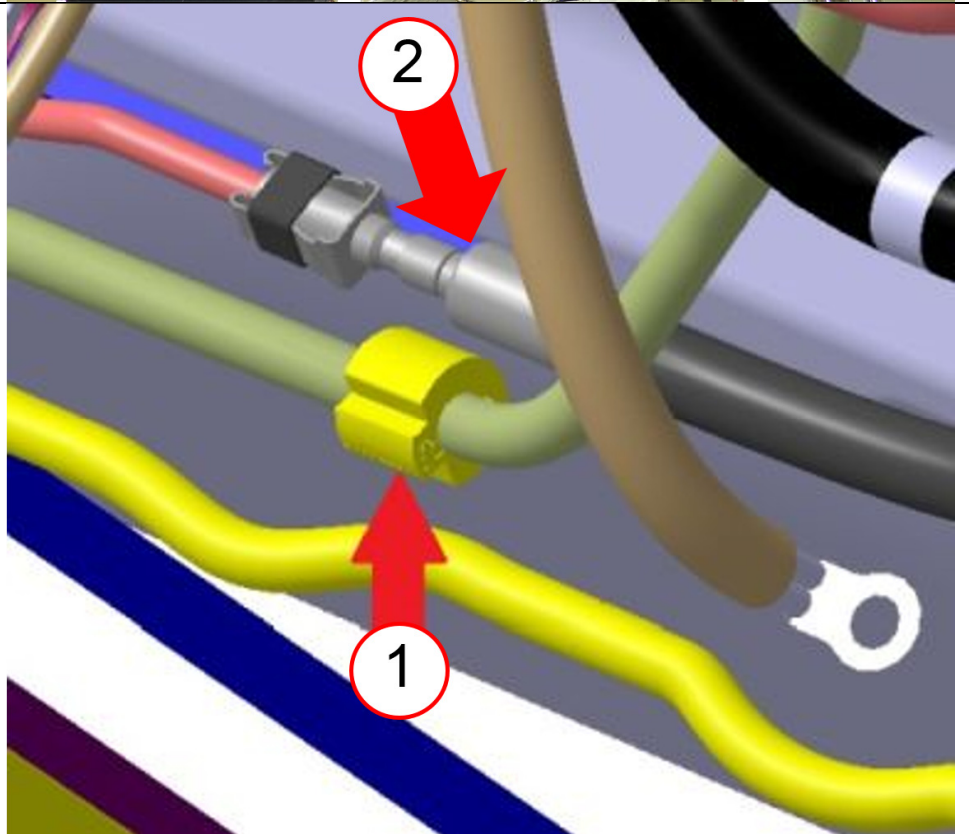
8. Secure the new abrasion protection (1) on a suitable position on the tank ventilation line, so that it protects from any contact between the tank ventilation line and the fuel feed line (2).

Note: The abrasion protection (1) is already preassembled on the new tank ventilation line and does not need to be retrofitted when replacing the tank ventilation line.
