PRODUCT CAMPAIGN BULLETIN

APPLICABILITY: 2017MY Impreza

NUMBER: WTN-74R

SUBJECT: Reprogramming File Availability to Optimize Rear View Camera Operation on Harman Gen 3 Audio and Navigation Head Units

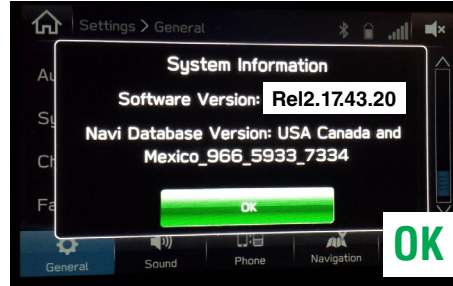
NG- Head Unit Must Be Updated, Proceed To Step 2.

OK- Latest Version Installed, Proceed To Step 7.

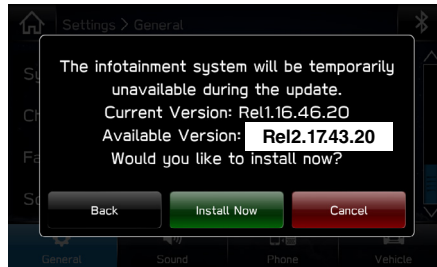
- The current and available software version information will be displayed. The **available** Version I.D should be “**Rel2.17.43.20**” (see 15-211-17R for latest available software version). This version number is the same for all three levels of head unit.
NOTE: The version number may say Rel.17.43.20 (the 2 is missing after the Rel). This is OK.

- After confirming the Available Version, press “Install Now” to start the reprogramming process. **NOTE:** The screen will go blank (black) for a brief period after installation begins.
- Each of the updates (Base, Mid and High) should take less than 10 minutes to install.
