PRODUCT CAMPAIGN BULLETIN

APPLICABILITY: 2017MY Impreza

NUMBER: WTN-74R

SUBJECT: Reprogramming File Availability to Optimize Rear View Camera Operation on Harman Gen 3 Audio and Navigation Head Units

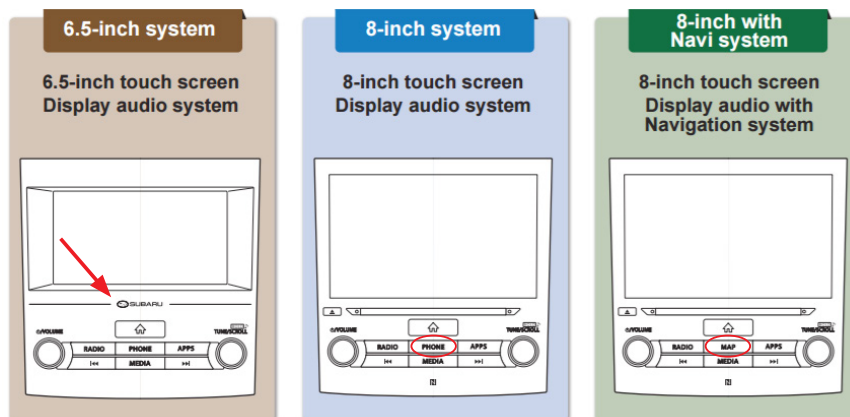
These reprogramming files apply to the following audio / navigation head unit part numbers:

Multimedia System Type	Part Numbers	Descriptive Features
6.5 Inch Display Audio System (Base)	86201FL60A and 61A	No CD slot / Eject Button
8.0 Inch Display Audio System (Mid)	86201FL62A and 63A	Phone Button in Top Row Center
8.0 Inch Audio / Navigation System (High)	86271FL60A	Map Button in Top Row Center
