PRODUCT CAMPAIGN BULLETIN

APPLICABILITY: 2017MY Impreza

NUMBER: WTN-74R

SUBJECT: Reprogramming File Availability to Optimize Rear View Camera Operation on Harman Gen 3 Audio and Navigation Head Units

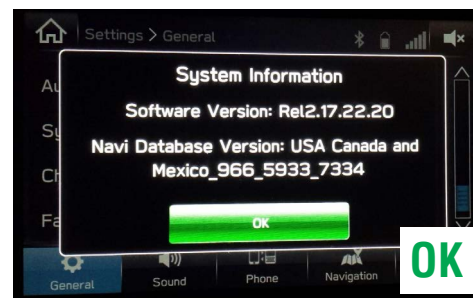
OK- Latest Version Installed, Proceed To Step 7.

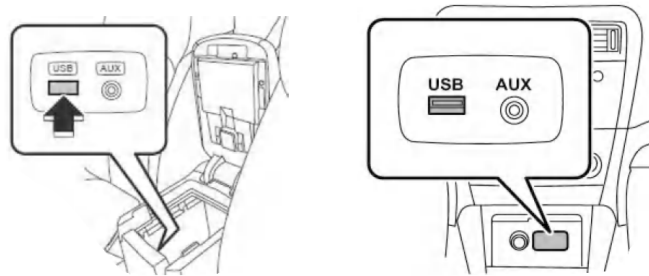
IMPORTANT NOTE: If the head unit does not recognize the USB flash drive during the reprogramming process, this may be due to an incompatible Controller IC in the USB flash drive or it is otherwise incompatible with the head unit. If this occurs, delete all files from the flash drive and re-format it to “FAT32”, instead of “NTFS” and reload the appropriate “update” folder to the USB flash drive. If the USB flash drive is still not recognized, please discontinue the use of that drive and instead use a USB flash drive from a different manufacturer.

- With the engine idling (or GR8 connected), plug the flash drive into the USB Port.

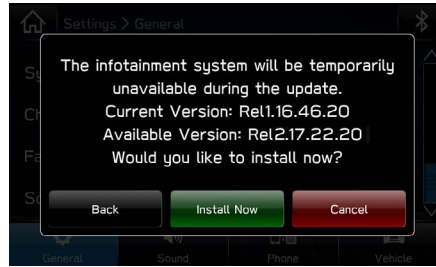
- The current and available software version information will be displayed. The **available** Version I.D should be “**Rel2.17.22.20**”. This version number is the same for all three levels of head unit.

- After confirming the Available Version, press “Install Now” to start the reprogramming process. **NOTE:** The screen will go blank (black) for a brief period after installation begins.
- All the updates (Base, Mid and High) should take less than 10 minutes to install.

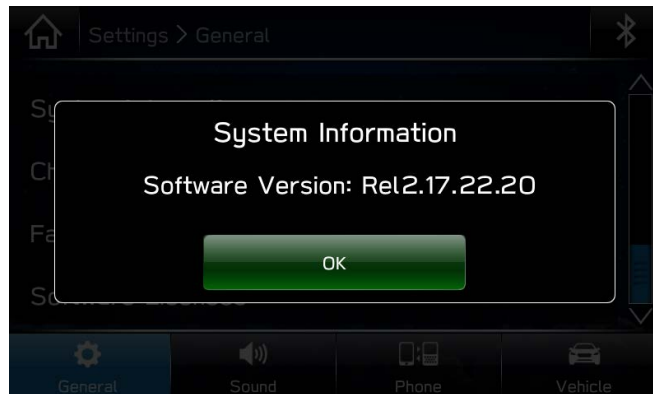
- Confirm Software Version is now “**Rel2.17.22.20**”.
