GROUP
Safety Recall Campaign

MODEL
**2011-2014MY
Optima (QF/TF)
2012-2014MY
Sorento (XMa)
2011-2013MY
Sportage (SL)**

NUMBER
SC147 (Rev 10, 05/16/2019)

SUBJECT: THETA II ENGINE INSPECTION AND/OR REPLACEMENT

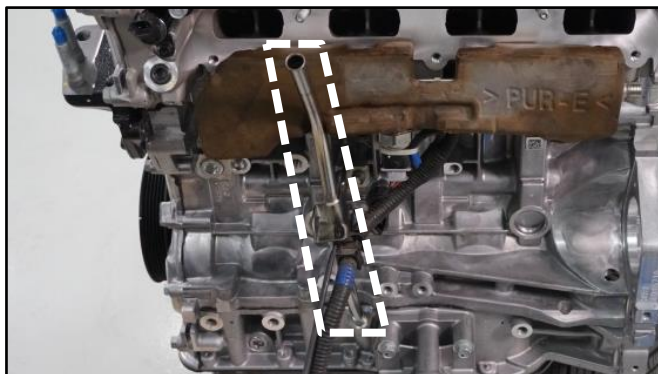
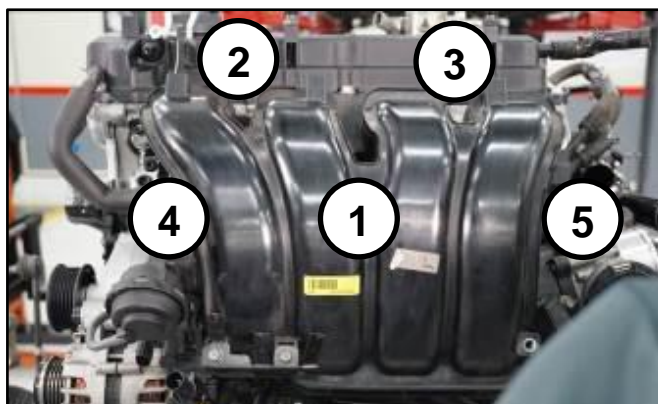
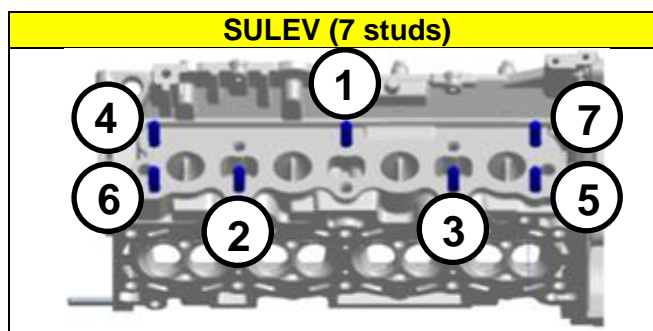
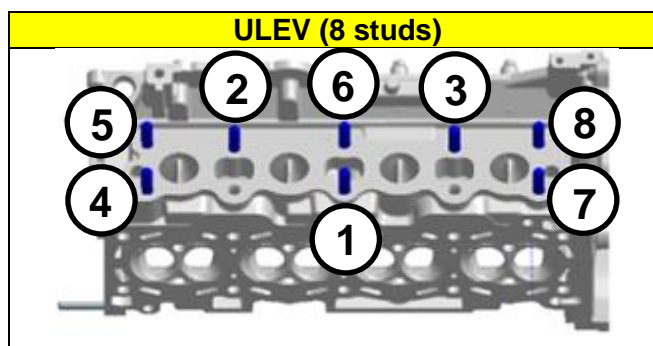
Replacement engines can be damaged due to ingestion of foreign material soon after installation. The source of this foreign material has been found to be metal debris from the original (damaged) engine. When an engine fails due to connecting rod breakage or piston failure, especially when the damage includes the combustion chamber area (valves/pistons/rings), pieces of metal or debris can be pushed past the intake valves and come to rest in the intake or exhaust manifold. After engine replacement, this metal debris will be pulled back into the engine via engine vacuum, usually during start up or during the first several miles of operation. Variable length intake runner systems are especially susceptible to this as the metal debris may come to rest on either side of the intake butterfly valves. In case of catastrophic failure, replace the intake manifold.

- Refer to “Guidelines in case of Catastrophic Failure” on page 14.
- In a case of a catastrophic engine failure, use a bore/videoscope and inspect the exhaust manifold for any metallic debris and remove.
- All engines supplied under this campaign have the exhaust manifold studs configured for SULEV engines.
- Using the pictures to the right, check the exhaust manifold stud location and quantity. Relocate as required for ULEV engines and obtain one (1) extra from the removed engine.
- Prior to installation, replace the exhaust manifold gasket and front muffler gasket.
- Torque nuts in the sequence shown.

Tightening torque of nuts:

**36.2 – 39.7 lb.ft (49.0 – 53.9 N.m,
5.0 – 5.5 kgf.m)**
