<b>GROUP</b> <b>Safety Recall Campaign</b>	<b>MODEL</b> <b>2011-2014MY Optima (QF/TF)</b> <b>2012-2014MY Sorento (XMa)</b> <b>2011-2013MY Sportage (SL)</b>
	<b>NUMBER</b> <b>SC147 (Rev 3, 7/14/2017)</b>	<b>DATE</b> <b>June 2017</b>
<b>SAFETY RECALL CAMPAIGN</b>		
<b>SUBJECT: THETA II ENGINE INSPECTION AND/OR REPLACEMENT</b>

This bulletin provides the procedure to inspect, and if necessary, replace the engine long block assembly on the following vehicles:

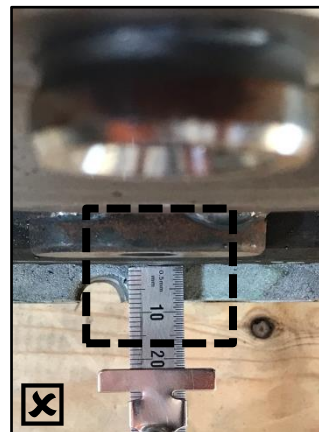
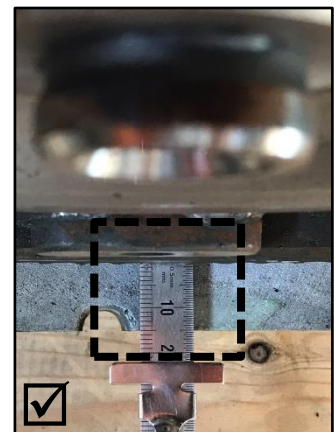
Torque Converter

Not Fully Inserted

Fully Inserted

- If the torque converter has moved from the fully inserted position, carefully push inward while rotating the torque converter until it is recessed approximately 9/16 – 5/8" (14 – 16mm) (☑) into the transaxle case when reinstalling the automatic transaxle.
