Vehicle Safety Recall - Technical Service Bulletin

Subject: Autocar® ACX with Cummins ISX12G engine and Peterbilt® 320 with Cummins ISX12G engine

Bulletin Date: April 2017

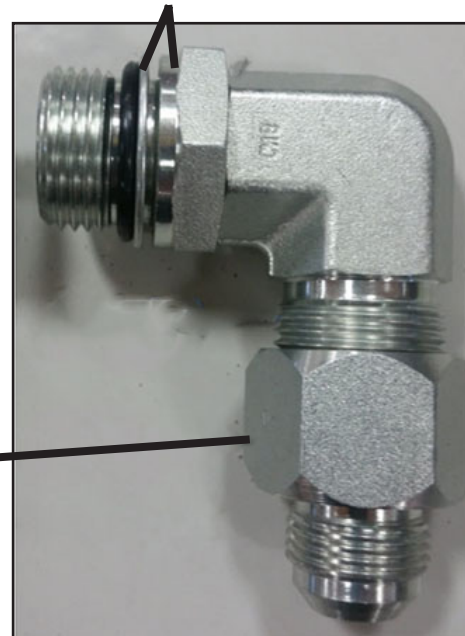
Correct Fitting

M27 x 2.0 x #12 JIC

No washer distortion
0 to 2 threads showing when installed

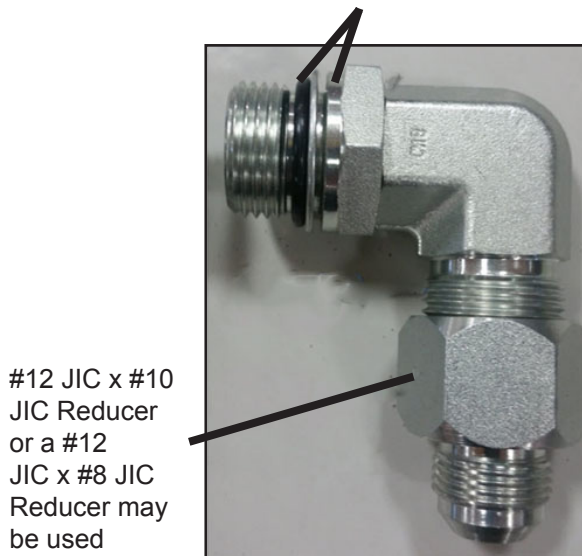
Peterbilt ISX12G units may have been shipped with a brass M27 x 2.0 x #10 JIC 45 or a SAE - 12 x #10 JIC 90 fitting at the filter (Figure 5). Both the brass M27 x 2.0 x #10 JIC 45 and SAE - 12 x #10 JIC 90 fitting do not fit into the housing correctly, allowing for a potential slow leak of CNG. See Figure 7 for an image of the correct fitting.

Correct Fitting for Peterbilt
M27 x 2.0 x #12 JIC

No washer distortion
0 to 2 threads showing
when installed
