SI B51 24 17
Body Equipment

RECALL 17V-328: E65/E66 (7 SERIES) DOOR LATCHES

E65 (7 Series)

E66 (7 Series)

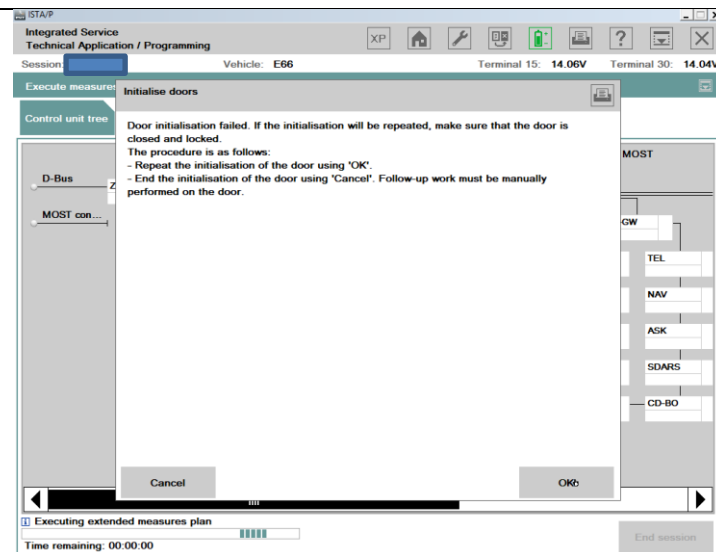
17. If the door does not open then this door will fail and need to be manually reworked.

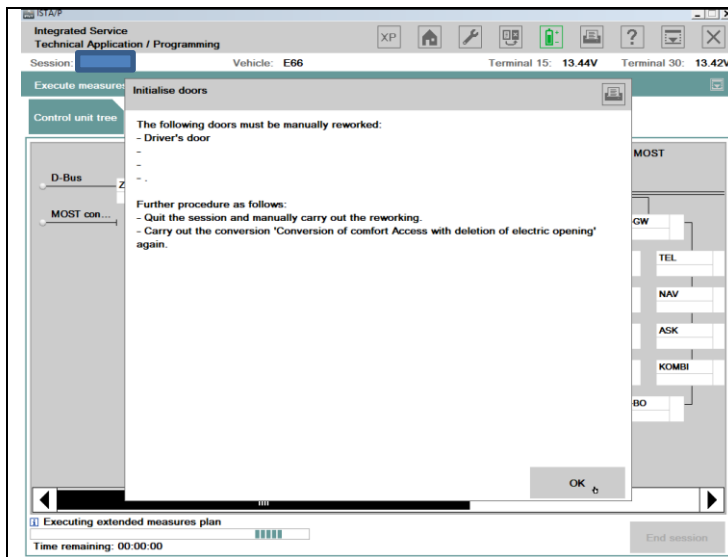
22. At the end of the session you will get the results of the test.
23. In this example only the driver's door needs to be reworked (door lock removed and electric opener cam removed). Always manually rework the doors that are listed.
24. **All other doors do not need to have the cam removed.**
25. **End the programming session, turn off the ignition.**
26. **At this point the windows cannot be moved so rework is not possible until after the 2nd programming session**
