Safety Recall T34 / NHTSA 17V-371 PHEV Power Inverter Module

2017-2018 (RU) Chrysler Pacifica PHEV

The Power Inverter Module (PIM) on about 1,600 of the above-referenced vehicles may experience diode failure due to an over-voltage condition. PIM diode failure will cause the vehicle to lose motive power without warning. The vehicle will not power back on and the diode failure may be accompanied by illumination of a Malfunction Indicator Lamp (MIL). A loss of motive power could cause a crash without warning. In addition, an update to the On-Board Diagnostic system is necessary.

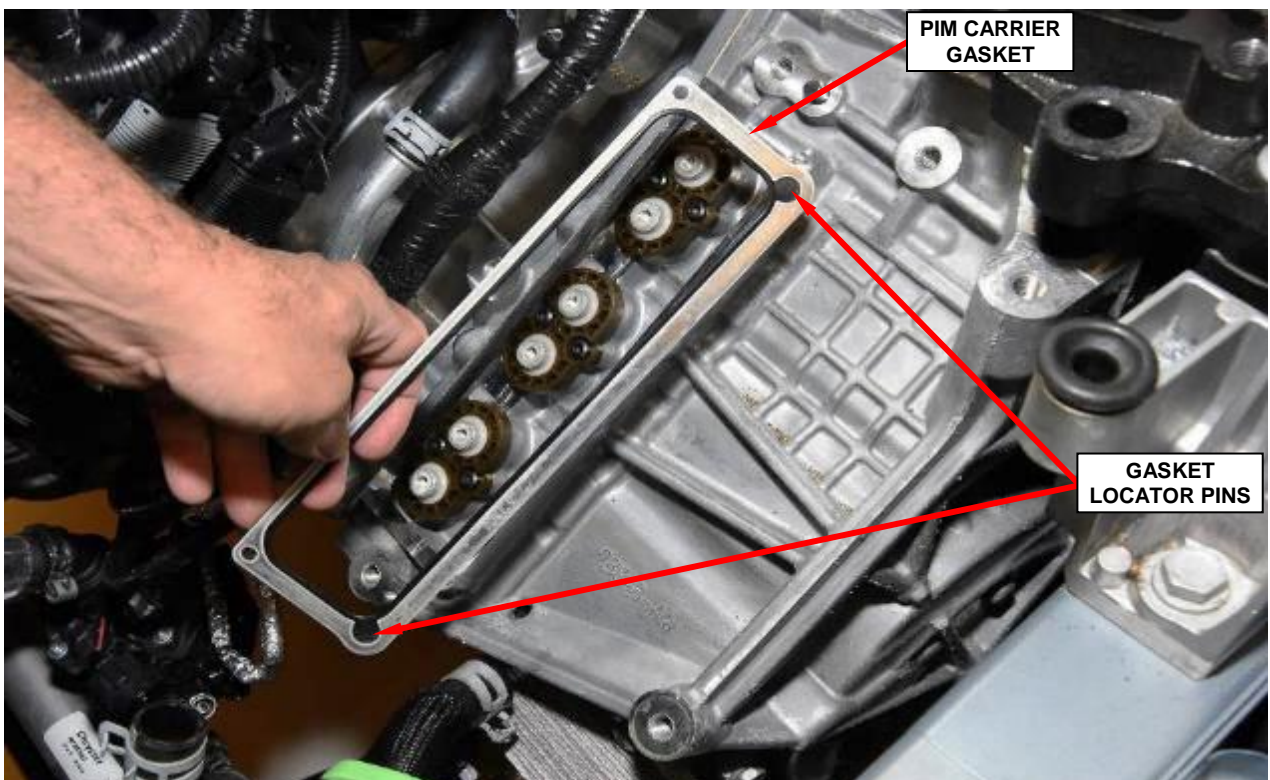
Figure 38 – PIM Carrier Gasket

NOTE: Ensure that the gasket locator pins are facing the transmission and are fully seated into the holes in the transmission housing (Figure 38). If the gasket is not installed correctly, water will enter the high voltage area and cause a loss of mobility.

1. Install the **new** PIM carrier gasket to the transmission housing while ensuring that that gasket locator pins are seated in the holes on the transmission housing (Figures 37 and 38).

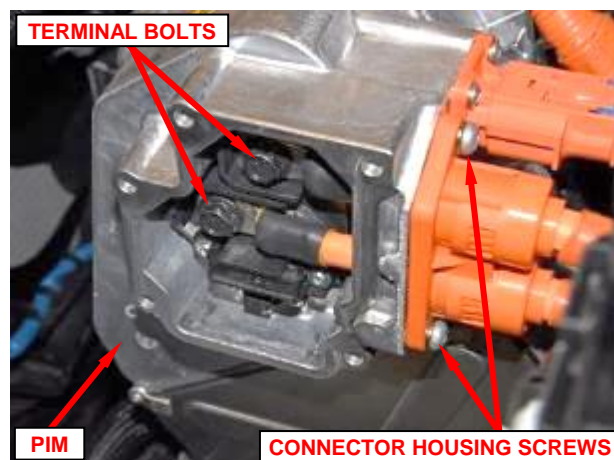
Figure 41 – High Voltage Battery Cables

CAUTION: Tightening of high voltage battery cable terminal bolts to proper torque specification is critical otherwise damage to PIM and/or high voltage battery cables may occur.

18. Install the high voltage battery cable connector housing into the PIM and tighten the two screws to 11 N·m (97 In. Lbs.) (Figures 23 and 22).
19. Install the high voltage battery cable terminal bolts and tighten to 25 N·m (18 Ft. Lbs.) (Figure 41).

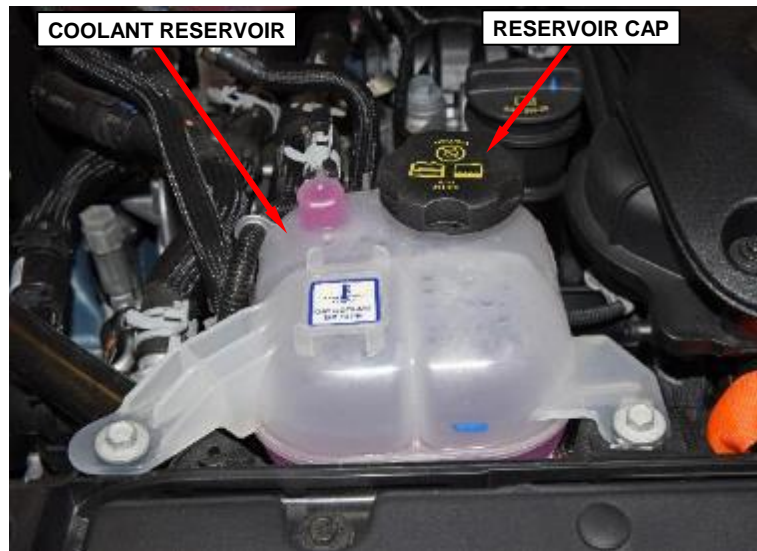
Figure 44 – Power Electronics Coolant Reservoir

CAUTION: Only deionized or distilled water can be used in the PHEV cooling systems. The use of tap water is prohibited as this can damage the components.

63. Add MS.12106 engine coolant to the power electronics cooling system pressurized coolant reservoir through the filler neck until the coolant level reaches the MAX level of the coolant reservoir (Figure 44).

NOTE: A 50/50 mixture of an ethylene glycol based antifreeze formulated with Organic Acid Technology (OAT) and deionized or distilled water is required such as Mopar® US - 68163849AB, Canada – 65175339AC 50/50 Prediluted Antifreeze/Coolant or equivalent meeting the requirements of FCA Material Standard MS.12106.
