GROUP Safety Recall	MODEL 2017MY Sorento (UMa) 3.3L
	NUMBER SC153 (Rev 2, 2/5/2018)	DATE November 2017
SAFETY RECALL		
SUBJECT: 3.3L LAMBDA ENGINE INSPECTION / REPLACEMENT (SC153)

This bulletin provides the procedure to inspect, and if necessary, replace the engine sub-assembly on certain 2017MY Sorento (UMa) vehicles, equipped with a Lambda engine produced from March 27, 2017 through March 30, 2017. The engine's crankshaft may not have been properly heat-treated during the manufacturing process. An improperly heat-treated crankshaft may produce a cyclic knocking noise from the engine, as well as result in the illumination of the vehicle's malfunction indicator lamp (MIL). If the warnings are ignored and the vehicle continues to be driven, the crankshaft may fail, and the vehicle may stall while in motion, increasing the risk of a crash. In addition, under certain conditions, a fire may occur. If the engine replacement is not necessary, replace the lower oil pan.

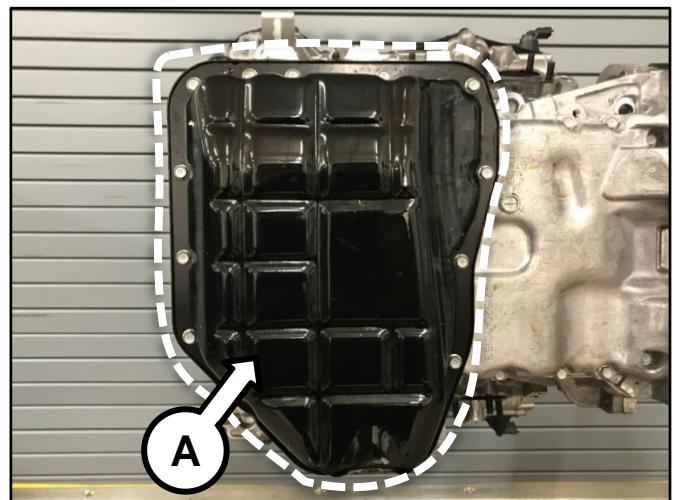
1. Remove the lower oil pan (A) by referring to the “Engine Mechanical System → Lubrication System → Oil Pan → Repair procedures” chapter in the applicable Shop Manual.

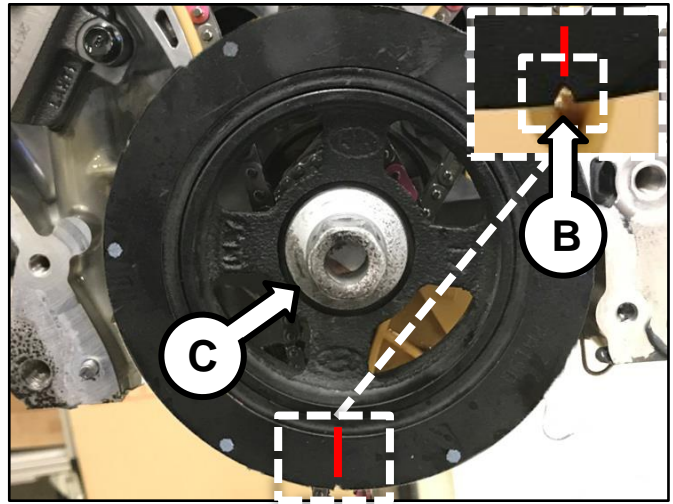
2. Rotate the crankshaft and bring the timing mark (B, red mark) on the crank pulley (C) to the 6 o'clock position.

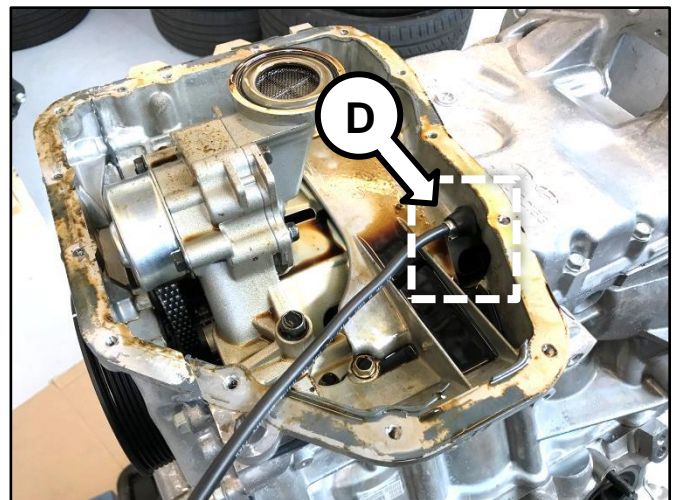
3. Insert the provided endoscope towards the rear of the engine through the oil return passage opening (D) of the upper oil pan.

4. Locate the last crankshaft counter weight (E) (furthest away from the crank pulley). Using the endoscope, locate the lot number stamped on the back side (F) of the counter weight.

If the lot number is 1, replace the engine (long block) by referring to the “Engine Mechanical System → Engine and Transaxle Assembly → Engine and Transaxle Assembly → Repair procedures” chapter in the applicable Shop Manual on KGIS.

If the lot number is 2, 3 or 4, replace the lower oil pan by referring to the “Engine Mechanical System → Lubrication System → Repair procedures” chapter in the applicable Shop Manual on KGIS and refill with new engine oil.
