GROUP Safety Recall Campaign	MODEL 2014-2016MY Soul (PS) Soul (PS EV)
	NUMBER SC155	DATE November 2017
SAFETY RECALL CAMPAIGN		
SUBJECT: STEERING GEAR ASSEMBLY PINION PLUG INSPECTION/REPAIR/REPLACEMENT (SC155)

This bulletin provides information related to inspection, repair, and, if necessary, the replacement of the steering gear assembly of some 2014-2016MY Kia Soul (PS) and Soul EV (PS EV) vehicles, produced from July 21, 2013 through September 30, 2015. The vehicles included in this recall were previously recalled under Recall SC108 (14v332) and SC125 (15v736). This recall is being conducted to confirm that the subject vehicles received a proper repair. In some cases, the pinion plug may not have been secured properly. As a result, the pinion gear may separate from the steering gear assembly, causing loss of steering and could increase the risk of a crash.

Dealers are to inspect the pinion plug to ensure the recall repair, if previously conducted, was properly done. Based upon the inspection results, the previous recall repairs will either be redone with an improved method or, if necessary, the steering gear assembly will be replaced. Vehicles that were not previously repaired

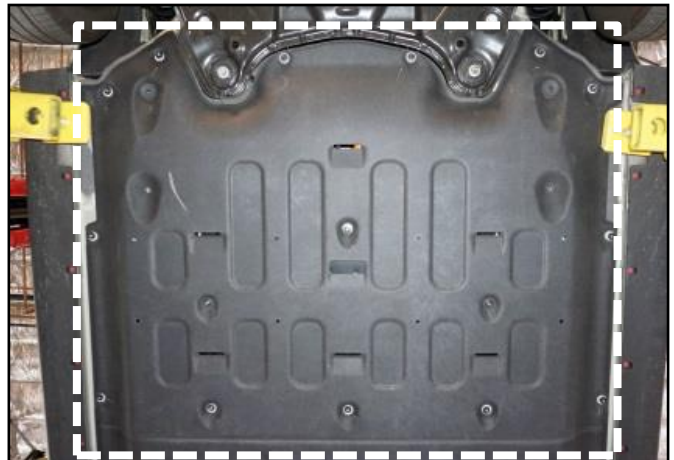
Soul (PS EV) Front Battery Cover shown

1. With the ignition off, vehicle raised on a lift, and the engine under-cover (PS) or front battery cover splash shield (PS EV) removed, check to see if a set screw was previously installed.
 - If so, remove the silicone previously applied during the SC125 repair.
 - If there is no set screw installed, proceed with the **Set Screw Installation Procedure** on page 7.
