Compliance Recall Code: 69T7

Subject	Head Curtain Airbags	
Release Date	January 05, 2018	
Affected Vehicles	U.S.A. : Certain 2018 MY Audi A5 Coupe	
	Check Campaigns/Actions screen in Elsa on the day of repair to verify that a VIN qualifies for repair under this action. Elsa is the <u>only</u> valid campaign inquiry & verification source.	
	✓ Campaign status must show "open."	
	✓ If Elsa shows other open action(s), inform your customer so that the work can also be completed at the same time the vehicle is in the workshop for this campaign.	
Problem Description	A head curtain airbag may not unfold properly from the A-pillar during deployment. In a crash where the head curtain airbag deploys, this may result in reduced airbag protection and could increase the risk of injury to vehicle occupants. This makes the head curtain airbags noncompliant with Federal Motor Vehicle Safety Standard No. 226 – Ejection Mitigation.	
Corrective Action	Remove excess fabric from the head curtain airbags, along with the paper sleeve on the upper part of the A-pillar.

Subject: Compliance Recall 69T7 – Head Curtain Airbags Certain 2018 Model Year Audi A5 Coupe

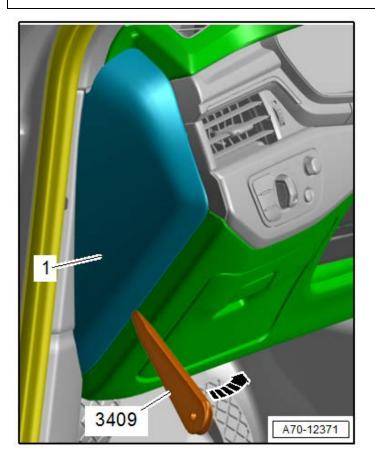
• Pry off the instrument panel side cover <1> using the -3409- in direction of <arrow>.

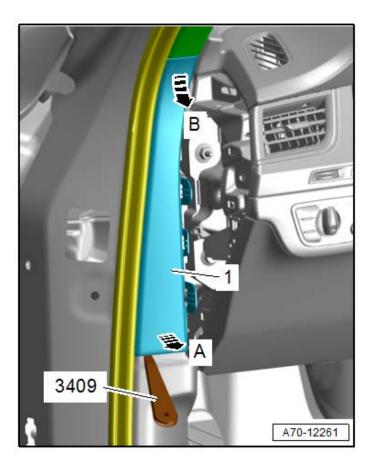
• Unclip the A-pillar gap cover <1> using the -3409- in direction of <arrow A> and disengage at the A-pillar upper trim panel in direction of <arrow B>.

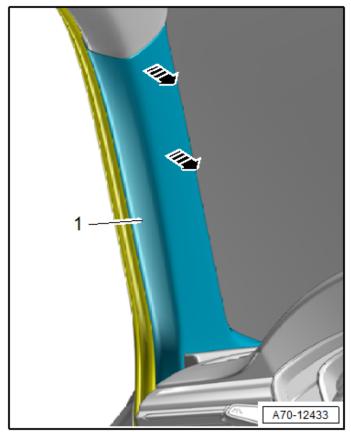
- Free up the A-pillar trim panel <1> in the door seal area.
- Detach the A-pillar trim panel using the -3409up to the first retainer <arrows>.

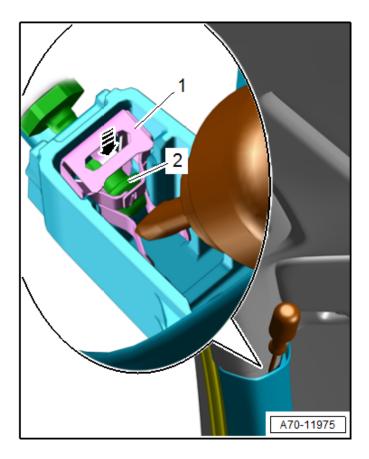
- Place a flat-head screwdriver at the position shown on the clip.
- Push the clip downward with the flat-head screwdriver into the trim panel <arrow>. This will move the clip hooks from the pin head <2>.

- The A-pillar clips <1> may be damaged during removal.
- The A-pillar clip must be replaced even if was not damaged during removal.
- Take care that the A-pillar trim is not damaged during removal.

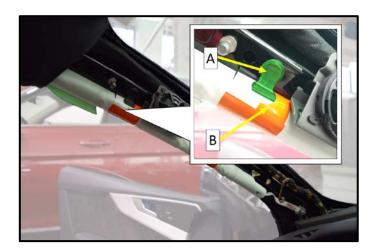
• Remove and discard clip <A> and tape from the head curtain airbag.

- Do not cut the airbag material when removing tape .
- All of the tape must be removed from the head curtain airbag.

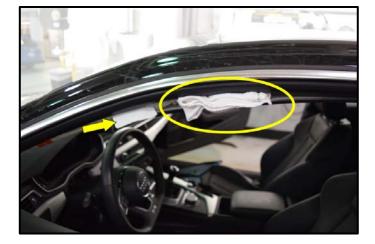
- The tape is perforated and should be able to be removed without using any tools.
- If the tape cannot be torn, used curved tip scissors to cut off the tape.
- Pull the headliner down slightly and place a clean folded shop rag <circle> between the roof and the headliner as shown.
- Pull the head curtain airbag material out slightly <arrow>.

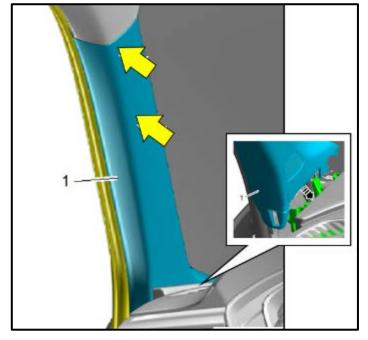
The A-pillar clip must be replaced even if was not damaged during removal.

• Install new clip into the A-pillar trim.
