Product Safety Recall

17009 Front Passenger Air Bag Inflator

Reference Number: N162017009

Release Date: December 2017

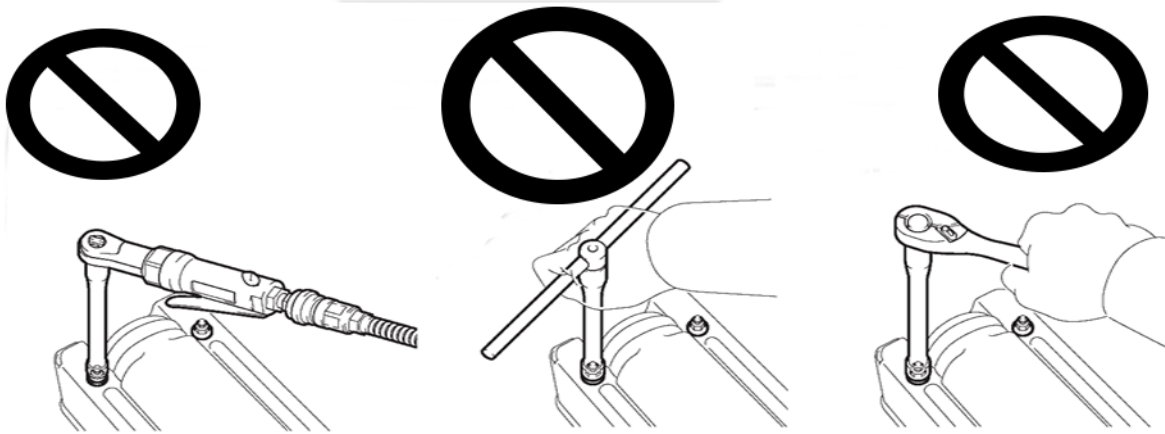
4751084

Important: If any gap exists, the aligned flats may move apart, resulting in failure in normal deployment of the airbag.

8. Remove the 3 remaining old self-locking nuts and install temporarily 3 NEW self-locking nuts by hand. Store the removed self-locking nuts in a replacement part box or the like.
9. Push the inflator and plate towards the position determining plate to eliminate any gap.

Important: The tightening torque is low (3.9 N·m). Use of an air ratchet wrench or tightening strongly with a T-handle wrench or a ratchet handle may cause deformation of the stud bolt.
