Product Safety Recall

17009 Front Passenger Air Bag Inflator

Reference Number: N162017009

Release Date: January 2018

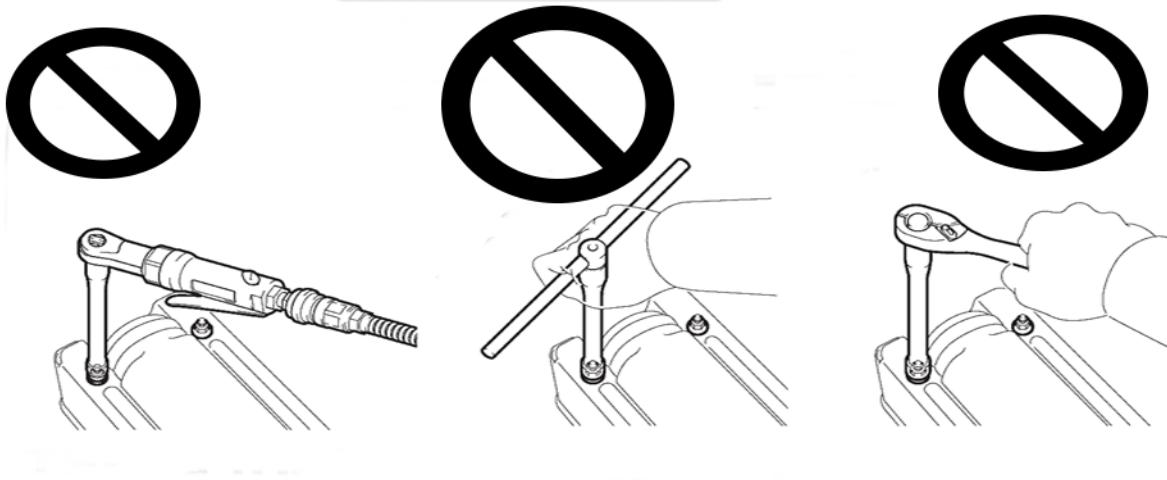
4751084

Important: If any gap exists, the aligned flats may move apart, resulting in failure in normal deployment of the airbag.

8. Remove the 3 remaining old self-locking nuts and install temporarily 3 **NEW** self-locking nuts by hand. Store the removed self-locking nuts in a replacement part box or the like.
9. Push the inflator and plate towards the position determining plate to eliminate any gap.

Important: The tightening torque is low (3.9 N·m). Use of an air ratchet wrench or tightening strongly with a T-handle wrench or a ratchet handle may cause deformation of the stud bolt.
