Product Safety Recall

17387 Driver Airbag Abnormal Deployment

Reference Number: N172103640

Release Date: October 2017
Revision: 01

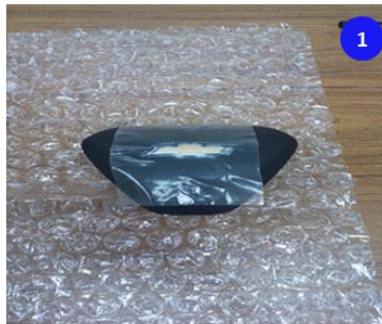
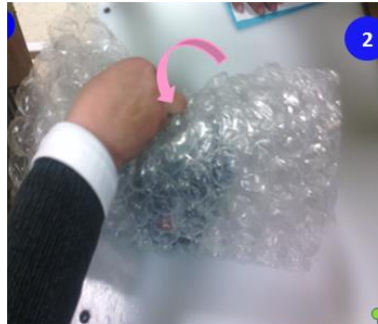
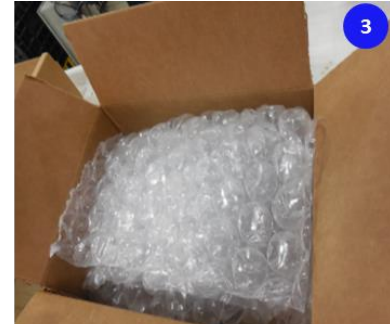
4481574

Note: The components required for the completed return package are dunnage (1) and foam (2), as shown in the graphic above.

1. **DO NOT DEPLOY THE AIRBAG.** Ensure that the box the replacement airbag arrived in is not damaged and place the steering wheel airbag in the box. Also, make sure to include a copy of the repair order in the box.
