Safety Recall Campaign 4009
SC-77

November 2, 2018

Safety Recall Campaign 4009 Power Steering Tensioner Pulley

Affected Models: Certain 2006 Grand Vitara Models

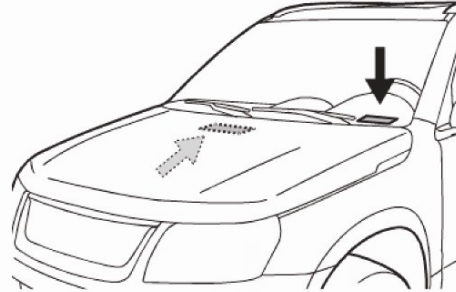
Vehicle Identification Number

The vehicle identification number is punched on the front dash panel in engine room and it is also attached on the left front top of instrument panel depending on vehicle specification.

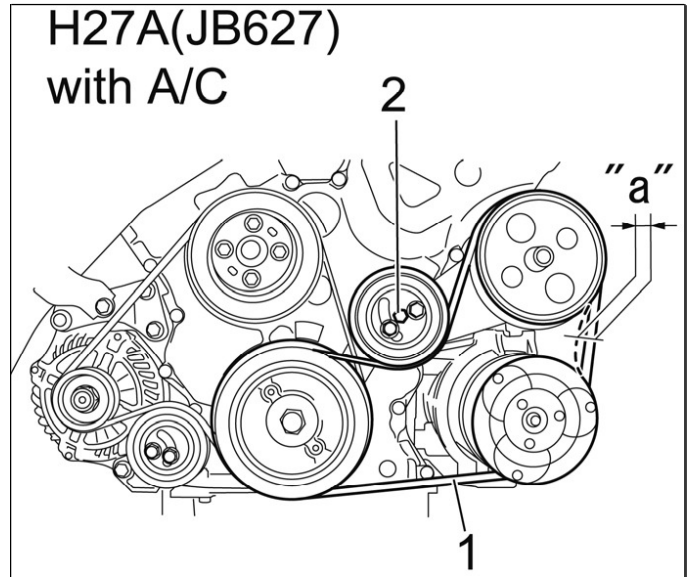
Measuring condition: When pushing on the belt at the center point between the pulleys with 100N (22.5 lbf-ft) of force as shown to the right.

Proceed to step 10.

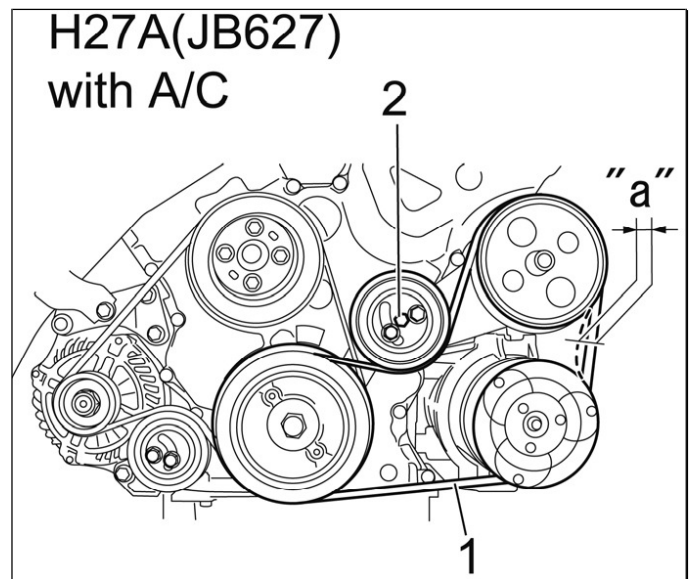
Sonic Tension Method

Readjustment: 400 ± N

- 7) Set the sonic tension meter to the following frequency filter values:

Proceed to step 10.

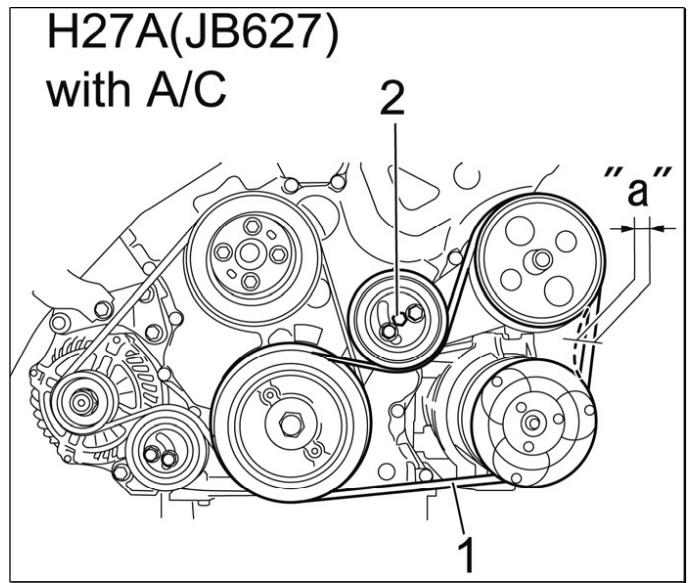
Torque Method

Readjustment:
12 N·m (9.0 lbf-ft)

- Using the 10mm hex socket, insert the 10mm hex tool in the hexagonal hole on the pulley and turn it counterclockwise to increase the tension until you obtain the specified torque value as shown below. Then temporarily tighten the adjusting bolt and pulley bolt.

Proceed to step 10.
