Service Engineering Operations  
Customer Service Division

**TO:** All U.S. Ford and Lincoln Dealers  
**SUBJECT:** **NEW VEHICLE DEMONSTRATION / DELIVERY HOLD**  
**Safety Recall 18S29 - Supplement #1**  
Certain 2017-2018 Model Year Ford GT Vehicles  
Module Reprogramming  
**REF:** **Safety Recall 18S29**  
Dated November 19, 2018

In some of the affected vehicles, fluid pressure within the Active Aero wing valve block assembly can exceed the capabilities of the seals, which may result in a leak of hydraulic fluid. Leaking of hydraulic fluid in the presence of an ignition source can increase the risk of a fire.

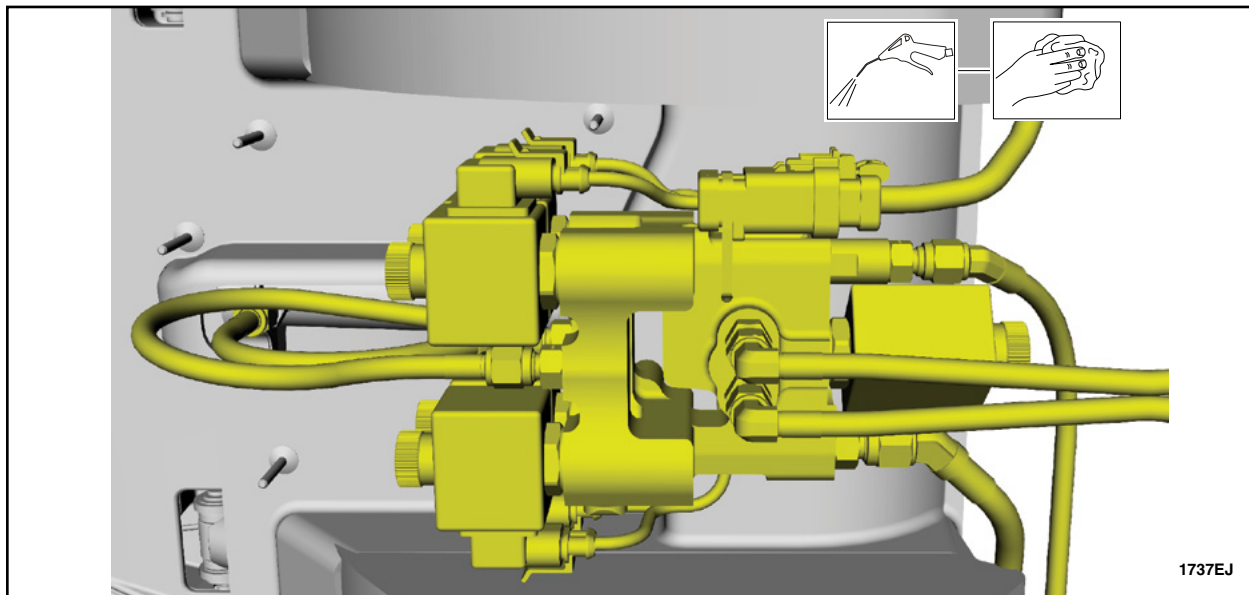
FIGURE 5

15. Thoroughly clean the area around the aero wing valve block assembly to ensure it is free of dirt or debris. See Figure 5.

**NOTICE:** Failure to do this may allow debris to enter the system and cause damage to the valves.
