PRODUCT CAMPAIGN BULLETIN

<p>APPLICABILITY: 2009-2013 model year Legacy 2009-2013 model year Outback 2009-2013 model year Forester 2009-2013 model year Tribeca 2009-2011 model year Impreza 2009-2013 model year WRX and STI</p> <p>SUBJECT: Takata Front Passenger Airbag Inflator Replacement (2018 Calendar year expansion)</p>	<p>NUMBERS: TKA-18R TKB-18R TKC-18R</p> <p>DATE: 02/09/18 REVISED: 12/28/23</p> <p>NHTSA ID: 18V-012 18V-013 18V-014</p>
---	---

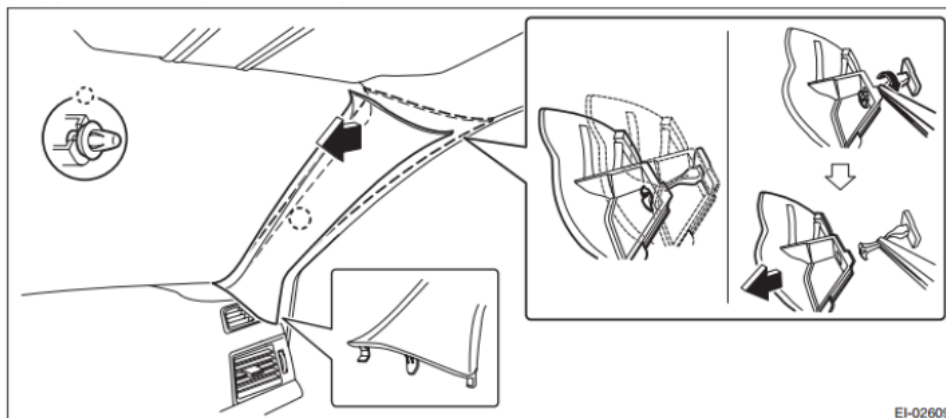
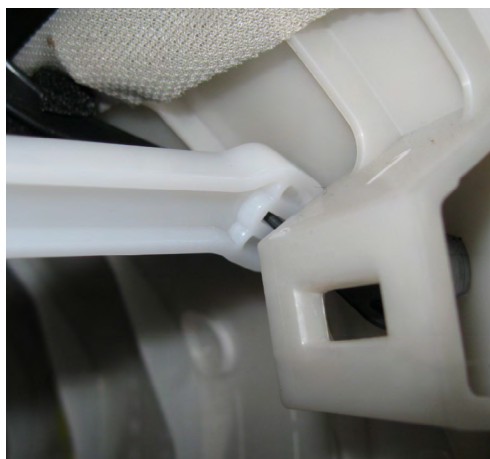
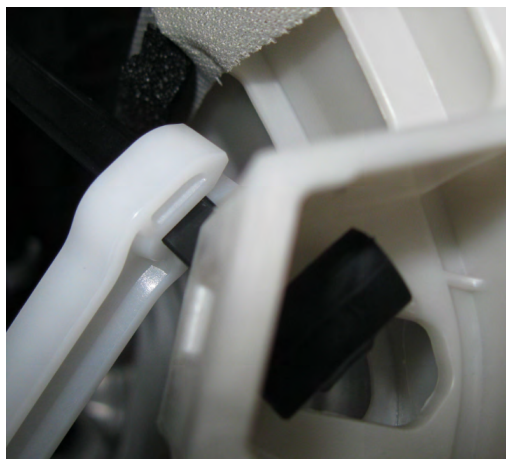
NOTE: Some models utilize a “tether clip” to secure the upper portion of the “A” pillar trim. The tether clip is located just below where the “A” pillar trim meets the head liner. If the tether clip becomes damaged, it **MUST** be replaced. The illustrations and photos below show the location of the tether clip and how to release it. It is **STRONGLY RECOMMENDED** to use the release tool (p.n. **SOA635147**) specifically designed for tether clip removal. Each Retailer has been supplied with 2 of these tools. If the tool is unavailable, a needle-nosed plier can be used to **CAREFULLY** release the tether clip as shown in the illustration below.

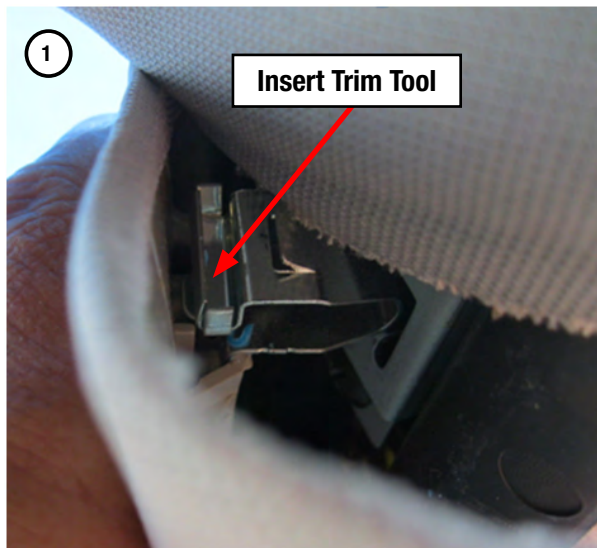
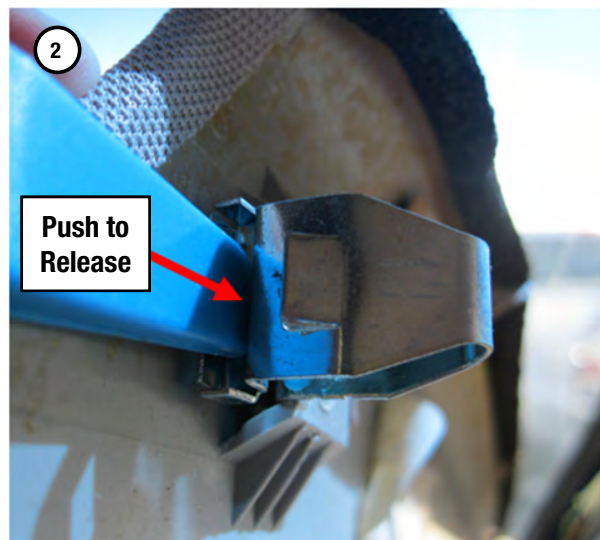
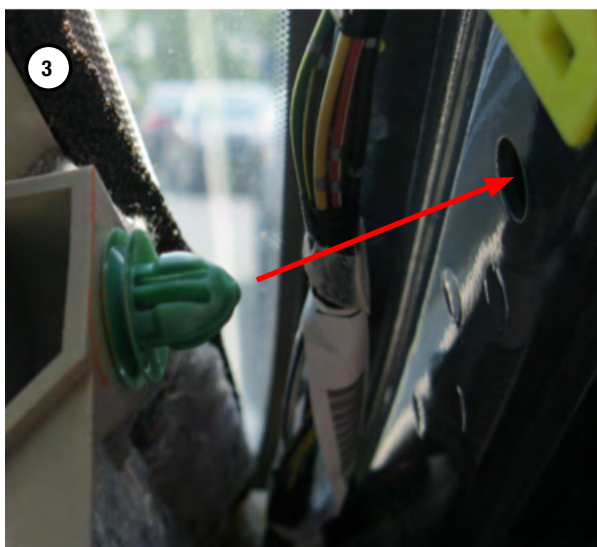
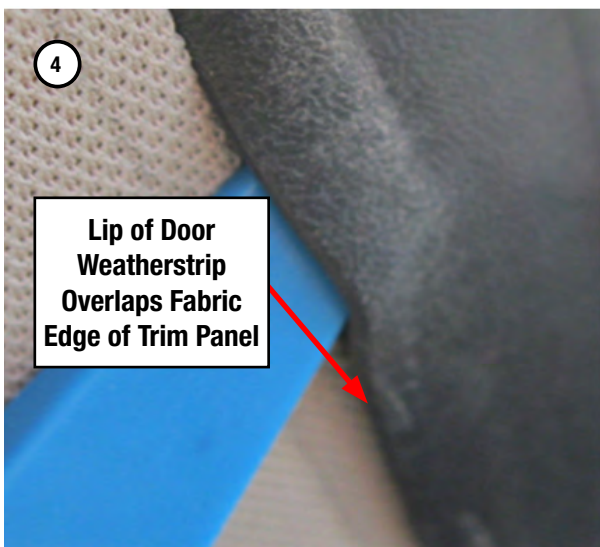
NOTE: When removing the "A" pillar trim, be **VERY CAREFUL** not to damage the upper metal retaining clip. The clip is located just below where the trim panel meets the head liner. If the metal retaining clip becomes damaged or separated from the trim panel, the trim panel **MUST** be replaced as the clip is not available separately. Use a plastic trim tool to push and release the upper portion of the metal clip from the body. Be careful to not pull the trim panel open any further than necessary to gain access for releasing the clip. There is a plastic retaining clip in the lower portion of the trim panel which will release easily once the upper retaining clip is loose. At reassembly and using a plastic trim tool, make sure the inner lip of the door weatherstrip overlaps the outer fabric edge of the trim panel to help secure it.

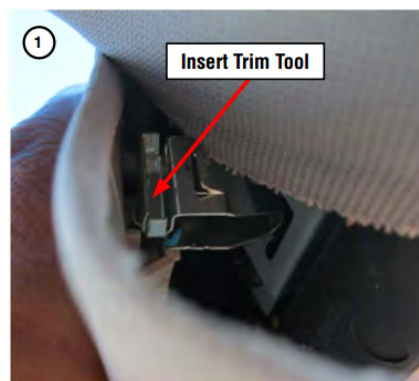
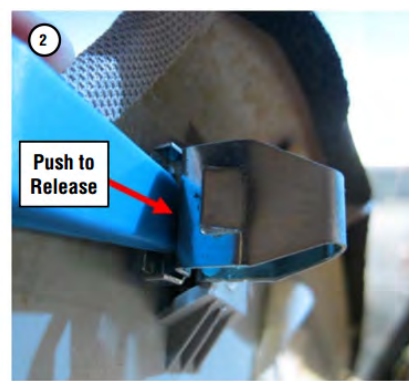
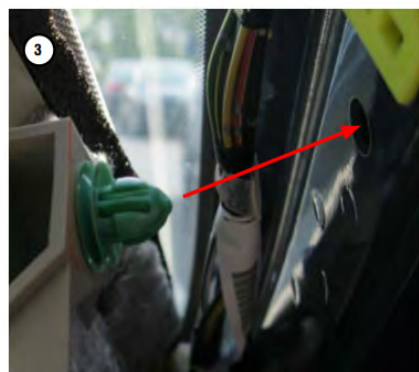
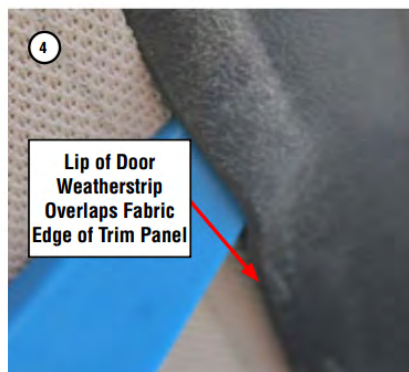
NOTE: When removing the “A” pillar trim, be **VERY CAREFUL** not to damage the upper metal retaining clip. The clip is located just below where the trim panel meets the head liner. If the metal retaining clip becomes damaged or separated from the trim panel, the trim panel **MUST** be replaced as the clip is not available separately. Use a plastic trim tool to push and release the upper portion of the metal clip from the body. Be careful to not pull the trim panel open any further than necessary to gain access for releasing the clip. There is a plastic retaining clip in the lower portion of the trim panel which will release easily once the upper retaining clip is loose. At reassembly and using a plastic trim tool, make sure the inner lip of the door weatherstrip overlaps the outer fabric edge of the trim panel to help secure it.
